WELDING INSPECTION REPORT

Report No: WIR-011951
Date Inspected: 07-Feb-2010

Project Name: SAS Superstructure
Prime Contractor: American Bridge/Fluor Enterprises, a JV
Contractor: Zhenhua Port Machinery Company, Ltd (ZPMC), Changxing Island

Bridge No: 34-0006
Component: Tower

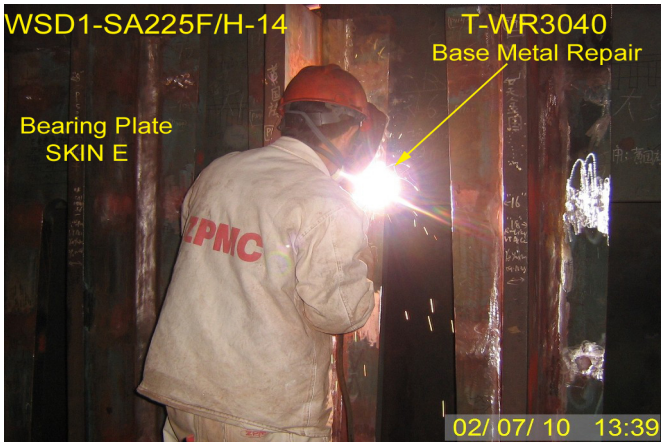
This QA inspector observed the following work in progress:
ZPMC performed Base metal repair of Bearing Plate located on Skin E (WSD1-SA225F/H -14). The base metal repair area is approximately 2mm depth and 85mm length. The material is A709M Grade 345 Non-SPCM. Welder is identified as 066674.ZPMC CWI is identified as Mr. You Qi Guo. SMAW Welding was been performed against welding repair report T-WR3040. The welding variables recorded by QC appeared to comply with the WPS-345-SMAW-3G (3F)-Repair.

This QA inspector observed the following work in progress:
ZPMC performed Weld metal repair of Bearing Plate located on Skin E (WSD1-SA225F/H -24). The weld metal repair area is approximately 8mm depth, 50mm length and 20mm width. The material is A709M Grade 345 Non-SPCM. Welder is identified as 066674.ZPMC CWI is identified as Mr. You Qi Guo. SMAW Welding was been performed against welding repair report T-WR3061. The welding variables recorded by QC appeared to comply with the WPS-345-SMAW-3G (3F)-Repair.
