Contract #: 04-0120F4
Cty: SF/ALA Rte: 80 PM: 13.2/13.9
File #: 69.28

WELDING INSPECTION REPORT

Report No: WIR-011952
Date Inspected: 09-Feb-2010

Project Name: SAS Superstructure
Prime Contractor: American Bridge/Fluor Enterprises, a JV
Contractor: Zhenhua Port Machinery Company, Ltd (ZPMC), Changxing Island

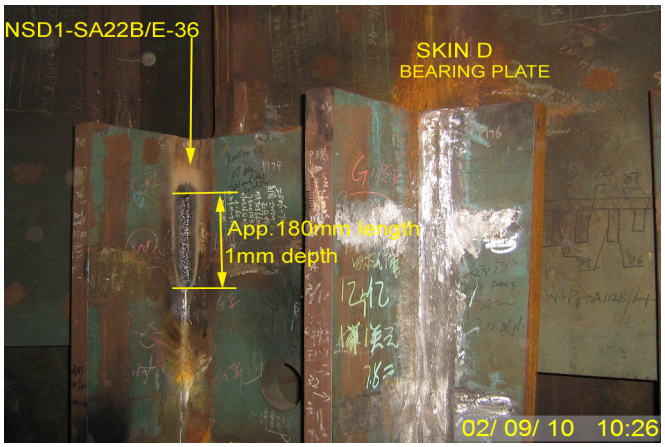
This QA inspector observed the following work in progress:
ZPMC performed Weld metal repair of Bearing Plate located on Skin D (NSD1-SA22B/E -36). The weld metal repair area is approximately 1mm depth and 180mm length. The material is A709M Grade 345 Non-SPCM. Welder is identified as 053829.ZPMC CWI is identified as Mr. You Qi Guo. SMAW Welding was been performed. The welding variables recorded by QC appeared to comply with the WPS-345-SMAW-3G (3F)-Repair.
