WELDING INSPECTION REPORT

Report No: WIR-012529
Date Inspected: 12-Feb-2010

Project Name: SAS Superstructure
Prime Contractor: American Bridge/Fluor Enterprises, a JV
Contractor: Zhenhua Port Machinery Company, Ltd (ZPMC), Changxing Island

Bridge No: 34-0006
Component: Tower

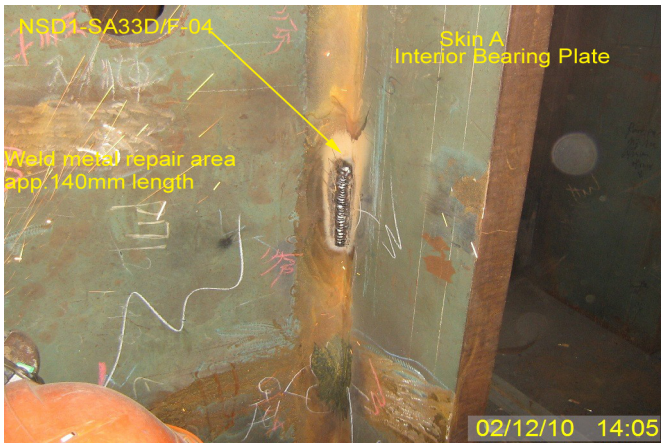
This QA inspector observed the following work in progress:
ZPMC performed Weld metal repair of Interior Bearing Plate located on Skin A (NSD1-SA33D/F-04). The weld metal repair area is approximately 2mm depth and 140mm length. The material is A709M Grade 345 Non-SPCM. Welder is identified as 053829.ZPMC CWI is identified as Mr. You Qi Guo. SMAW welding was been performed. The welding variables recorded by QC appeared to comply with the WPS-345-SMAW-3G (3F)-Repair.Please see the attached picture below

This QA inspector observed the following work in progress:
ZPMC performed Weld metal repair of Bearing Plate located on Skin C (NSD1-SA17F/G-20). The weld metal repair area is approximately 2mm depth and 50mm length. The material is A709M Grade 345 Non-SPCM. Welder is identified as 040270.ZPMC CWI is identified as Mr. You Qi Guo. SMAW welding was been performed. The welding variables recorded by QC appeared to comply with the WPS-345-SMAW-3G (3F)-Repair. Please see the attached picture below.
