DEPARTMENT OF TRANSPORTATION
DIVISION OF ENGINEERING SERVICES
Office of Structural Materials
Quality Assurance and Source Inspection

WELDING INSPECTION REPORT

Report No: WIR-012493
Date Inspected: 03-Mar-2010

Project Name: SAS Superstructure
Prime Contractor: American Bridge/Fluor Enterprises, a JV
Contractor: Zhenhua Port Machinery Company, Ltd (ZPMC), Changxing Island

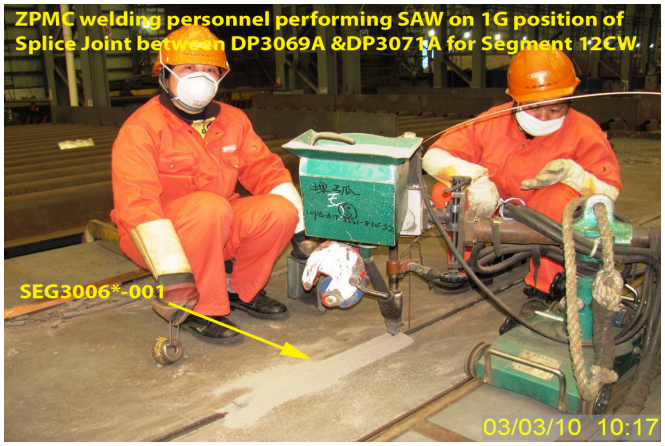
Unless otherwise noted, all work observed on this date appeared to generally comply with applicable contract documents.
