WELDING INSPECTION REPORT

Report No: WIR-013035
Date Inspected: 14-Apr-2010

Project Name: SAS Superstructure
Prime Contractor: American Bridge/Fluor Enterprises, a JV
Contractor: Zhenhua Port Machinery Company, Ltd (ZPMC), Changxing Island

Bridge No: 34-0006
Component: Tower

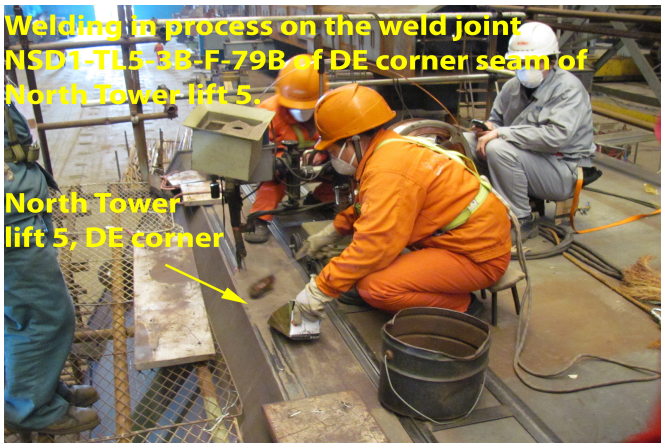
Unless otherwise noted, all work observed on this date appeared to generally comply with applicable contract documents.
