DEPARTMENT OF TRANSPORTATION
DIVISION OF ENGINEERING SERVICES
Office of Structural Materials
Quality Assurance and Source Inspection

WELDING INSPECTION REPORT

Report No: WIR-015744
Date Inspected: 20-Jul-2010

Project Name: SAS Superstructure
Prime Contractor: American Bridge/Fluor Enterprises, a JV
Contractor: Zhenhua Port Machinery Company, Ltd (ZPMC), Changxing Island

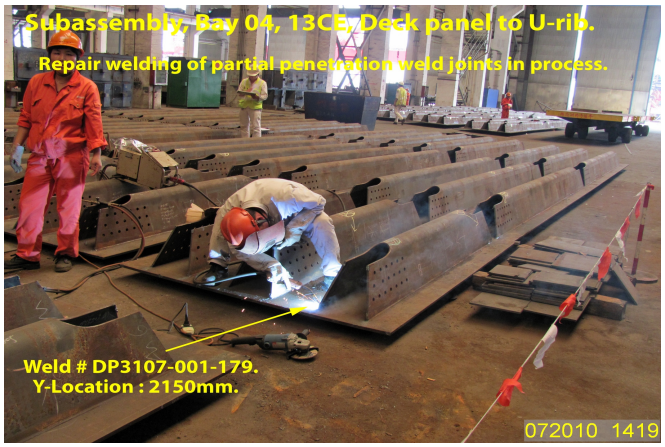
FCAW Repair welding of partial penetration weld joints DP3107-001-005, 003, 138, 179; located on subassembly, Bay 04, 13CE. Welder is identified as 062265; ZPMC Quality Control Inspector (QC) is identified as Yang Bai Qian. The welding variables recorded by Quality Control Inspector (QC) appeared to comply with the Applicable WPS: WPS-345-FCAW-2G(2F)-FCM-REPAIR. The attached photographs provide additional detail.

During Random Visual in process Inspection, this QA inspector observed ZPMC NDT personnel “Tany Xingshan” carrying out Ultrasonic Testing (UT) for Lack of Penetration (LOP) on Deck panel to U-rib weld on repair locations. Deck Panel identified as DP3078-001. The attached photographs provide additional detail.
