WELDING INSPECTION REPORT

Report No: WIR-016422
Date Inspected: 19-Aug-2010

Project Name: SAS Superstructure
Prime Contractor: American Bridge/Fluor Enterprises, a JV
Contractor: Zhenhua Port Machinery Company, Ltd (ZPMC), Changxing Island

Bridge No: 34-0006
Component: OBG

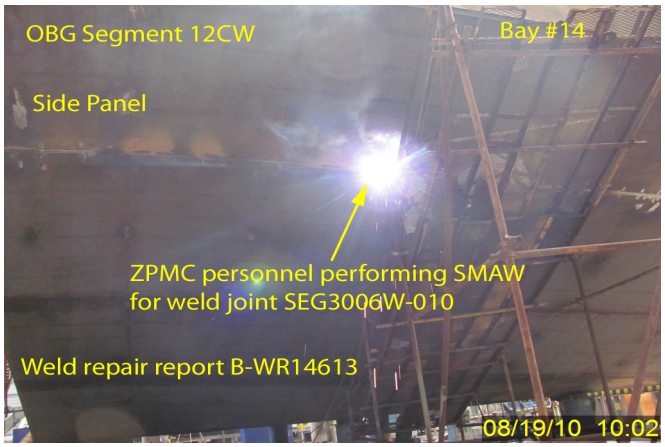
This QA inspector observed the following work in progress:
SMAW welding of weld joint no: SEG3006W-010 located on OBG Segment 12CW Side panel to Side panel. Welder is identified as #067904. ZPMC QC is identified as Mr. Wang wei ming. Welding was performed according to the weld repair report B-WR14613 and UT report number: B787-UT-14496.The welding variables recorded by QC appeared to comply with the WPS-345-SMAW-4G(4F)-Repair. Please see the attached picture

This QA Inspector observed the following work in progress:
FCAW in the 1G position for the OBG Segment 13CE Side Plate, weld No: SEG3011A-013. The welder is identified as #044790. ZPMC QC is identified as Mr. Guo xing hui. The welding variables recorded by QC appear

to comply with WPS-B-T-2231-B-U2-F.Please see the attached picture.
