Contract #: 04-0120F4
Cty: SF/ALA Rte: 80 PM: 13.2/13.9
File #: 69.28

WELDING INSPECTION REPORT

Report No: WIR-017161
Date Inspected: 01-Oct-2010

Project Name: SAS Superstructure
Prime Contractor: American Bridge/Fluor Enterprises, a JV
Contractor: Zhenhua Port Machinery Company, Ltd (ZPMC), Changxing Island

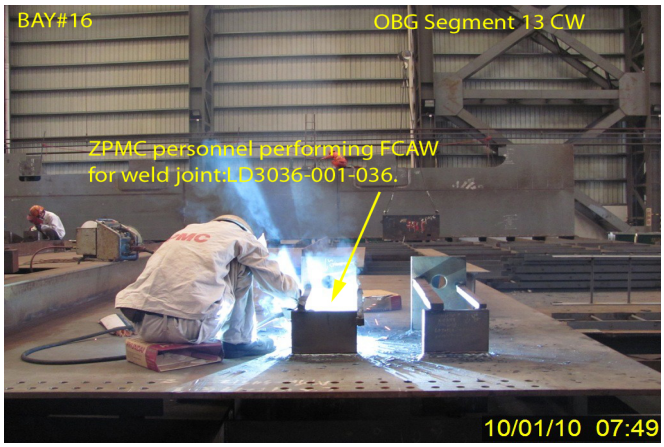
This QA Inspector observed the following work in progress:
FCAW in the 2G position for the OBG Segment 13 CW, weld No: LD3036-001-036. The welder is identified as #045174. ABF QA is identified as Mr. Zou Lui Hai. The welding variables recorded by QC appear to comply with WPS-B-T-2232-B-U5-F. Please see the attached picture.

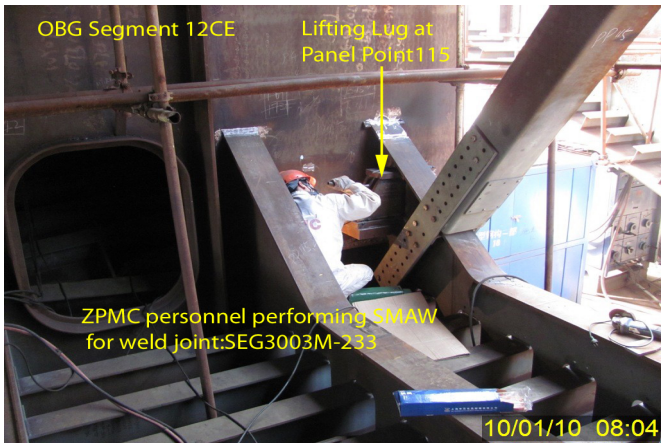
This QA Inspector observed the following work in progress:
SMAW in the 4G position for the OBG Segment 12CE Lifting lug at Panel point115, weld No: SEG3003M-233. The welder is identified as #054013. ZPMC QC is identified as Mr. Li ping. The welding variables recorded by QC appear to comply with WPS-B-P-2214-TC-U4b-FCM-1. Please see the attached picture.
