Contract #: 04-0120F4
Cty: SF/ALA Rte: 80 PM: 13.2/13.9
File #: 99.28

WELDING INSPECTION REPORT

Report No: WIR-023815
Date Inspected: 05-Jan-2011

Project Name: SAS Superstructure
Prime Contractor: American Bridge/Fluor Enterprises, a JV
Contractor: Zhenhua Port Machinery Company, Ltd (ZPMC), Changxing Island

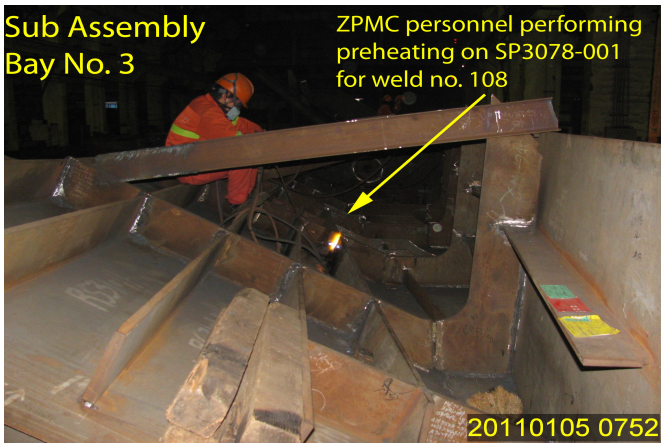
SMAW welding of complete join penetration welds located on Side Plate component identified as SP3078-001 for weld no. 108 & 118. Welder is identified as welder no. 058087. The welding variables recorded by ZPMC QC identified as Tian Lei appeared to comply with applicable WPS(s) WPS-B-P-2213-TC-U4b.

FCAW welding of complete join penetration welds located on Architectural Housing component identified as AH3152A for weld no. 111. Welder is identified as welder no. 050977. The welding variables recorded by ZPMC QC identified as Tian Lei appeared to comply with applicable WPS(s) WPS-B-T-2233-ESAB.

FCAW welding of fillet welds located on Architectural Housing component identified as AH3152A for weld no. 112. Welder is identified as welder no. 050977. The welding variables recorded by ZPMC QC identified as Tian Lei appeared to comply with applicable WPS(s) WPS-B-T-2232-ESAB.

FCAW welding of complete join penetration welds located on Side Plate component identified as SP3077-001 for weld no. 095 & 096. Welder is identified as welder no. 054069. The welding variables recorded by ZPMC QC identified as Tian Lei appeared to comply with applicable WPS(s) WPS-B-T-2132-ESAB.

Unless otherwise noted above all items observed on this day appeared to be in general compliance with the applicable contract documents
