DEPARTMENT OF TRANSPORTATION
DIVISION OF ENGINEERING SERVICES
Office of Structural Materials
Quality Assurance and Source Inspection

WELDING INSPECTION REPORT

Report No: WIR-023858
Date Inspected: 18-May-2011

Project Name: SAS Superstructure
Prime Contractor: American Bridge/Fluor Enterprises, a JV
Contractor: Zhenhua Port Machinery Company, Ltd (ZPMC), Changxing Island

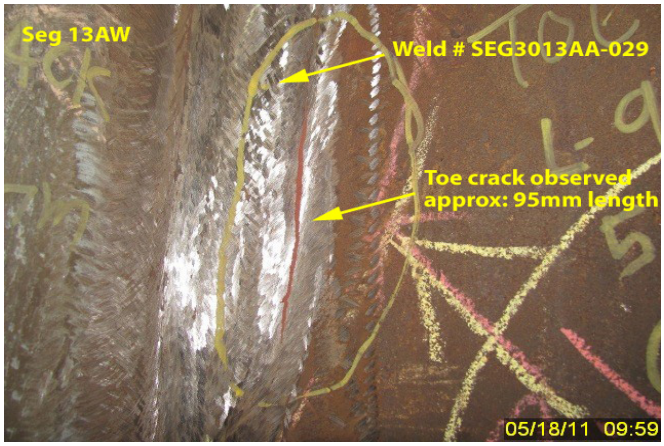
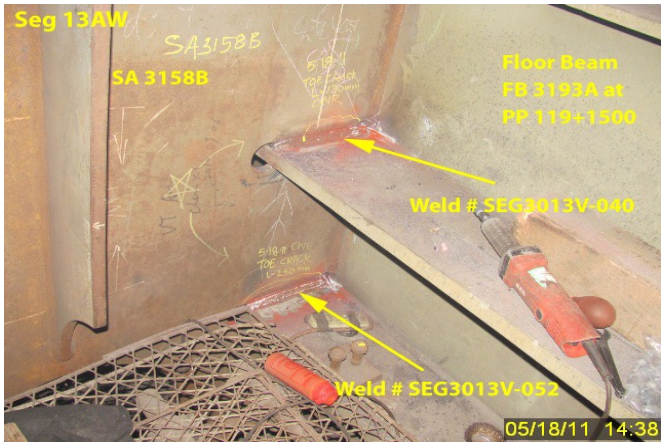
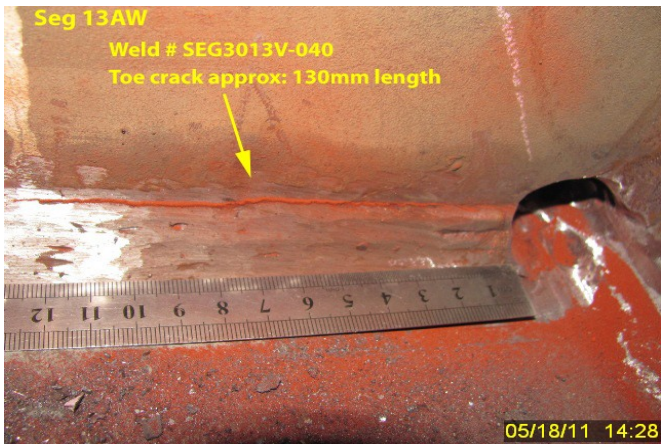
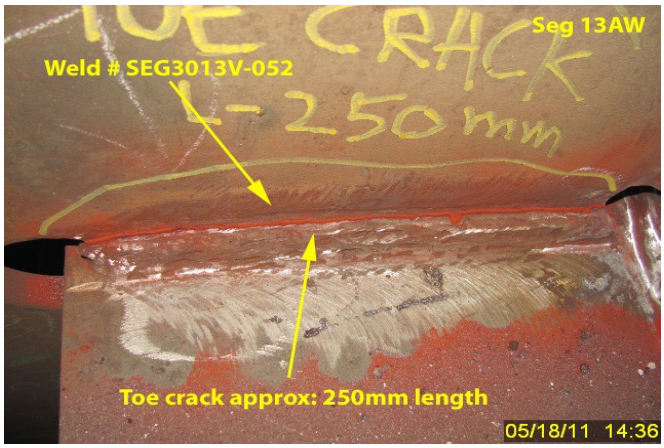
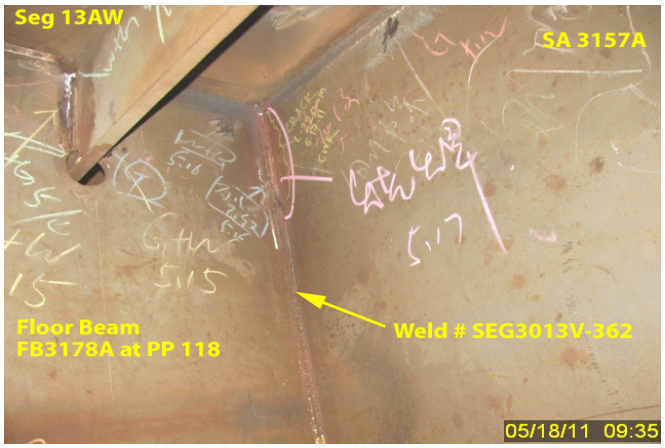
This QA Inspector, along with Mr. Shailesh Wadkar; performed in process Visual Inspection of welds (Seg 13AW) at Panel Points (PP) 117.5, PP118 and PP118.35. Visual Inspection was performed on the welds between Longitudinal Diaphragm (LD) 3034A to Edge Panel (EP) 3023A (on the welds inside of the Segment). At various locations on the EP to FB welds, this QA Inspector observed cope holes that require to be profiled correctly. In addition, the following welds were observed to have toe cracks. Details are as follows:

SEG3013V-040, 052, 362
SEG3013AA-029

This QA Inspector informed to ZPMC CWI, identified as Mr. An Qing Xiang. The weld locations were

documented and forwarded to the CT Lead QA Inspector for further disposition. See attached photo for details.
