DEPARTMENT OF TRANSPORTATION
DIVISION OF ENGINEERING SERVICES
Office of Structural Materials
Quality Assurance and Source Inspection

WELDING INSPECTION REPORT

Report No: WIR-024289
Date Inspected: 10-Jun-2011

Project Name: SAS Superstructure
Prime Contractor: American Bridge/Fluor Enterprises, a JV
Contractor: Zhenhua Port Machinery Company, Ltd (ZPMC), Changxing Island

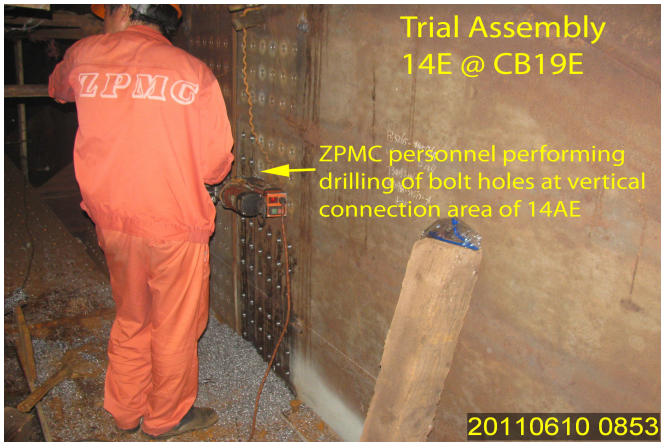
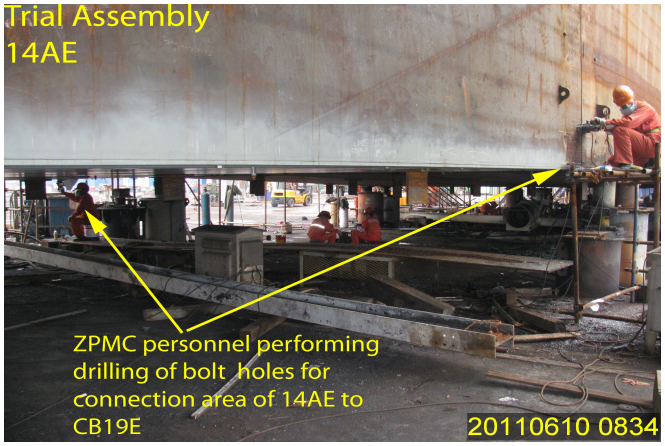
This inspector observed ZPMC personnel performing match drilling at bottom and each vertical side at east side of CB19E.

This QA inspector performed MT of approximately 15% of the area previously tested and accepted by ZPMC Quality Control personnel. This QA Inspector generated an MT report for this date. All components were as listed on NWIT notification no. 09419. The member(s) is/are identified as OBG Floor Beams, Longitudinal, & Segment components identified below with the following identifying weld no.(s):

Unless otherwise noted above all items observed on this day appeared to be in general compliance with the applicable contract documents
