DEPARTMENT OF TRANSPORTATION
DIVISION OF ENGINEERING SERVICES
Office of Structural Materials
Quality Assurance and Source Inspection

WELDING INSPECTION REPORT

Report No: WIR-024597
Date Inspected: 20-Jun-2011

Project Name: SAS Superstructure
Prime Contractor: American Bridge/Fluor Enterprises, a JV
Contractor: Zhenhua Port Machinery Company, Ltd (ZPMC), Changxing Island

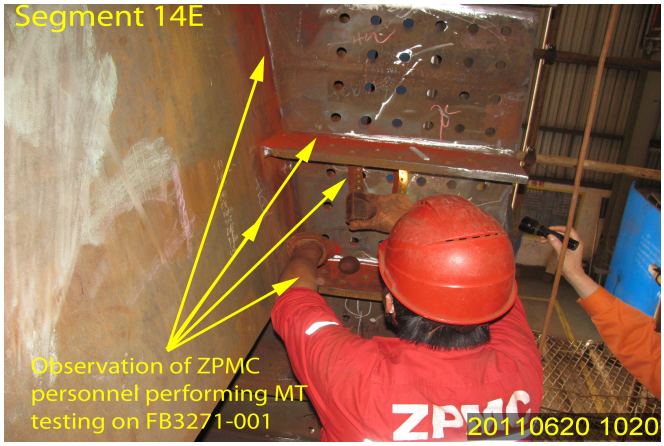
This QA inspector performed MT of approximately 15% of the area previously tested and accepted by ZPMC Quality Control personnel. This QA Inspector generated an MT report for this date. All components were as listed on NWIT notification no. 09531. The member(s) is/are identified as OBG Segments & Floor Beams components identified below with the following identifying weld no.(s):

Unless otherwise noted above all items observed on this day appeared to be in general compliance with the applicable contract documents
