QUALITY ASSURANCE -- NON-CONFORMANCE REPORT

Location: Changxing Island, Shanghai, P.R. China **Report No:** NCR-000305
Prime Contractor: American Bridge/Fluor Enterprises, a JV **Date:** 10-Jun-2009
Submitting Contractor: Zhenhua Port Machinery Company, Ltd (ZPMC), Changxing Island **NCR #:** ZPMC-0279

Reference Description: Missed MT Indication by QC, Plate X195B, Segment 1AAW

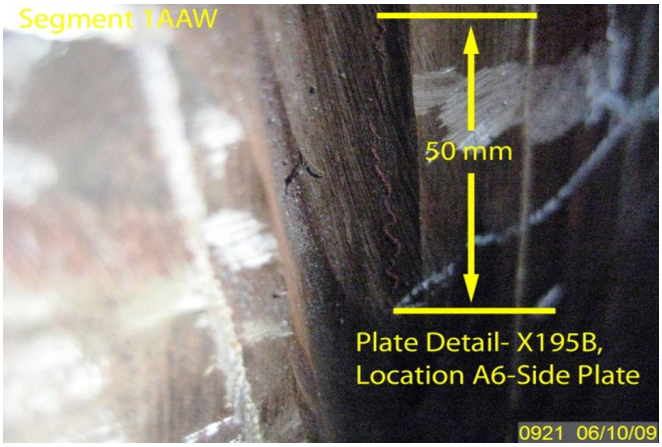
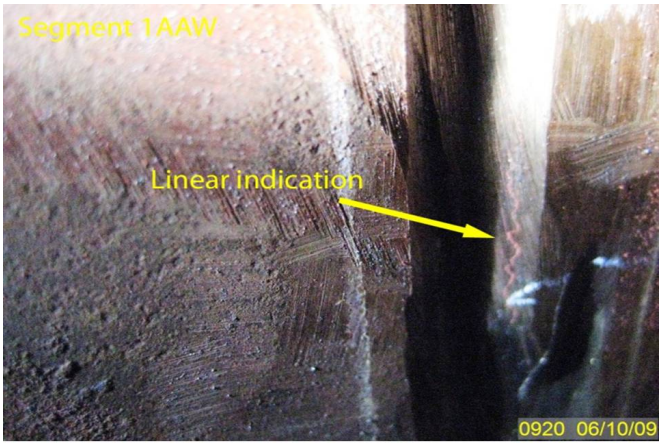
During random verification magnetic particle testing (MT) of the internal components of OBG Segment 1AAW, Caltrans Quality Assurance (QA) Inspector discovered a linear indication approximately 50mm in length in the base metal where a weld had been removed on A6 side plate X195B. This area was previously tested and accepted by ZPMC Quality Control (QC) MT technicians.

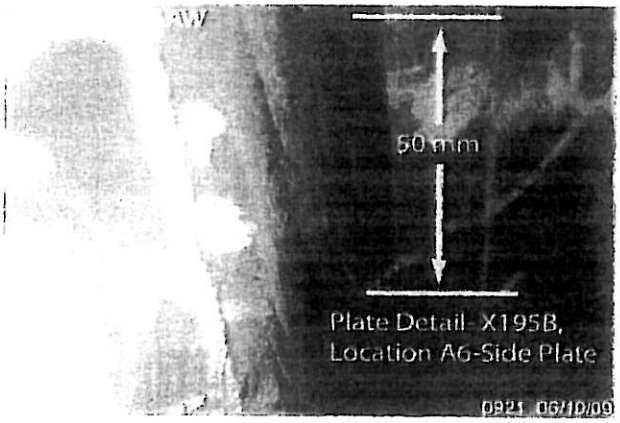
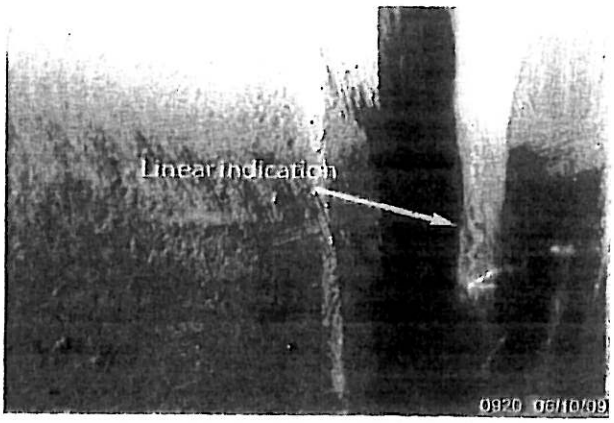
During random verification magnetic particle testing (MT) of the internal components of OBG Segment 1AAW, Caltrans Quality Assurance (QA) Inspector discovered a linear indication approximately 50mm in length in the base metal where a weld had been removed on A6 side plate X195B. This area was previously tested and accepted by ZPMC Quality Control (QC) MT technicians.

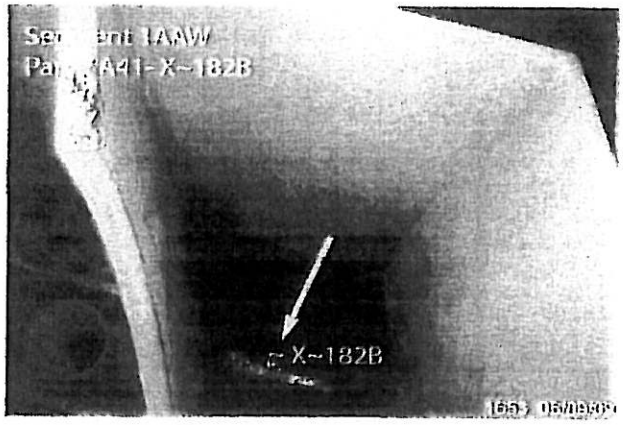
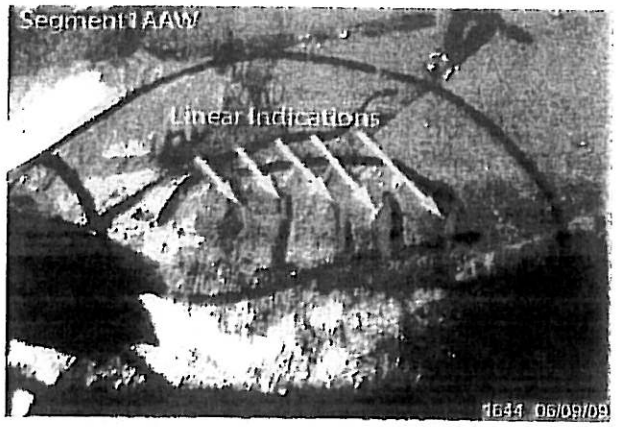
During random verification magnetic particle testing (MT) of the internal components of OBG Segment 1AAW, Caltrans Quality Assurance (QA) Inspector discovered a total of five (5) linear indications ranging from 5 to 15mm in length in the base metal where weld had been removed on Plate X182B. These welds have been previously tested and accepted by ZPMC Quality Control (QC) MT technicians.

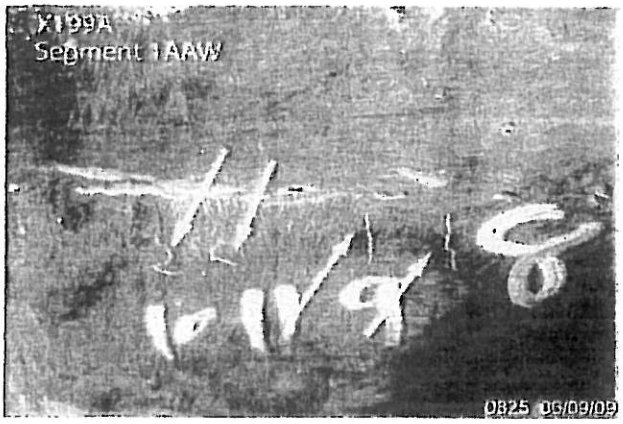
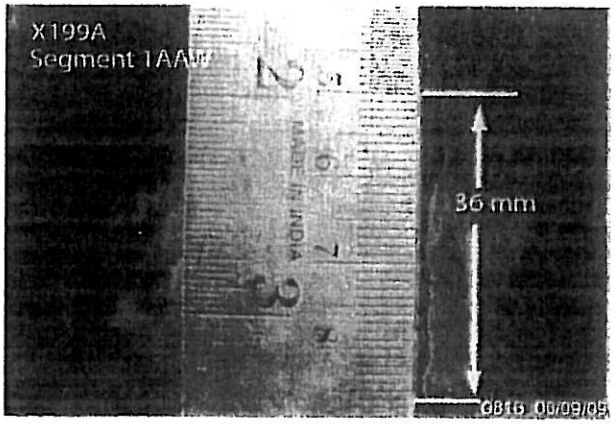
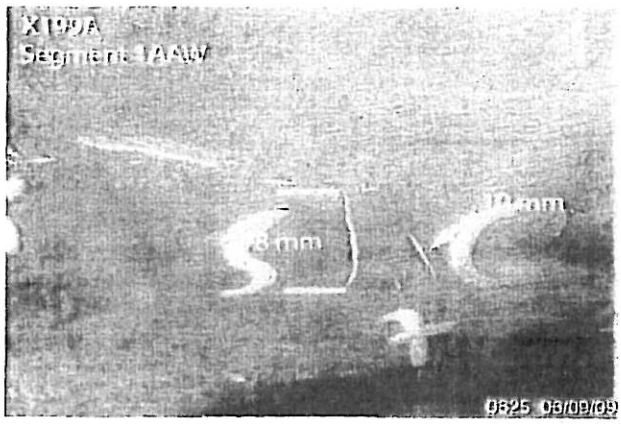
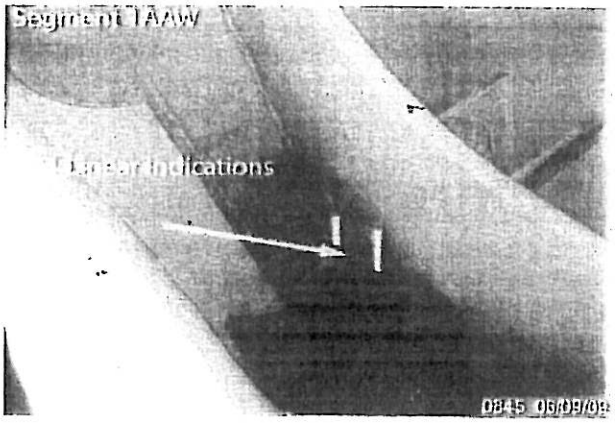
During random verification magnetic particle testing (MT) of the internal components of OBG Segment 1AAW, Caltrans Quality Assurance (QA) Inspector discovered a total of eleven (11) linear indications ranging from 5 to 35mm in length in the base metal where weld had been removed on Plate X199A. These welds have been previously tested and accepted by ZPMC Quality Control (QC) MT technicians.

Propose a resolution for the identified recurring non-conformance which constitutes a systematic problem on both materials/workmanship and quality control issues to remedy the defected work and with revised procedures to prevent future occurrences. A response for the resolution of this issue is expected within 14 days.

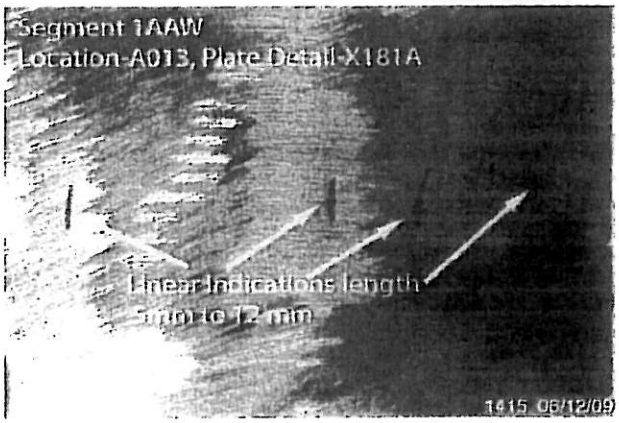
During random verification magnetic particle testing (MT) of the internal components of OBG Segment 1AAW, Caltrans Quality Assurance (QA) Inspector discovered a total of four (4) linear indications ranging from 5 to 12mm in length in the base metal (weld removal area) at location A13, plate X181A. These areas have been previously tested and accepted by ZPMC Quality Control (QC) MT technicians.

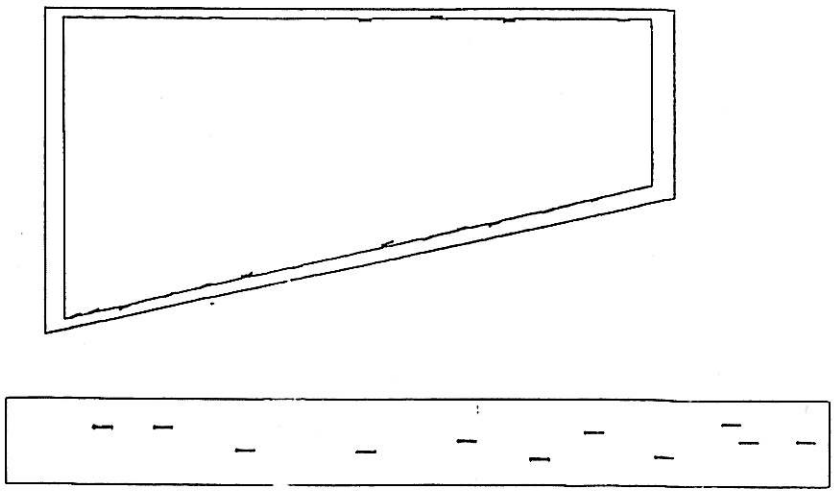
Draft of Welding Discontinuity:

We found sixty-four cracks in material after removed stiffener.

Original stiffener was cross stiffener, and stiffeners removed for the gap exceeded technology requirement, which stress released and caused crack.

1. Remove the crack by means of grinding.
2. Prepare excavation according to the approved repair WPS.
3. Grind the area to a smooth and shiny finish, with tapered ends, to ensure staggered starts and stops.
4. Verify with VT and MT repair areas are crack free before welding.
5. Preheat and weld according to the approved repair WPS.
6. Preheat prior to welding to a minimum temperature of 100℃ or what's required in the approved WPS, whichever is higher.
7. The preheat area shall be a minimum of 150mm in all directions around the repair area.
8. Grind the repaired area flush with base metal or the adjacent weld.
9. Perform VT UT and MT of the repair areas. per the contract requirement

Perform repair according to WPS, and enhance controlling every weld pass, grind the cracks after removing stiffeners and perform MT to ensure all the repair area free of cracks, and grind smoothly before assembly stiffeners.
