DEPARTMENT OF TRANSPORTATION
DIVISION OF ENGINEERING SERVICES
Office of Structural Materials
Quality Assurance and Source Inspection

QUALITY ASSURANCE -- NON-CONFORMANCE REPORT

Location: Changxing Island, Shanghai, P.R. China **Report No:** NCR-000583
Prime Contractor: American Bridge/Fluor Enterprises, a JV **Date:** 02-Jan-2010
Submitting Contractor: Zhenhua Port Machinery Company, Ltd (ZPMC), Changxing Island **NCR #:** ZPMC-0556

Reference Description: Missed MT transverse indication by QC for Bike Path Cantilever Beam BK001-032

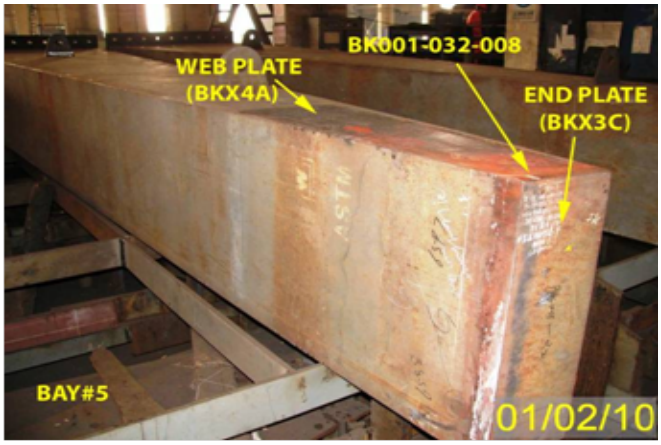
During Magnetic Particle Testing (MT) review of welds on Bike Path Cantilever Beams, this Quality Assurance Inspector (QA) discovered the following issues:

-One (1) transverse linear indication measuring approximately 8mm in length.
-The member is identified as Bike Path Cantilever Beam BK001-032.
-The weld is identified as BK001-032-008.
-The weld is a Partial Joint Penetration (PJP) T-joint joining the Web Plate (BKX4A) to the Diaphragm Flange Plate (BKX3C).
-The member is Non-Seismic Performance critical Member (SPCM).
-The member is located in OBG Bay 5.

The Notice of Witness Inspection Number (NWIT) is 004981. The indication is located inside the area that has been previously tested and accepted by ZPMC Quality Control (QC) personnel. As per the contract documents, ZPMC's QC personnel are required to perform 100% MT inspection of this weld.

Reference Resolution: As a means of preventing future occurrences, the ABF QCM has performed refresher MT training. See attached MT training agenda and attendance roster.

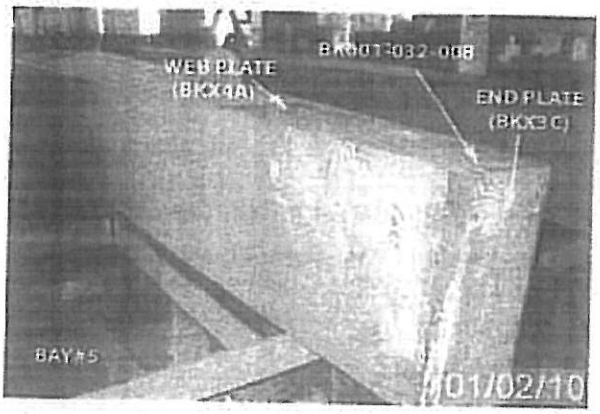
-One (1) transverse linear indication measuring approximately 8mm in length.
-The member is identified as Bike Path Cantilever Beam BK001-032.
-The weld is identified as BK001-032-008.
-The weld is a Partial Joint Penetration (PJP) T-joint joining the Web Plate (BKX4A) to the Diaphragm Flange Plate (BKX3C).
-The member is Non-Seismic Performance critical Member (SPCM).
-The member is located in OBG Bay 5.

The Notice of Witness Inspection Number (NWIT) is 004981. The indication is located inside the area that has been previously tested and accepted by ZPMC Quality Control (QC) personnel. As per the contract documents, ZPMC's QC personnel are required to perform 100% MT inspection of this weld.

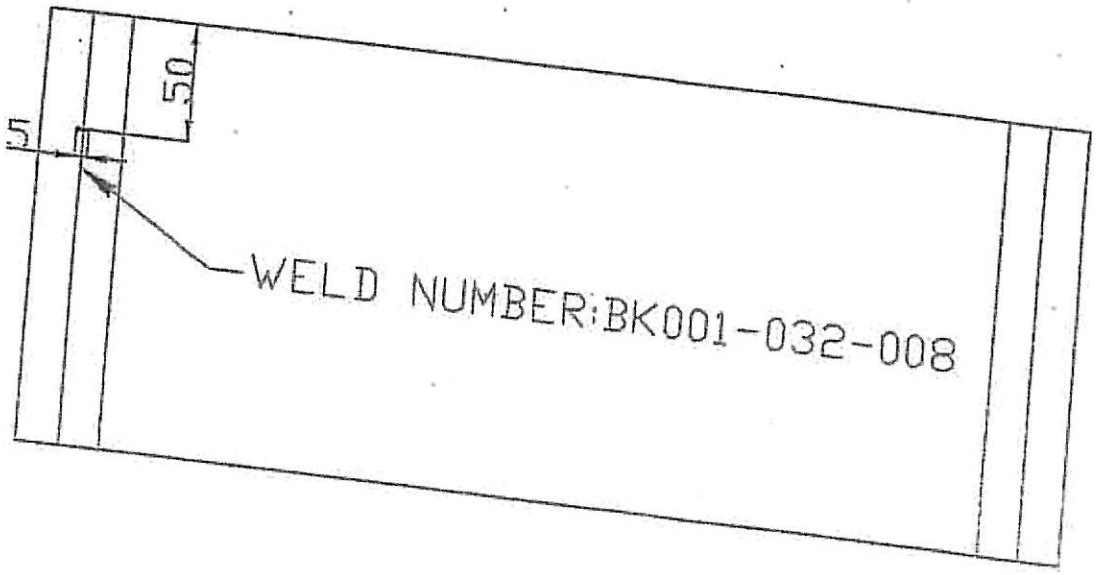
Draft of Welding Discontinuity:

One transverse crack was found by use of MT on BK001-032-008.

1. Moisture wasn't completely removed during drying operation (preheating) or the area wa sn't preheated sufficiently.

1. QC and a Lead CWI shall be present, direct and supervise all grinding and welding operations during this re pair to ensure the repair is per the disposition requirements

2. QC and a Lead CWI shall have an approved copy of the CWR in hand prior to the repair.
3. Remove paint≥25mm in all direction of HAZ prior to MT.
4. Clean the excavation area of all loose debris including MT powder. Preheat to 65° C before removing cracks by grinding, repair area shall extend a minimum of 50mm beyond each end of single crack repairs.

5. If base metal is damaged by grinding, the damaged area shall be ground clean prior to performing weld repa ir. If gap>5mm is found during or after grinding, comply with the notification on changing fillet weld to CJP w hich is submitted for Engineer's review and approval form.

6. Prepare excavation in accordance with the New Repair Procedure prior to welding.
7. Before this repair, Verify with VT and MT repair areas are defects free, and also MT shall be performed on the base metal laying abroad cracks to ensure that no cracks were propagated to the base metal. Separate CWR approval is needed if cracks are found in the base metal, and only after this new CWR's approval can continue the repair.

8. Clean excavation area of all loose debris including MT powder after excavation. Preheat and weld according t o repair WPS, the preheat shall between 160° C-230° C.

9. Perform post weld heating according to repair WPS, the postheat shall between 230° C—315° C and for on e hour minimum.
10. Allow the weld to cool to ambient temperature gradually. Control cooling rate after PWHT to no more than 50° C per hour.

11. Grind the repaired area flush with base metal or the adjacent weld after post weld heating.
12. Wait 48 hours at least after the repair area has cooled to ambient temperature before performing NDT.

13. Perform MT inspection to all repair area according to Contract Drawings along with all additional NDT requ ired by the applicable notes Special Provision Section 10-1.59 "Steel Structure", subsection "Inspection testing". NDT include VT, MT and UT if it is a CJP weld.

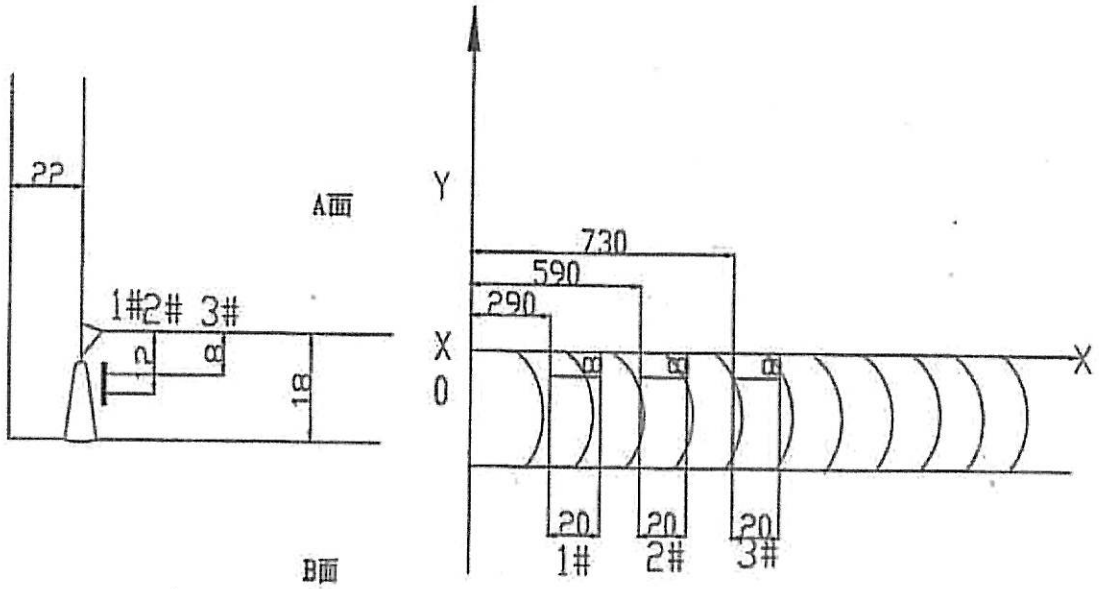
WELD NUMBER: CB202A-016-002

Rejected indication found by ultrasonic inspection is less than the maximum allowance aggregate length.

1. Gouge or grind from nearer side from metal edge （D≤0.65T, "D" is depth of defects, "T" is thickness of metal） to remove all defects;
2. Follow repair WPS for joint preparation, preheat, and weld deposit;
3. Verify with VT no defects remain in the weld joint prior to welding;
4. Grind the repaired area flush with base metal or the adjacent weld;
5. Check the welds according to the working drawings;

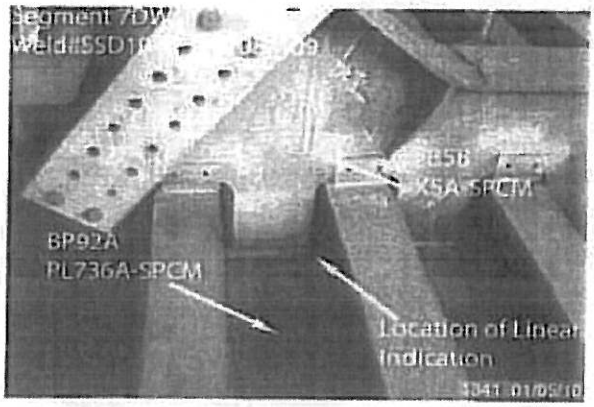
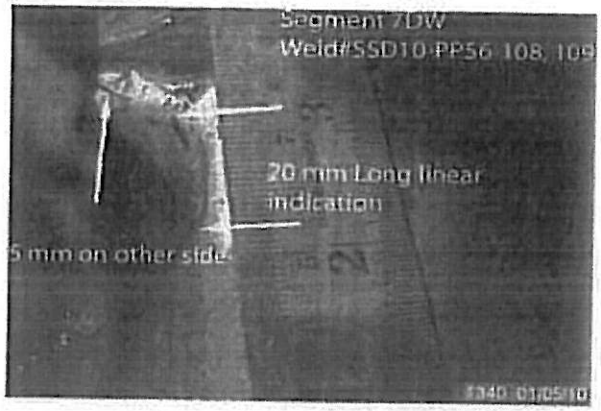
-One (1) Longitudinal linear indication measuring approximately 20mm in length.
-The welds are identified as: SSD10-PP56-108, 109.
-These welds are a Fillet Weld type joining the Bottom Plate (BP92A) to Floor Beam (FB5B) web plate.
-These welds are designated as Seismic Performance Critical Member (SPCM) on the approved drawing (SEGSD10).
-The OBG segment 7DW is located outside in the Trial Assembly area.

The Notice of Witness Inspection Number (NWIT) is 004993. The indication is located inside the area that has been previously tested and accepted by ZPMC Quality Control (QC) personnel. ZPMC's QC personnel are required to perform twenty five (25%) percent MT inspection of this weld.

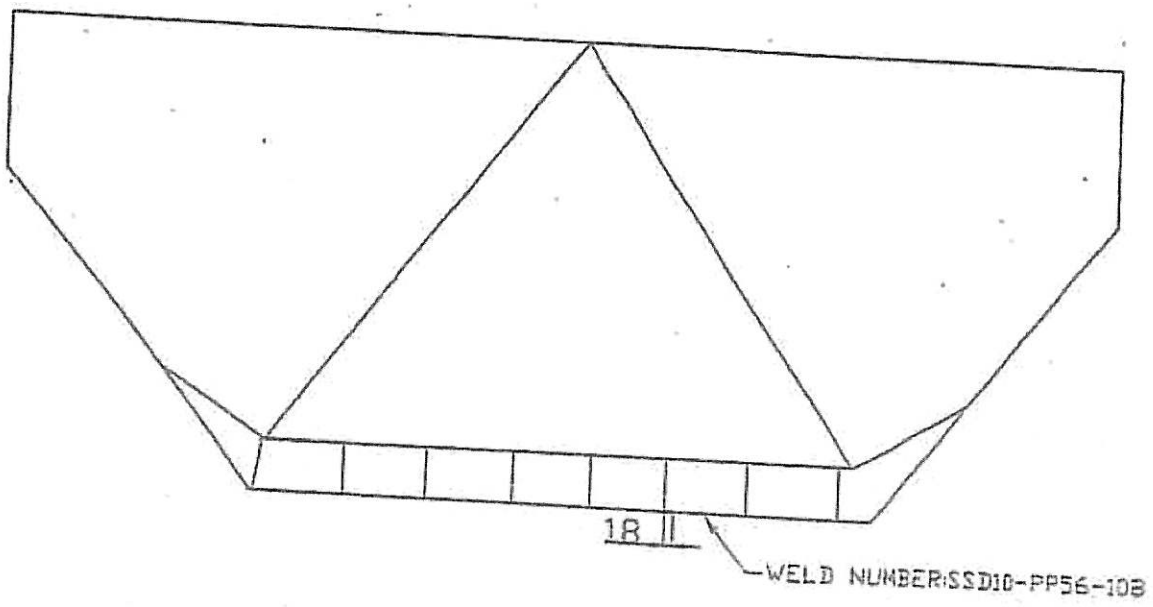
Draft of Welding Discontinuity:

One longitudinal crack was found by use of MT on SSD10-PP56-108.

1. Moisture wasn't completely removed during drying operation (preheating) or the area wa sn't preheated sufficiently.

1. QC and a Lead CWI shall be present, direct and supervise all grinding and welding operations during this re pair to ensure the repair is per the disposition requirements

2. QC and a Lead CWI shall have an approved copy of the CWR in hand prior to the repair.
3. Remove paint≥25mm in all direction of HAZ prior to MT.
4. Clean the excavation area of all loose debris including MT powder. Preheat to 65° C before removing cracks by grinding, repair area shall extend a minimum of 50mm beyond each end of single crack repairs.

5. If base metal is damaged by grinding, the damaged area shall be ground clean prior to performing weld repa ir. If gap>5mm is found during or after grinding, comply with the notification on changing fillet weld to CJP w hich is submitted for Engineer's review and approval form.

6. Prepare excavation in accordance with the New Repair Procedure prior to welding.
7. Before this repair, Verify with VT and MT repair areas are defects free, and also MT shall be performed on the base metal laying abroad cracks to ensure that no cracks were propagated to the base metal. Separate CWR approval is needed if cracks are found in the base metal, and only after this new CWR's approval can continue the repair.

8. Clean excavation area of all loose debris including MT powder after excavation. Preheat and weld according t o repair WPS, the preheat shall between 160° C-230° C.

9. Perform post weld heating according to repair WPS, the postheat shall between 230° C—315° C and for on e hour minimum.
10. Allow the weld to cool to ambient temperature gradually. Control cooling rate after PWHT to no more than 50° C per hour.

11. Grind the repaired area flush with base metal or the adjacent weld after post weld heating.
12. Wait 48 hours at least after the repair area has cooled to ambient temperature before performing NDT.

13. Perform MT inspection to all repair area according to Contract Drawings along with all additional NDT requ ired by the applicable notes Special Provision Section 10-1.59 'Steel Structure', subsection 'Inspection testing'. NDT include VT, MT and UT if it is a CJP weld.

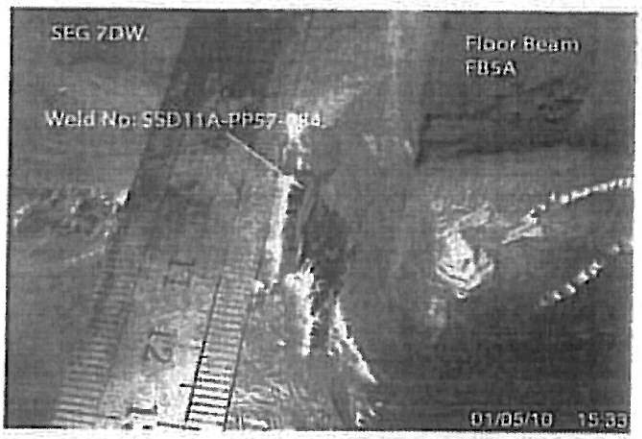
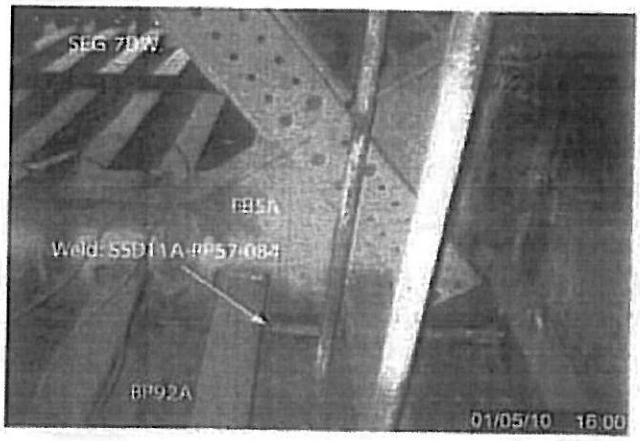
-The approved shop drawings, detail this weld as a Fracture Critical Weld (FCW).

-Segment 7DW is located at outside yard, north end of bays 13 and 14.

The Notice of Witness Inspection Number (NWIT) is 004993. The indication is located within the area that has been previously tested and accepted by ZPMC Quality Control (QC) personnel. ZPMC's QC personnel are required to perform twenty five (25%) percent MT inspection of this weld.

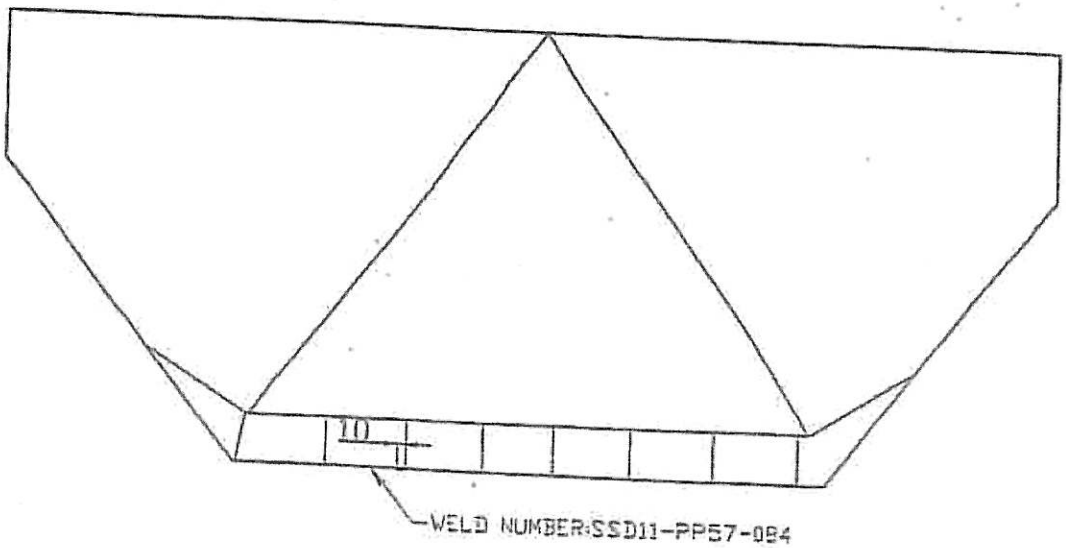
Draft of Welding Discontinuity:

One longitudinal crack was found by use of MT on SSD11-PP57-084.

1. Moisture wasn't completely removed during drying operation (preheating) or the area wasn't preheated sufficiently.

1. QC and a Lead CWI shall be present, direct and supervise all grinding and welding operations during this repair to ensure the repair is per the disposition requirements

2. QC and a Lead CWI shall have an approved copy of the CWR in hand prior to the repair.
3. Remove paint≥25mm in all direction of HAZ prior to MT.
4. Clean the excavation area of all loose debris including MT powder. Preheat to 65° C before removing cracks by grinding, repair area shall extend a minimum of 50mm beyond each end of single crack repairs.

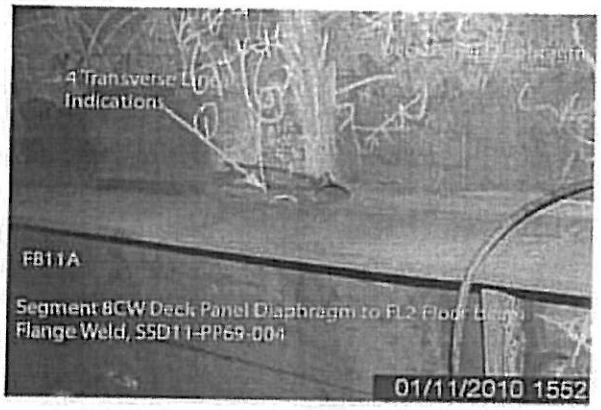
-The Notice of Witness Inspection Number (NWIT) is 005037.

-The indication is located in an area that has been previously tested and accepted by ZPMC Quality Control (QC) personnel. According to the contract documents ZPMC Quality Control (QC) is required to perform 100% Magnetic particle Testing (MT) of this weld.

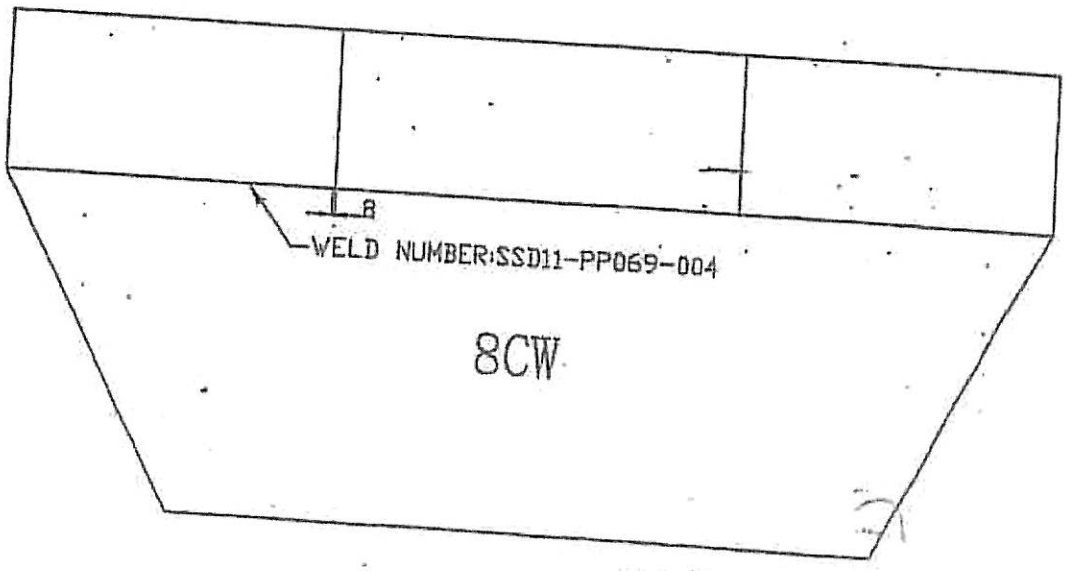
Draft of Welding Discontinuity:

1. Moisture wasn't completely removed during drying operation (preheating) or the area wa sn't preheated sufficiently.

1. QC and a Lead CWI shall be present, direct and supervise all grinding and welding operations during this repair to ensure the repair is per the disposition requirements

2. QC and a Lead CWI shall have an approved copy of the CWR in hand prior to the repair.
3. Remove paint≥25mm in all direction of HAZ prior to MT.
4. Clean the excavation area of all loose debris including MT powder. Preheat to 65° C before removing cracks by grinding, repair area shall extend a minimum of 50mm beyond each end of single crack repairs.

5. If base metal is damaged by grinding, the damaged area shall be ground clean prior to performing weld repair. If gap>5mm is found during or after grinding, comply with the notification on changing fillet weld to CJP which is submitted for Engineer's review and approval form.

6. Prepare excavation in accordance with the New Repair Procedure prior to welding.
7. Before this repair, Verify with VT and MT repair areas are defects free, and also MT shall be performed on the base metal laying abroad cracks to ensure that no cracks were propagated to the base metal. Separate CWR approval is needed if cracks are found in the base metal, and only after this new CWR's approval can continue the repair.

8. Clean excavation area of all loose debris including MT powder after excavation. Preheat and weld according to repair WPS, the preheat shall between 160° C-230° C.

9. Perform post weld heating according to repair WPS, the postheat shall between 230° C—315° C and for one hour minimum.
10. Allow the weld to cool to ambient temperature gradually. Control cooling rate after PWHT to no more than 50° C per hour.

11. Grind the repaired area flush with base metal or the adjacent weld after post weld heating.
12. Wait 48 hours at least after the repair area has cooled to ambient temperature before performing NDT.

13. Perform MT inspection to all repair area according to Contract Drawings along with all additional NDT required by the applicable notes Special Provision Section 10-1.59 'Steel Structure', subsection 'Inspection testing'. NDT include VT, MT and UT if it is a CJP weld.

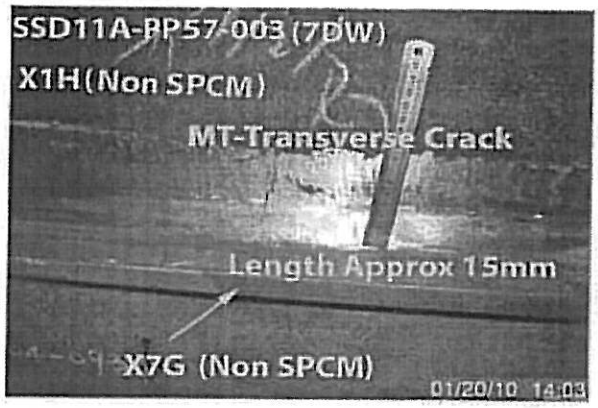
-One (1) Transverse linear crack measuring approximately 15mm in length.
-The Y location is 4500mm from corner of the Panel Point PP57 at Cross Beam side.
-The indication is clearly marked on the material near the weld.
-The weld is identified as: SSD11A-PP57-003.
-This weld is a Complete Joint Penetration (CJP) weld joining the Deck Panel Diaphragm (X1H) to Floor Beam Flange (X7G).
-The Deck Panel Diaphragm (X1H) is identified as Non-Seismic Performance Critical Member (SPCM).
-The Floor Beam Flange (X7G) is identified as Non-SPCM.
-OBG segment 7DW is located outside North side of Bay 13.

The Notice of Witness Inspection Number (NWIT) is 005086. The indication is located inside an area that has been previously tested 100% and accepted by ZPMC Quality Control (QC) personnel.

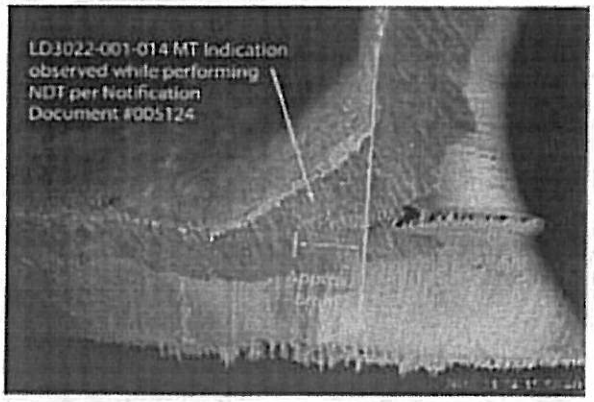
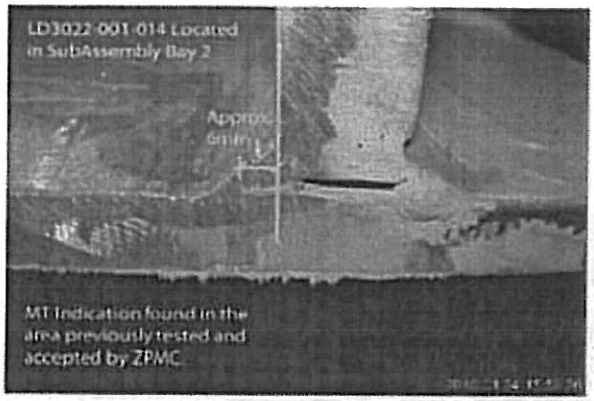
During the Quality Assurance Magnetic Particle Testing (MT) review of welds located on LD3022-001, this Quality Assurance Inspector (QA) discovered the following issues:

-One (1) linear indication measuring approximately 6mm in length.
-The weld is identified as: LD3022-001-014 for Lift 12.
-The area was previously repaired by ZPMC using Critical Weld Repair (CWR) 1151.
-The fillet weld size is 12mm.
-This Fillet Weld joins longitudinal diaphragm stiffener to longitudinal diaphragm web plate.
-This weld is designated as Non-Seismic Performance Critical Member.
-The Notice of Witness Inspection Number (NWIT) is 005124. The indication is located inside the area that has been previously tested and accepted by ZPMC Quality Control (QC) personnel. ZPMC Quality Control (QC) has performed 100% Magnetic particle Testing (MT) of this weld.
