DEPARTMENT OF TRANSPORTATION
DIVISION OF ENGINEERING SERVICES
Office of Structural Materials
Quality Assurance and Source Inspection

QUALITY ASSURANCE -- NON-CONFORMANCE REPORT

Location: Changxing Island, Shanghai, P.R. China **Report No:** NCR-000869
Prime Contractor: American Bridge/Fluor Enterprises, a JV **Date:** 19-Oct-2010
Submitting Contractor: Zhenhua Port Machinery Company, Ltd (ZPMC), Changxing Island **NCR #:** ZPMC-0831

Welding	☐	**Concrete**	☐	**Other**	☑	
Welding	☐	**Curing**	☐	**Procedural**	☐	**Bridge No:** 34-0006
Joint fit-up	☐	**Coating**	☐	**Other**	☑	**Component:** Segment 12AE Floorbeam Joint
Procedural	☐	**Procedural**	☐	**Description:**		Missed UT Indication by QC

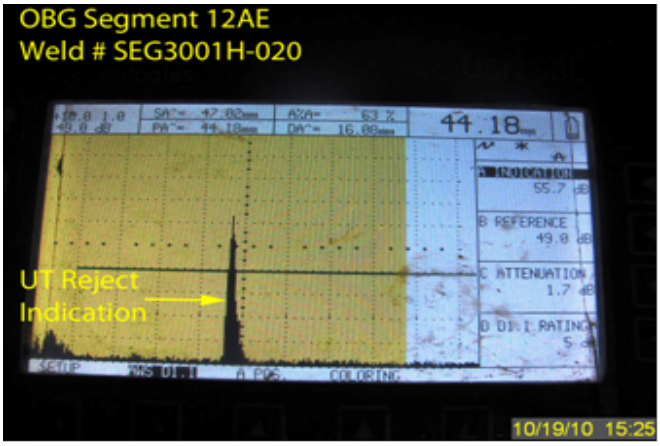
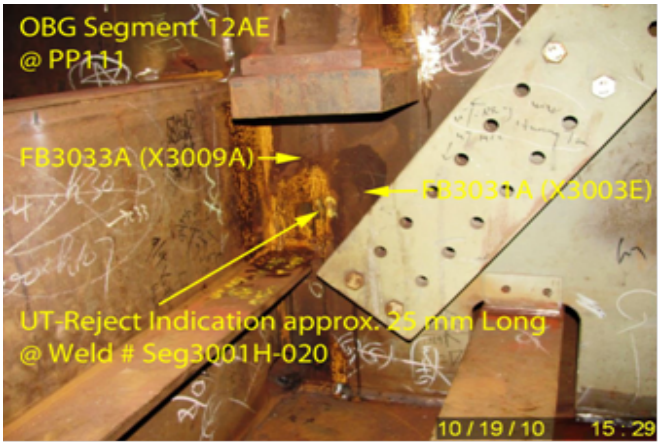
During the Quality Assurance (QA) Ultrasonic Testing (UT) verification of weld located on Segment 12AE, this QA Inspector discovered the following issue:

- One (1) Class “A” indication measuring approximately 25mm in length.
- The Indication rating is +5dB and length approximately 25mm.
- The thickness of the plate is 30mm and depth of the indication is approximately 15mm.

- The indication is located on the weld joint identified as SEG3001H-020.
- The “Y” location for this indication is approximately 500mm from Bottom plate.

- The weld is a Complete Joint Penetration (CJP) butt joint, joining Floor Beam FB3033A (X3009A) to Floor Beam FB03031A (X3003E).
- The indication is clearly marked by QA on/near the weld.

- This weld is identified as Seismic Performance Critical Member (SPCM).
- OBG Segment 12AE is located at the outside yard west side of Blast Shop 1.
-The Notice of Witness Inspection Number (NWIT) is 006956. The indication is located within the area that has been previously tested and accepted by ZPMC Quality Control (QC) personnel. As per the contract documents, ZPMC’s QC personnel are required to perform 100% UT inspection of this weld.

Contractor repaired and provided acceptable NDT records to close the issues. The proposed resolution is acceptable. This NCR is closed.

ZPMC acknowledged the indication was missed and has issued an internal NCR to address this problem. ZPMC has repaired the indication and is providing the NDT record to show the acceptance of this weld. Based on this, ZPMC is requesting closure of this NCR.

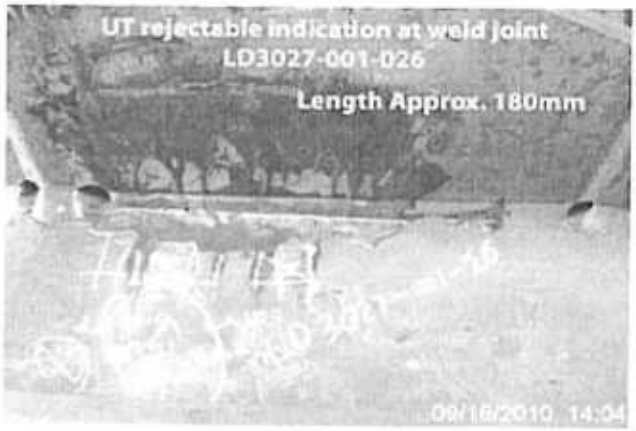
During the Quality Assurance (QA) Ultrasonic Testing (UT) review of welds located on Orthotropic Box Girder (OBG) segment13BE and 13CE, this QA Inspector discovered the following issues:

-Three (3) longitudinal linear class "A" rejectable indications measuring approximately 180mm~260mm in length.
-The welds are identified as LD3028-001-031, LD3027-001-026 and LD3030-001-053.
-Material thickness for all joints is 30mm.
-The indication db rating for joint LD3028-001-031 is a -6.
-The indication db rating for joint LD3027-001-026 is a -4.
-The indication db rating for joint LD3030-001-053 is a -5.
-The depth of the indications are from 20mm~23mm deep.
-The Weld LD3028-001-031 is joining longitudinal diaphragm (X3682A) to lifting Lug.
-The Weld LD3027-001-026 is joining longitudinal diaphragm (X3684B) to lifting Lug.
-The Weld LD3030-001-053 is joining longitudinal diaphragm (X3685A) to lifting Lug.
-All Welds are Complete Joint Penetration (CJP) "T" joint.
-All welds are Seismic Performance Critical Members (SPCM).
-The Y distance for joint LD3028-001-031 is 110mm from bottom cope hole.

-The Y distance for joint LD3027-001-026 is 40mm from bottom cope hole.
-The Y distance for joint LD3030-001-053 is 700mm from bottom cope hole.
-The indications are clearly marked on or near the weld.
-All components are located in fabrication Bay#3.

The Notice of Witness Inspection (NWIT) No. is 006680. The indications all joints are located within an area previously tested and accepted by ZPMC Quality Control (QC) personnel.

These welds were designated to be PJP welds and no UT is required. The NWIT were submitted due to the internal fault between the floor QC & NDT operator of ZPMC. ZPMC is providing the MT records to show the acceptance of these welds and is requesting closure of this NCR.

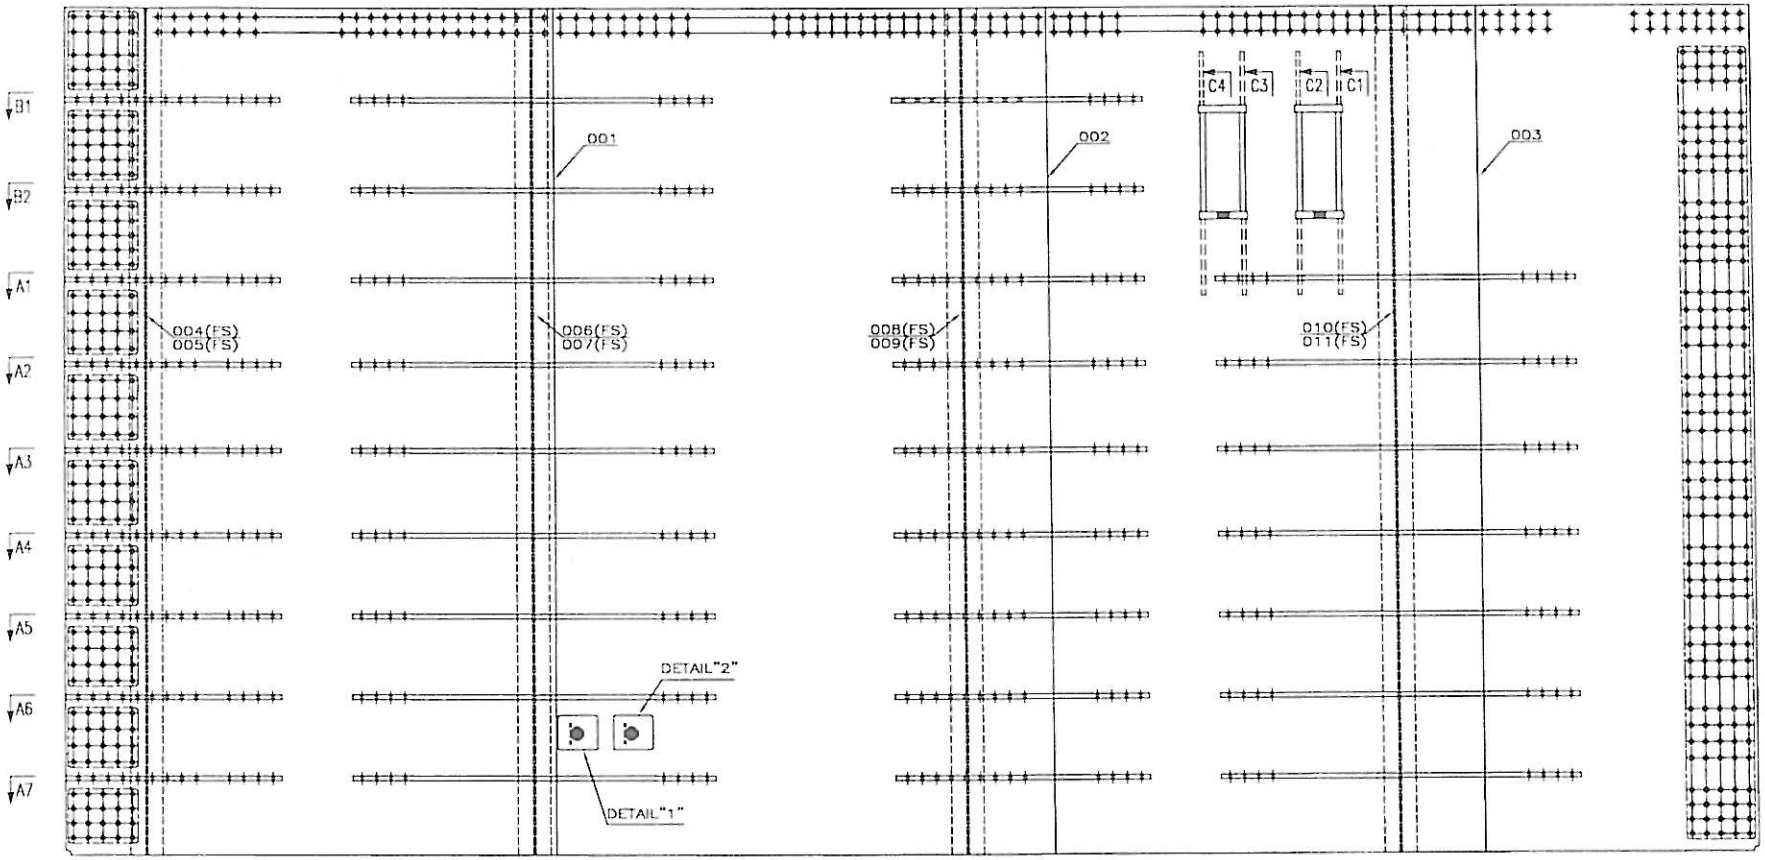
DRAWN		SHOP DRAWNING NO.	PAGINATION
CHECKED		LD3028	1/3

SECTION C1

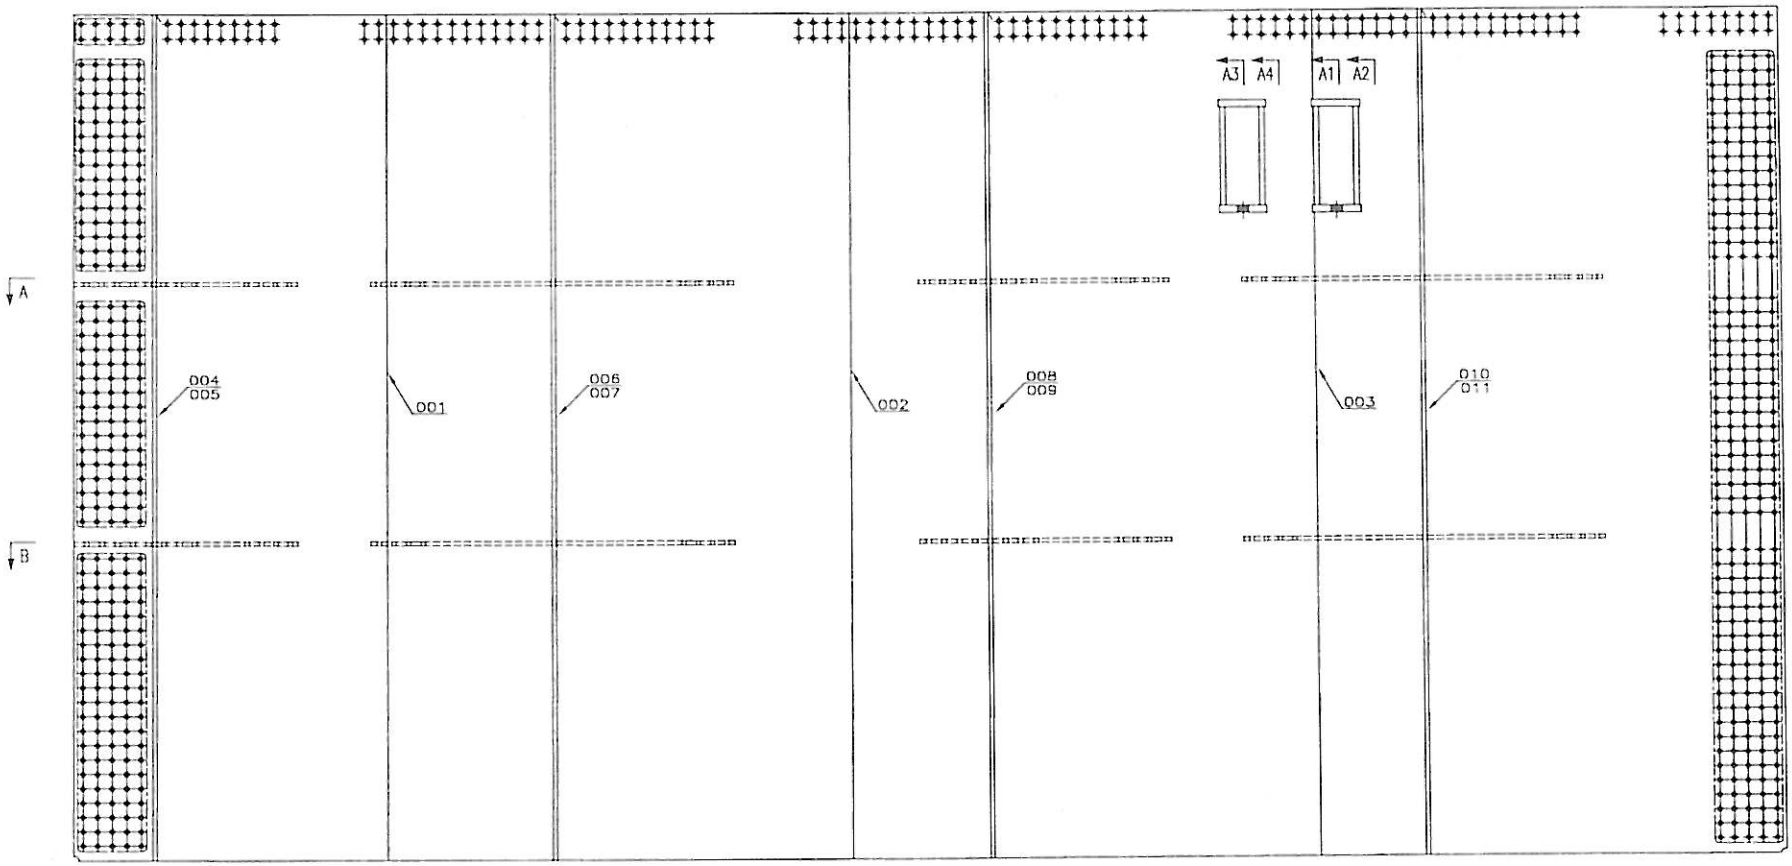
DRAWN		SHOP DRAWNING NO.	PAGINATION
CHECKED		LD3027	1/2

SECTION A1

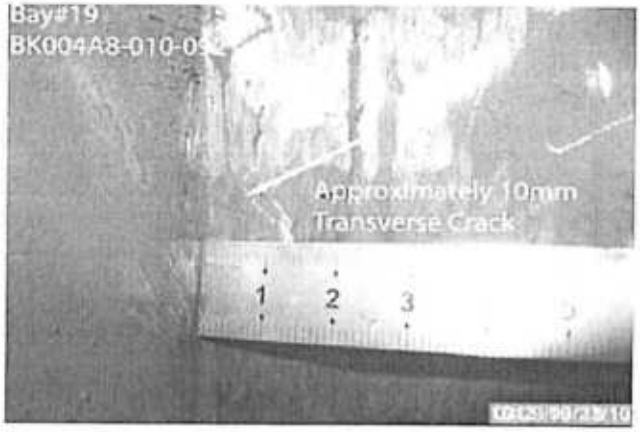
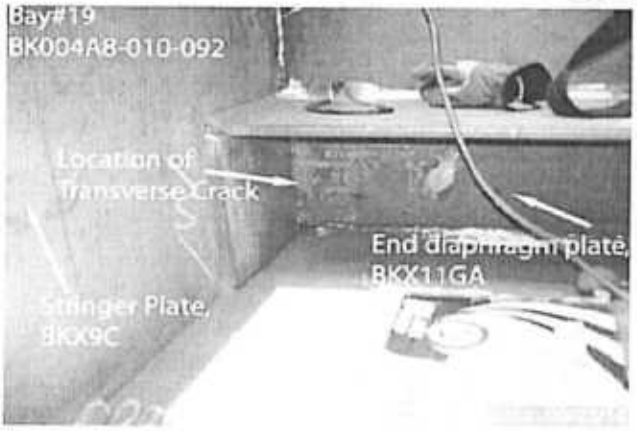
Reference Description: QA found a missed MT transverse crack after ZPMC had tested and accepted the weld in the Bikepath

-One transverse crack that measured approximately 10mm in length.

-This crack is clearly marked on the material on/near the weld.

-The Notice of Witness Inspection Number (NWIT) is 006731.

-The crack is located within the area that has been re-tested and accepted by ZPMC Quality Control (QC) subsequent to the heat straightening procedure.

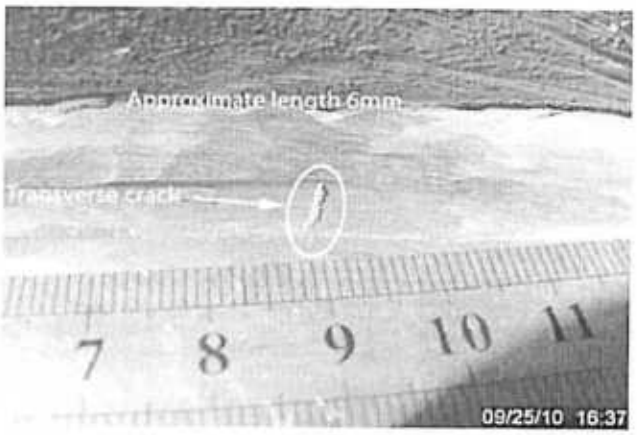
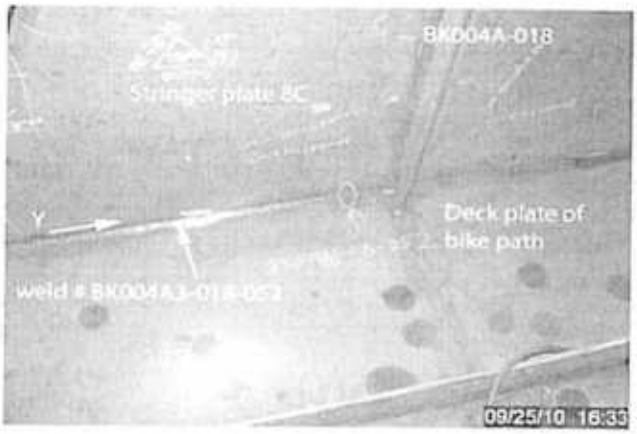
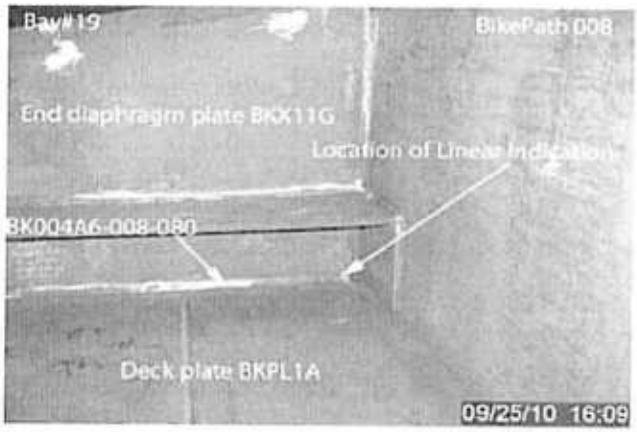
Reference Description: QA found a missed MT transverse crack and MT longitudinal crack after ZPMC had tested and accepted the welds in Bikepath Assembly

-One Longitudinal linear crack in the weld measuring approximately 15mm in length.
-The weld is identified as BK004A6-008-080.
-The weld is partial joint penetration (PJP), joining the End Diaphragm plate identified as BKX11G to the Deck Plate identified as BKPL1A.
-This weld joint is designated as Non-Seismic performance critical (Non-SPCM) weld member.
-The crack is clearly marked on the material near the weld.
-The OBG Bike Path 008 is located in Bay #19.

-One (1) transverse crack found on the weld measuring approximately 6mm in length.
-Y location of the indication is measured to be 2160mm.
-The crack is clearly marked on the weld joint.
-The weld is identified as: BK004A3-018-052.
-The Weld is a fillet weld joining the stringer plate (8C) to the deck plate of bike path.
-The member is located in bay 11.

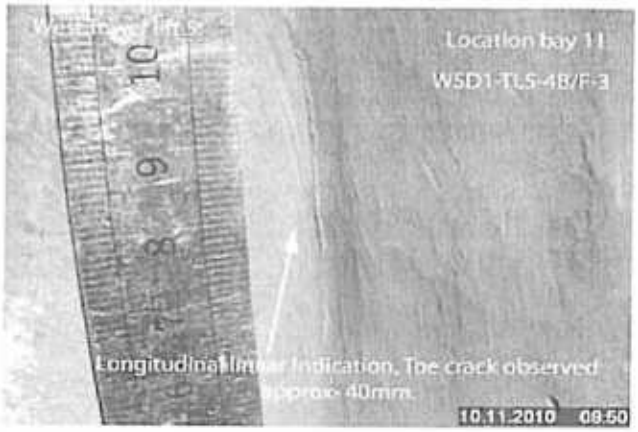
Reference Description: Lift 5 West Shaft: Missed MT Crack at Skin D and Transverse Plate

-One longitudinal toe crack measuring approximately 40mm in length.
-The weld is identified as: WSD1-TL5-4B/F-3.
-The Weld is a Complete Joint Penetration (CJP) weld, joining the grillage plate to skin plate.
-The material is Non Seismic Performance Critical Member (NON SPCM)
-The member is located in Bay 11.

-The Notice of Witness Inspection Number (NWIT) is 06917. The indication is located on CJP weld area that has been previously tested and accepted by ZPMC Quality Control (QC) personnel. As per the contract documents, ZPMC's QC personnel are required to perform 100% MT inspection of this weld. The attached photographs provide additional detail.

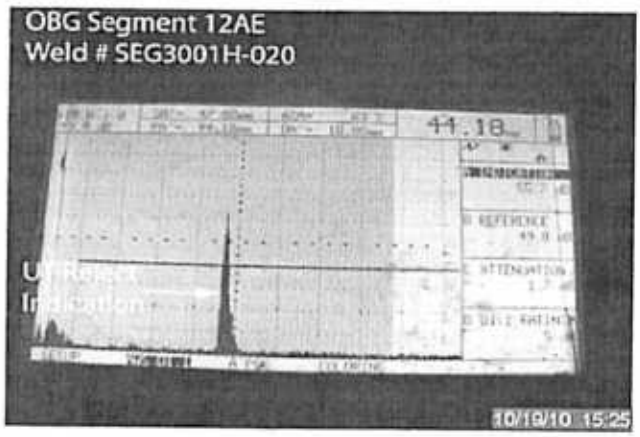
Reference Description: QA found a missed UT indication after ZPMC had tested and accepted the weld in Segment 12AE Floorbeam Joint

Contractor proposes to repair the weld indication, and provide NDT report to prove the weld is acceptable. Contractor will monitor the inspector who missed the indication, and take disciplinary action should be continuously making similar mistakes.

Contractor repaired and provided acceptable NDT records to close the issues. Contractor identified the inspector responsible and is monitoring his performance.
