Contract #: **04-0120E4**
Cty **SF** Rte **80** PM **13.4,13.8**
File # **13 .25 B**

QUALITY ASSURANCE - NONCONFORMANCE REPORT

Prime Contractor: Kiewit, FCI & Manson Joint Venture **NCR #105**

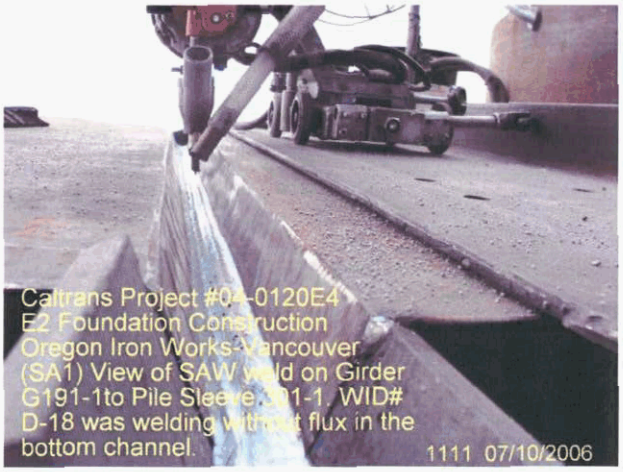
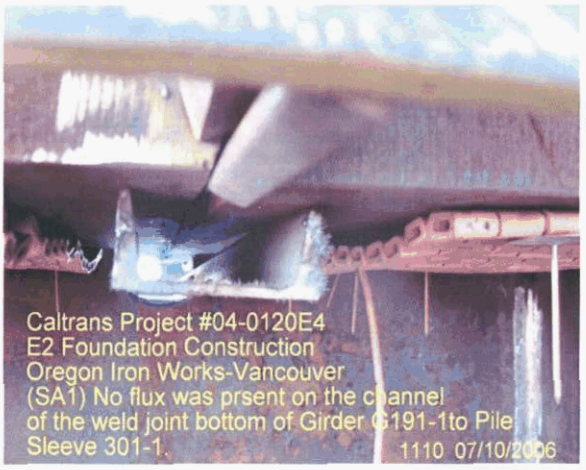
Description of Non-Conformance: Oregon Iron Works (OIW) Quality Control allowed OIW Welder Shannon Doolittle welder identification D-18 to perform welding outside the parameters of the Oregon Iron Works Welding Procedure Specification 4226. The welding was being performed without a flux-filled channel as described in the above mentioned welding procedure specification (WPS). Welding was performed with the submerged arc welding process on the South Pod Assembly (SA1) – Girder 191-1 to Pile Sleeve 301-1. *Attached pictures from this observation.*

Applicable reference: AWS D1.5-2002, Sec.5.21.2, OIW WPS 4226, Contract 04-012024 Special Provisions Section 8.3.

15. NCR 105 was issued on July 10, 2006 to document the Contractor welding outside the parameters of the WPS for the connection of G191-1 to Pile Sleeve 301-1. The

WPS requires a flux filled channel as backing for the weld joint; however, the channel did not contain any flux. As stated in OIW's response letter to State Letter 05.003.01-001517, dated September 7, 2006, the Contractor performed a deeper backgouge to ensure the root and butter passes were removed before depositing subsequent fill passes. METS agreed to this proposal and has verified the repair. METS considers this NCR to be resolved at this time.
