WELDING INSPECTION REPORT

Report No: WIR-000213
Date Inspected: 03-Jun-2007

Project Name: SAS Superstructure
Prime Contractor: American Bridge/Fluor Enterprises, a JV
Contractor: Zhenhua Port Machinery Company, Ltd (ZPMC), Changxing Island

Bridge No: 34-0006
Component: HP200777-1

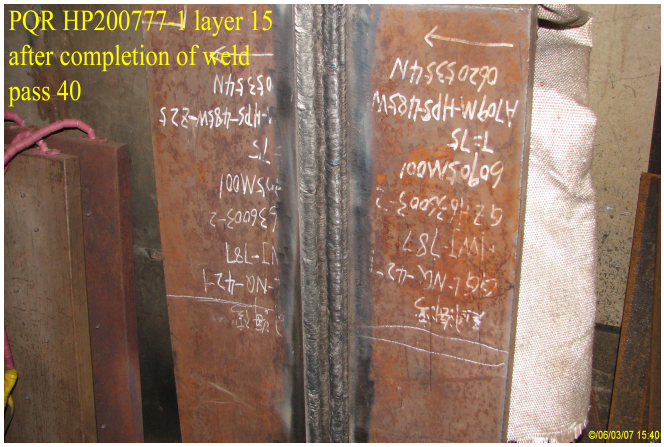
Caltrans Quality Assurance (QA) Inspector Bruce J. Berger continued witnessing ZPMC performing shield metal arc welding (SMAW) procedure qualification record (PQR) HP200777-1, PWPS-B-T-3213 test. The welder is identified as Mr. Zhu Hai Ping, welding passes forty through fifty-one. The test plate material type is identified as A709 Grade HPS485W and thickness, 75 mm. The PQR complete joint penetration groove weld testing was performed in the vertical up (3G) position. The welding consumable is identified as a 4.0 mm electrode, classification E9018M MR, specification AWS A5.5. Caltrans QA observed ZPMC QA Inspector, Mr. Wei Huang and two associates monitoring and supervising the testing per AWS 5.13 criteria; amperages, voltages, travel speeds, preheat and inter-pass temperatures. Also present at the test site was American Bridge/Fluor (ABF) quality control (QC) inspector, Mr. Song Wei Min. QA observed that the wind velocity at the ZPMC testing site appear to be in conformance with AWS D1.5, paragraph 4.14.3 requirements. Welding was not completed prior to the completion of the shift, so welding will continue tomorrow morning.
