DEPARTMENT OF TRANSPORTATION
DIVISION OF ENGINEERING SERVICES
Office of Structural Materials
Quality Assurance and Source Inspection

WELDING INSPECTION REPORT

Report No: WIR-008229
Date Inspected: 31-Jul-2009

Project Name: SAS Superstructure
Prime Contractor: American Bridge/Fluor Enterprises, a JV
Contractor: Oregon Iron Works Clackamas, Or.

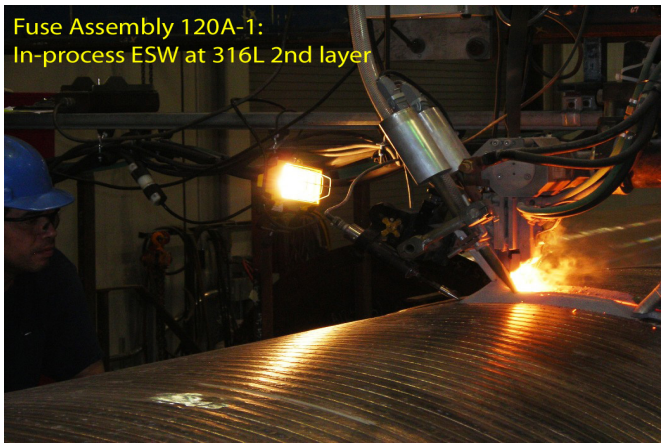
The QA Inspector intermittently observed OIW qualified welder Vincent Vu (WID V7) during in-process welding of Soudotape 316L stainless steel overlay to hinge k pipe beam fuse sub-assembly 120A-1. The weld joint is identified as 316L 2nd layer. Mr. Vu was observed welding in the flat position utilizing automatic electro slag welding (ESW) overlay process with a .5mm x 60mm Soudotape 316L stainless electrode, filler metal brand Soudotape class EQ316L automatic. An OIW helper was observed assisting welder V7 during ESW activity. The QA Inspector observed OIW QC Inspector Steve Barnett regularly monitoring and recording the in process ESW parameters. The QA Inspector also intermittently observed in process welding parameters and determined that the ESW parameters (1200 amps, 25.2 volts, 254mm/min travel speed) and minimum preheat temperature of 70° F appeared to be in general compliance with the contract requirements and approved OIW Welding Procedure Specification (WPS) 7003.
