DEPARTMENT OF TRANSPORTATION
DIVISION OF ENGINEERING SERVICES
Office of Structural Materials
Quality Assurance and Source Inspection

WELDING INSPECTION REPORT

Report No: WIR-009775
Date Inspected: 12-Oct-2009

Bridge No: 34-0006
Component: Pier E2 Bearing and Shear key

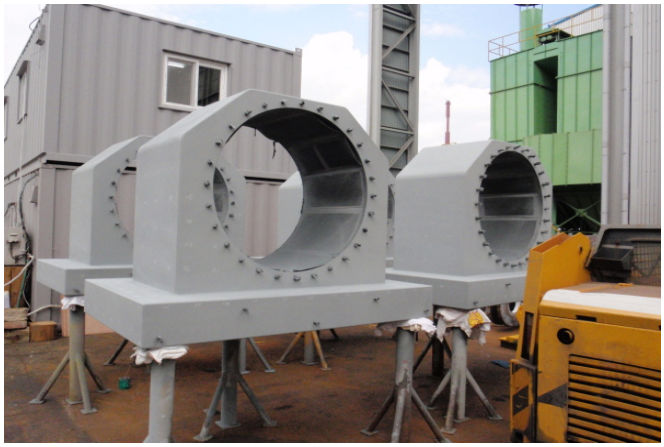
On this date HMI Certified welder Mr. GH. Lee started welding on bearing plate. QA inspector and HMIC QC inspector checked welding parameters prior to welding. Welding process utilized Flux Core Arc Welding (FCAW) with ER 309LMoTo-1 DW 309Mol (Kobe Steel) with diameter 1.2mm wire. Amperage was 135 (Root) 190 (fill and Cap), Voltage was 28, gas flow 25 l/Min. All welding parameters comply with approved welding procedure specifications No WPS-GT-011.
