WELDING INSPECTION REPORT

Report No: WIR-010951
Date Inspected: 20-Nov-2009

Project Name: SAS Superstructure
Prime Contractor: American Bridge/Fluor Enterprises, a JV
Contractor: HoChang, Korea

Bridge No: 34-0006
Component: Pier E2 Bearing and Shear key

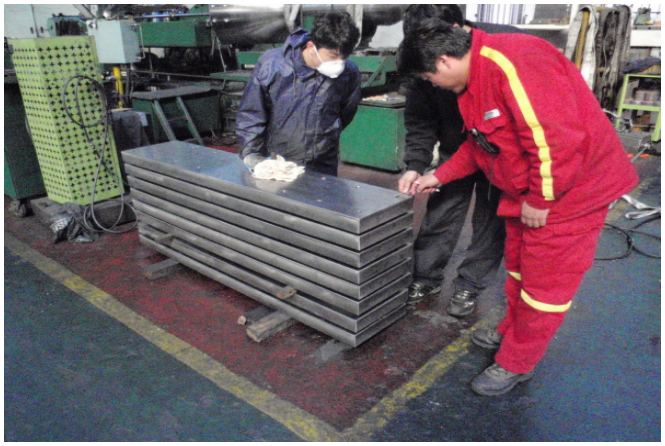
On this date, HMI Qualified welder Mr. O. J. Park performed minor repair welding on Bearing Top Housing, Shear key Stub and Shear Key Housing. QA inspector and HMI QC Inspector verified welding parameters prior to start welding. Welding process utilized was Gas Tungsten Arc Welding (GTAW) with ER70S-6 with diameter 2. 4mm rod manufactured by Hyundai Steel, Brand name ST-50.6 with 100% Argon gas. QA inspector verified welding parameter range was 15-17 volts, 200-245 amps, travel speed 74-89mm/min, Gas flow 12-15little/min., preheat temperature over 150ºC and interpass temperature of less than 250º C. After completing repair welding, HMIC increased the preheat to 300ºC for PWHT and covered by Heat blanket for slow cool down. All of welding parameters comply with approved welding procedure specifications No A-T-Z1Z1-147.
