WELDING INSPECTION REPORT

Report No: WIR-011547
Date Inspected: 12-Jan-2010

Project Name: SAS Superstructure
Prime Contractor: American Bridge/Fluor Enterprises, a JV
Contractor: Zhenhua Port Machinery Company, Ltd (ZPMC), Changxing Island

Bridge No: 34-0006
Component: OBG Components

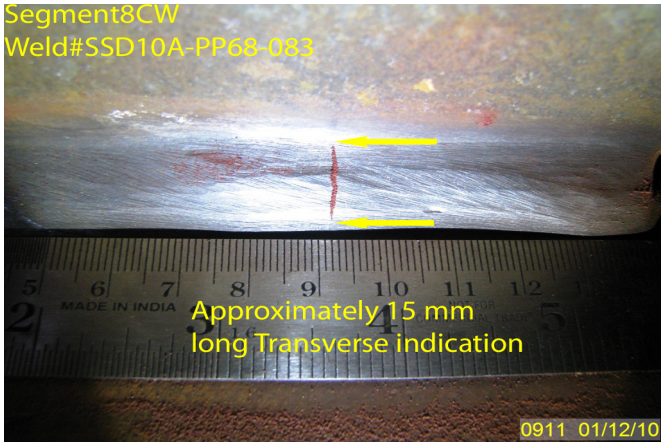
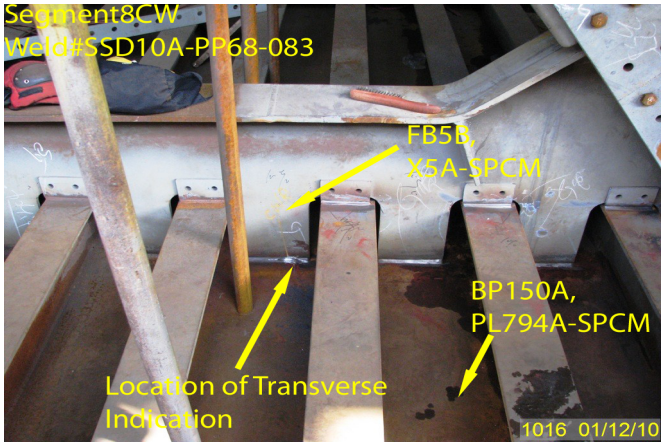
Segment 8CW

During the Quality Assurance Magnetic Particle Testing (MT) review of welds located on Segment 8CW, this Quality Assurance Inspector (QA) discovered the following issues:
-One (1) Transverse linear indication measuring approximately 15mm in length.
-The Y location is 140mm from the left end of the weld.
-The indication is clearly marked on the material near the weld.
-The weld is identified as: SSD10A-PP68-083.
-This weld is a Fillet Weld joining the Bottom Plate (BP150A) to Floor Beam (FB5B) web plate.
-This weld is designated as Seismic Performance Critical Member (SPCM) on the approved drawing (SEGSD10).
-OBG segment 8CW is located outside in west of Blast Shop area.

The Notice of Witness Inspection Number (NWIT) is 005037.
The indication is located inside the area that has been previously tested and accepted by ZPMC Quality Control (QC) personnel. ZPMC's QC personnel are required to perform twenty five (25%) percent MT inspection of this weld.

-(SSD21-PP67.5-079~084, 087~092)
-(SSD22-PP68.5-079~084, 087~092)
-(SSD22-PP69.5-079~084, 087~092)
-(SSD21-PP70.5-079~084, 087~092)
-(SSD10A-PP68-082, 084, 085, 086, 087, 088, 089, 090, 034~039, 026~031)
-(SSD11A-PP69-082~088, 034~039, 026~031)
-(SSD12A-PP70-085~091, 035~040, 027~032)
-(SSD9A-PP71-110, 108, 106, 104, 100, 098, 096, 042, 040, 038, 050, 048, 046)
-(SSD10A-PP68-083)-Rejectable indication found
