DEPARTMENT OF TRANSPORTATION
DIVISION OF ENGINEERING SERVICES
Office of Structural Materials
Quality Assurance and Source Inspection

WELDING INSPECTION REPORT

Report No: WIR-011950
Date Inspected: 06-Feb-2010

Project Name: SAS Superstructure
Prime Contractor: American Bridge/Fluor Enterprises, a JV
Contractor: Zhenhua Port Machinery Company, Ltd (ZPMC), Changxing Island

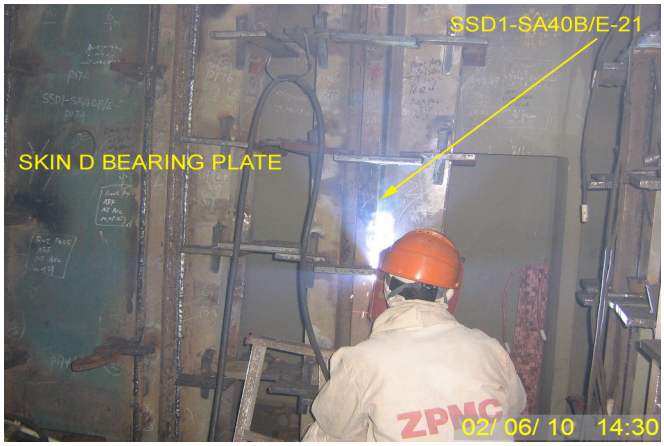
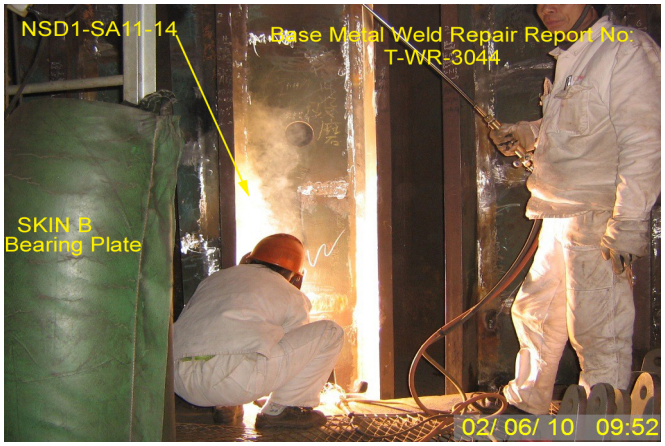
This QA inspector observed the following work in progress:
ZPMC performed Base metal repair of Bearing Plate located on Skin B (NSD1-SA11-14). The base metal repair area is approximately 3mm depth and 50mm length. The material is A709M Grade 345 Non-SPCM. Welder is identified as 053829.ZPMC CWI is identified as Mr. Zhao Chen Sun. SMAW Welding was been performed against welding repair report T-WR3044. The welding variables recorded by QC appeared to comply with the WPS-345-SMAW-3G(3F)-Repair.
