WELDING INSPECTION REPORT

Report No: WIR-012533
Date Inspected: 17-Feb-2010

Project Name: SAS Superstructure
Prime Contractor: American Bridge/Fluor Enterprises, a JV
Contractor: Zhenhua Port Machinery Company, Ltd (ZPMC), Changxing Island

Bridge No: 34-0006
Component: Tower

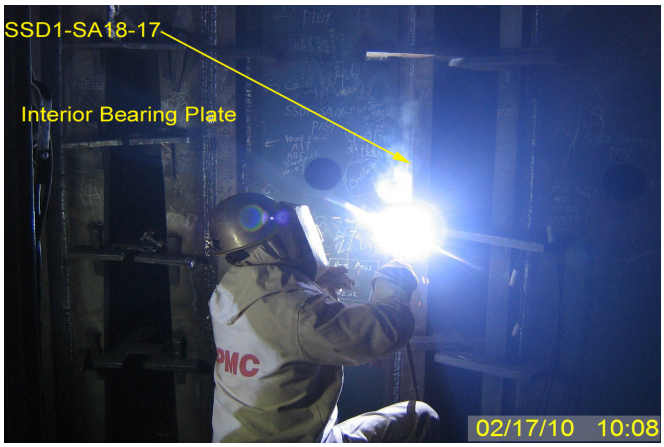
This QA inspector observed the following work in progress:
FCAW welding of weld joint no: SSD1-SA18-17 located on Skin B Interior Bearing Plate. Welder is identified as 066477.ZPMC QC is identified as Mr. Sun Tian Liang. The welding variables recorded by QC appeared to comply with the WPS-B-T-2333-TC-P4-F. Please see the attached picture below.
