WELDING INSPECTION REPORT

Report No: WIR-012535
Date Inspected: 20-Feb-2010

Project Name: SAS Superstructure
Prime Contractor: American Bridge/Fluor Enterprises, a JV
Contractor: Zhenhua Port Machinery Company, Ltd (ZPMC), Changxing Island

Bridge No: 34-0006
Component: Tower

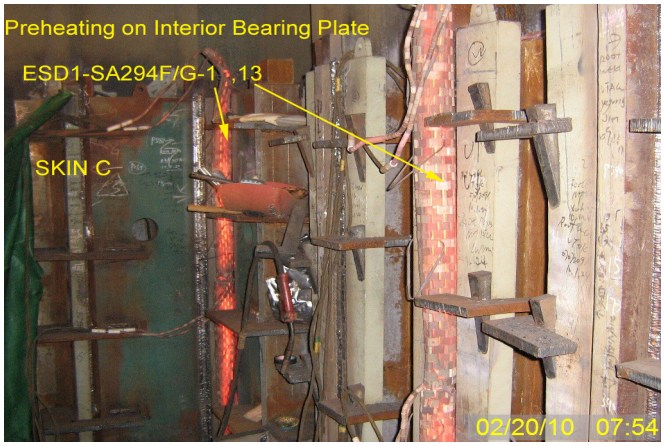
This QA inspector observed the following work in progress:
FCAW welding of weld joint no: ESD1-SA294F/G-1 located on Skin C Interior Bearing Plate. Welder is identified as 040736.ZPMC CWI is identified as Mr. You Qi Guo. The welding variables recorded by QC appeared to comply with the WPS-B-T-2333-TC-P4-F. Please see the attached picture below.

This QA inspector observed the following work in progress:
FCAW welding of weld joint no: ESD1-SA294F/G-13 located on Skin C Interior Bearing Plate. Welder is identified as 066674.ZPMC CWI is identified as Mr. You Qi Guo. The welding variables recorded by QC appeared to comply with the WPS-B-T-2333-TC-P4-F. Please see the attached picture below.
