Contract #: 04-0120F4
Cty: SF/ALA Rte: 80 PM: 13.2/13.9
File #: 69.28

WELDING INSPECTION REPORT

Report No: WIR-012542
Date Inspected: 27-Feb-2010

Project Name: SAS Superstructure
Prime Contractor: American Bridge/Fluor Enterprises, a JV
Contractor: Zhenhua Port Machinery Company, Ltd (ZPMC), Changxing Island

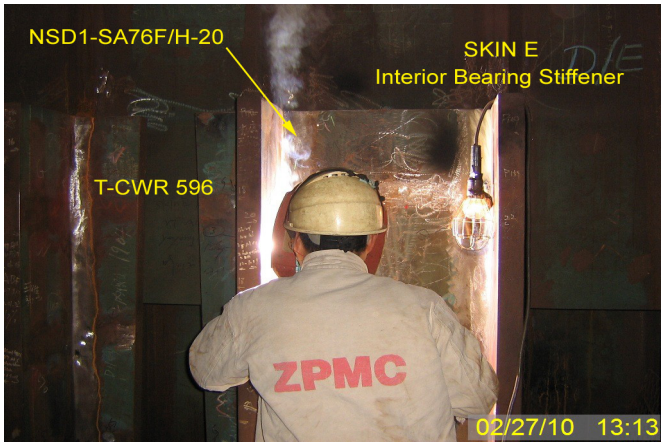
weld metal repair areas were approximately 3mm depth and 150mm, 90mm length at 2 random locations. The material is A 709M Grade 345 Non-SPCM. Welder is identified as 500331.ZPMC CWI is identified as Mr. You Qi Guo. SMAW welding was been performed against Critical Weld repair reportT-CWR596. The welding variables recorded by QC appeared to comply with the WPS-345-SMAW-3G(3F)-Repair. Please see the attached picture below.

This QA inspector observed the following work in progress:
ZPMC performed Base metal repair of Interior Bearing Stiffener located on Skin B (NSD1-SA11-2). The weld metal repair areas were approximately 3mm depth and app.100mm length at 5 random locations. The material is A 709M Grade 345 Non-SPCM. Welder is identified as 500373.ZPMC CWI is identified as Mr. You Qi Guo. SMAW welding was been performed against Critical Weld repair report T-CWR593. The welding variables recorded by QC appeared to comply with the WPS-345-SMAW-3G(3F)-Repair.Please see the attached picture below.
