WELDING INSPECTION REPORT

Report No: WIR-013044
Date Inspected: 19-Mar-2010

Project Name: SAS Superstructure
Prime Contractor: American Bridge/Fluor Enterprises, a JV
Contractor: Zhenhua Port Machinery Company, Ltd (ZPMC), Changxing Island

Bridge No: 34-0006
Component: Tower

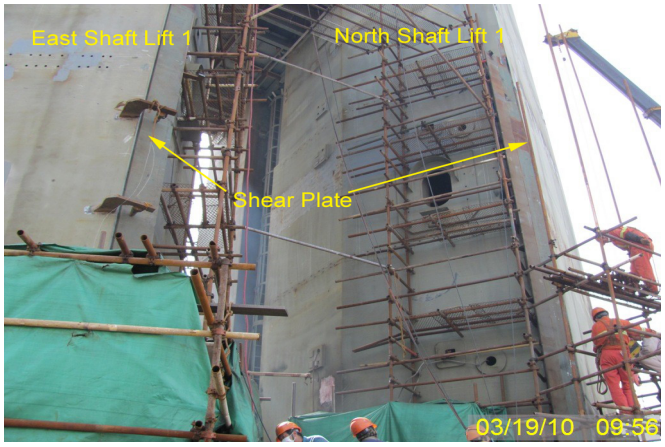
Unless otherwise noted, all work observed on this date appeared to generally comply with the applicable contract documents.
