DEPARTMENT OF TRANSPORTATION
DIVISION OF ENGINEERING SERVICES
Office of Structural Materials
Quality Assurance and Source Inspection

Contract #: 04-0120F4
Cty: SF/ALA Rte: 80 PM: 13.2/13.9
File #: 69.28

WELDING INSPECTION REPORT

Report No: WIR-014579
Date Inspected: 30-May-2010

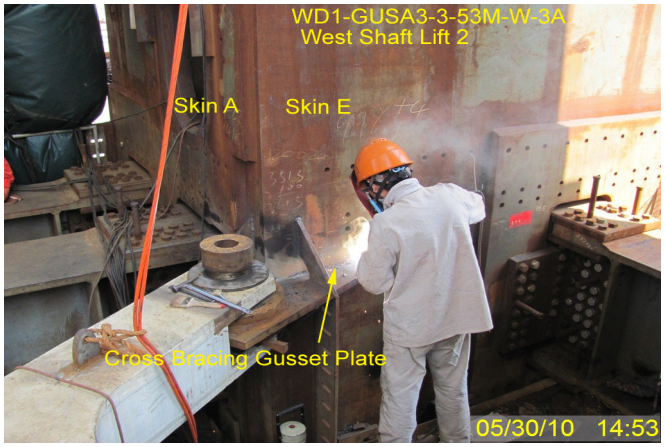
This QA inspector observed the following work in progress:
SMAW welding of weld joint no: WD1-GUSA3-3-53M-E-3A located on Cross Bracing Gusset Plate. Welder is identified as 040655.ZPMC CWI is identified as Mr.Qiu Wen. The welding variables recorded by QC appeared to comply with the WPS-B-P-2211-TC-U5b-FCM.

This QA inspector observed the following work in progress:
SMAW welding of weld joint no: WD1-GUSA3-3-53M-W-3A located on Cross Bracing Gusset Plate. Welder is identified as 040690.ZPMC CWI is identified as Mr.Qiu Wen. The welding variables recorded by QC appeared to comply with the WPS-B-P-2211-TC-U5b-FCM.

This QA inspector observed the following work in progress:
SMAW welding of weld joint no: WD1-GUSA3-3-65M-E-4A located on Cross Bracing Gusset Plate. Welder is identified as 040610.ZPMC CWI is identified as Mr.Qiu Wen. The welding variables recorded by QC appeared to comply with the WPS-B-P-2211-TC-U5b-FCM.

This QA inspector observed the following work in progress:
SMAW welding of weld joint no: WD1-GUSA3-3-65M-S-3A located on Cross Bracing Gusset Plate. Welder is identified as 500373.ZPMC CWI is identified as Mr.Qiu Wen. The welding variables recorded by QC appeared to comply with the WPS-B-P-2211-TC-U5b-FCM.
