WELDING INSPECTION REPORT

Report No: WIR-016724
Date Inspected: 30-Aug-2010

Project Name: SAS Superstructure
Prime Contractor: American Bridge/Fluor Enterprises, a JV
Contractor: Zhenhua Port Machinery Company, Ltd (ZPMC), Changxing Island

Bridge No: 34-0006
Component: Orthotropic Box Girder(OBG)

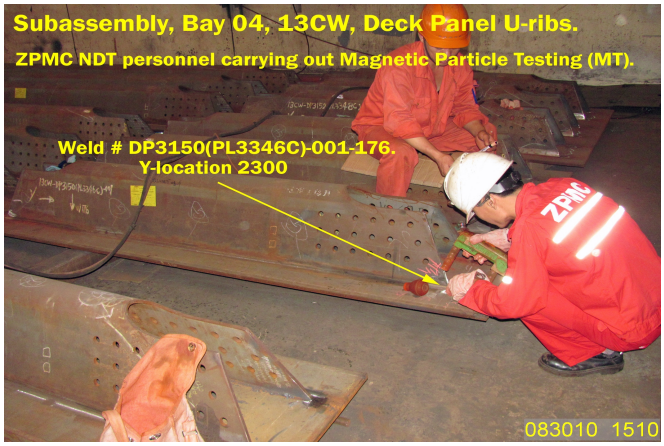
During Random Visual in process Inspection, this QA inspector observed ZPMC NDT personnel “Liu Zhong Min” carrying out Magnetic Particle Testing (MT) on Deck panel to U-rib welds. Deck Panel identified as DP3150-001. The attached photographs provide additional detail.
