WELDING INSPECTION REPORT

Report No: WIR-022529
Date Inspected: 04-Apr-2011

Project Name: SAS Superstructure
Prime Contractor: American Bridge/Fluor Enterprises, a JV
Contractor: Zhenhua Port Machinery Company, Ltd (ZPMC), Changxing Island

Bridge No: 34-0006
Component: OBG

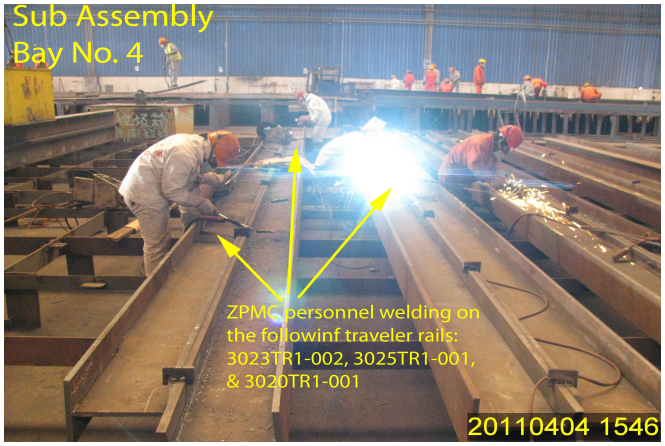
Unless otherwise noted above all items observed on this day appeared to be in general compliance with the applicable contract documents
