WELDING INSPECTION REPORT

Report No: WIR-024595
Date Inspected: 18-Jun-2011

Project Name: SAS Superstructure
Prime Contractor: American Bridge/Fluor Enterprises, a JV
Contractor: Zhenhua Port Machinery Company, Ltd (ZPMC), Changxing Island

Bridge No: 34-0006
Component: OBG

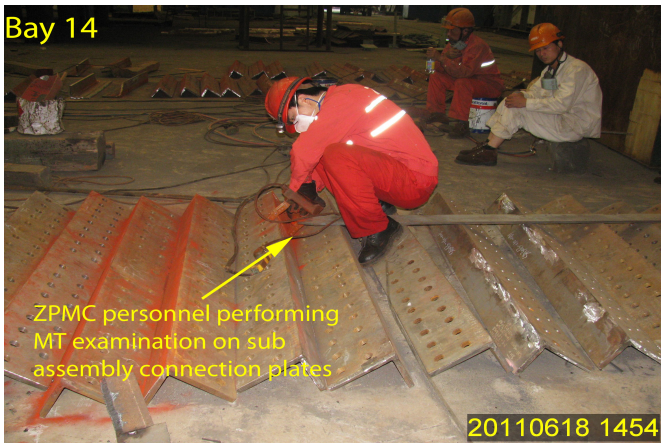
This inspector conducted continuous observation of ZPMC QC personnel performing MT inspection on the components listed below including applicable weld numbers. Also observed any grinding and welding of indication detected by MT testing:

This QA inspector performed MT of approximately 100% of the area previously tested and accepted by ZPMC Quality Control personnel. This QA Inspector generated an MT report for this date. The member(s) is/are identified as OBG Sub Assembly components identified below with the following identifying weld no.(s):

Unless otherwise noted above all items observed on this day appeared to be in general compliance with the applicable contract documents
