DEPARTMENT OF TRANSPORTATION
DIVISION OF ENGINEERING SERVICES
Office of Structural Materials
Quality Assurance and Source Inspection

WELDING INSPECTION REPORT

Report No: WIR-024596
Date Inspected: 19-Jun-2011

Project Name: SAS Superstructure
Prime Contractor: American Bridge/Fluor Enterprises, a JV
Contractor: Zhenhua Port Machinery Company, Ltd (ZPMC), Changxing Island

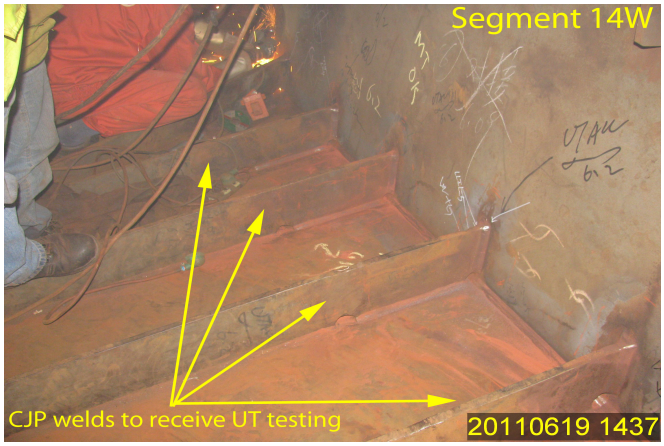
Unless otherwise noted above all items observed on this day appeared to be in general compliance with the applicable contract documents
