WELDING INSPECTION REPORT

Report No: WIR-024598
Date Inspected: 21-Jun-2011

Project Name: SAS Superstructure
Prime Contractor: American Bridge/Fluor Enterprises, a JV
Contractor: Zhenhua Port Machinery Company, Ltd (ZPMC), Changxing Island

Bridge No: 34-0006
Component: OBG

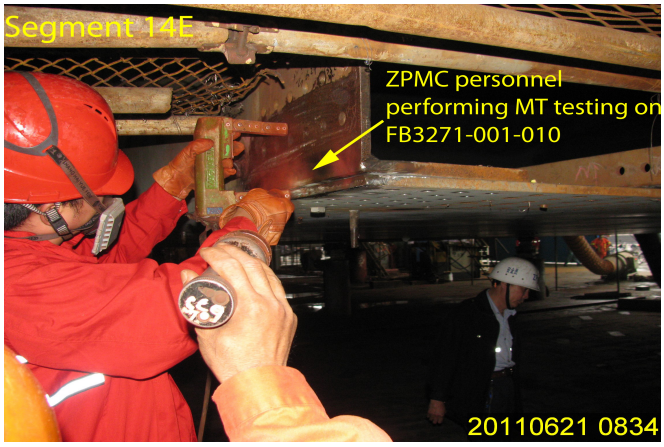
This inspector conducted continuous observation of ZPMC QC personnel performing MT inspection on the components listed below including applicable weld numbers. Also observed any grinding and welding of indications detected by MT testing:

1. SEG3019V-153, 154, 155, 156, 158, 160, 162, 164, 166, & 168.
2. SEG3019AG-038, 051, 040, 042, 044, & 001.
3. SEG3019V-032, 197, 195, 199, 200~202, 204~225, 119, 121, 123, 125, 127, 228, 226, 234, 230, 231, & 236.
