DEPARTMENT OF TRANSPORTATION
DIVISION OF ENGINEERING SERVICES
Office of Structural Materials
Quality Assurance and Source Inspection

WELDING INSPECTION REPORT

Report No: WIR-024607
Date Inspected: 11-Jun-2011

Project Name: SAS Superstructure
Prime Contractor: American Bridge/Fluor Enterprises, a JV
Contractor: Zhenhua Port Machinery Company, Ltd (ZPMC), Changxing Island

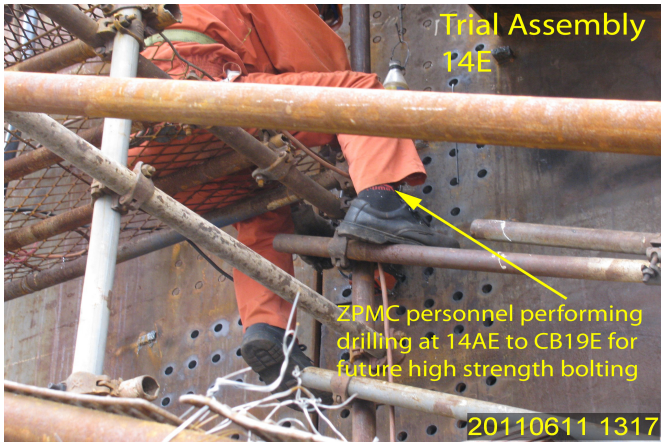
Trial Assembly Segment 14AE @ CB19E

This inspector observed ZPMC personnel performing match drilling at bottom and each vertical side at CB19E.
