DEPARTMENT OF TRANSPORTATION
DIVISION OF ENGINEERING SERVICES
Office of Structural Materials
Quality Assurance and Source Inspection

Contract #: 04-0120F4
Cty: SF/ALA Rte: 80 PM: 13.2/13.9
File #: 1.28

WELDING INSPECTION REPORT

Report No: WIR-025391
Date Inspected: 02-Aug-2011

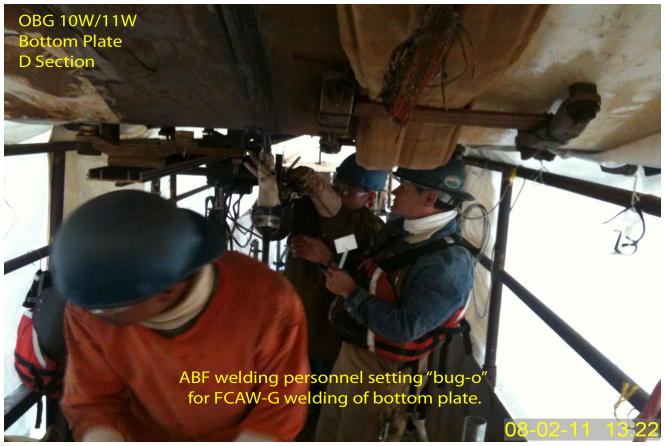
Unless otherwise noted, all work observed on this date appeared to generally comply with applicable contract documents.
