WELDING INSPECTION REPORT

Report No: WIR-025664
Date Inspected: 08-Jul-2011

Project Name: SAS Superstructure
Prime Contractor: American Bridge/Fluor Enterprises, a JV
Contractor: Zhenhua Port Machinery Company, Ltd (ZPMC), Changxing Island

Bridge No: 34-0006
Component: OBG

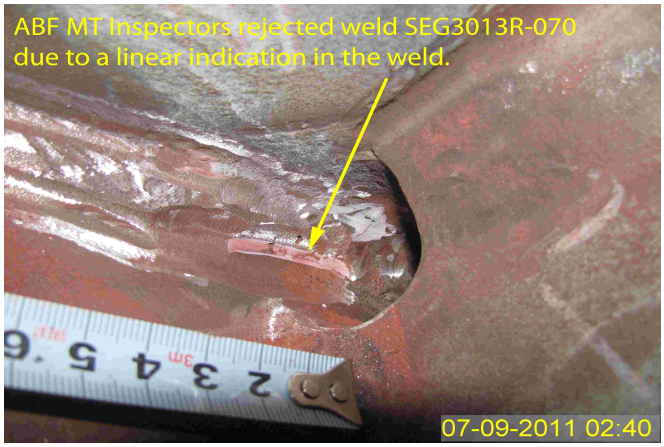
Caltrans and ABF have agreed to conduct visual and magnetic particle inspections (MT) of segment 13East welds as part of a special inspection program, reference NWIT number 9665. This QA Inspector observed ABF Inspectors had completed and accepted MT inspections of welds: SEG3013R-071; SEG3013P-082, 083; SEG3013M-041, 042, SEG3013K-049, 050, 104, 105, 154, 155, 159, 160 and 164. ABF Inspectors rejected weld SEG3013R-070 and ZPMC performed a weld repair of this weld. This QA Inspector performed random visual and magnetic particle inspection of welds: SEG3013P- 083; SEG3013M-041, 042, SEG3013K-049, 050, 104, 105, 155, 159 and these welds appear to comply with AWS D1.5 MT and visual requirements. For additional information on these inspections see this QA Inspector's TL6028 Magnetic Particle Test Report.
