DEPARTMENT OF TRANSPORTATION
DIVISION OF ENGINEERING SERVICES
Office of Structural Materials
Quality Assurance and Source Inspection

WELDING INSPECTION REPORT

Report No: WIR-026403
Date Inspected: 22-Sep-2011

Project Name: SAS Superstructure
Prime Contractor: American Bridge/Fluor Enterprises, a JV
Contractor: American Bridge/Fluor Enterprises, a JV

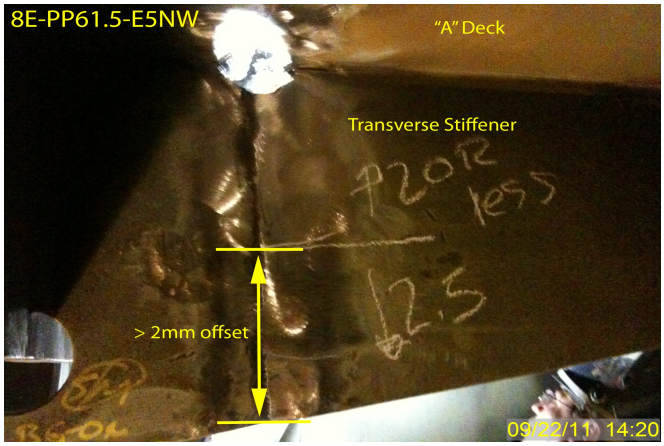
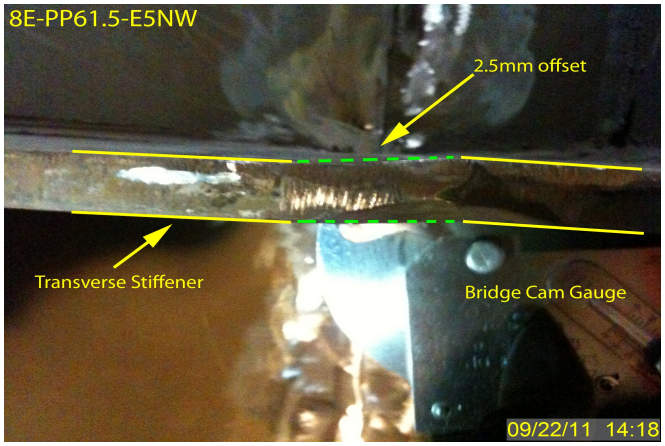
Approximately:
14:00 this QA observed an approximate 2.5mm offset in the plate alignment of the transverse stiffener at location 8E-PP61.5-E5 NW. QC Salvador Marino noted this offset in a report issued for Magnetic Particle testing he had performed earlier on this date. For further information please review photographs filed with this report.
