WELDING INSPECTION REPORT

Report No: WIR-027921
Date Inspected: 05-Jul-2012

Project Name: SAS Superstructure
Prime Contractor: American Bridge/Fluor Enterprises, a JV
Contractor: American Bridge/Fluor Enterprises, a JV

Bridge No: 34-0006
Component: OBG

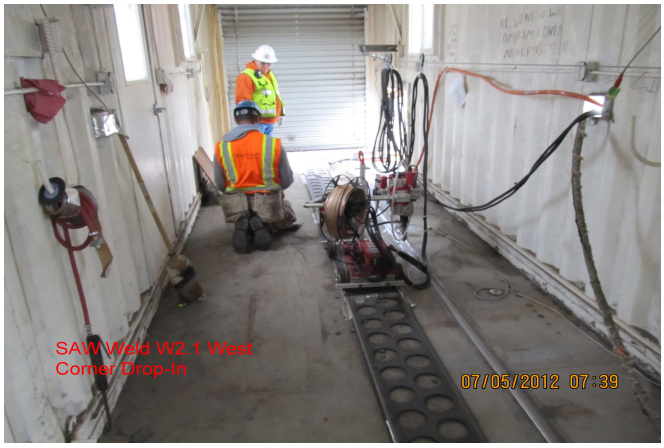
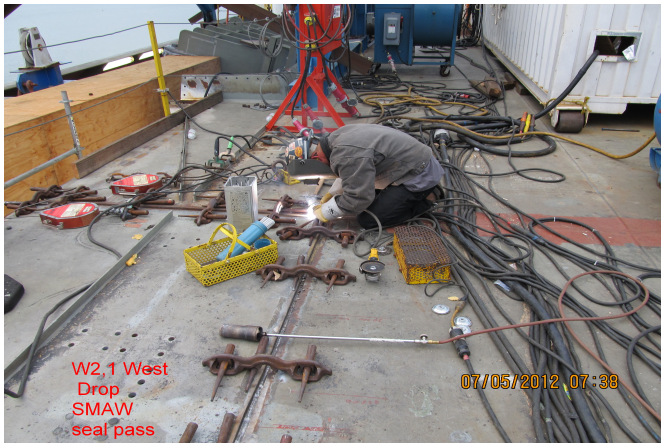
QAI observed the preheating of weld joint W12 Corner Drop-In W2.1 by Welder Jeremy Doleman ID#5042, utilizing the use of a rosebud torch. The joint was preheated to a Quality Control Recorded; Quality Assurance verified temperature of 150F. This QAI observed QC inspector Fred Michaels take multiple temperature readings along the length of the weld joint prior to the start of welding operations, and after work stoppages randomly throughout the day. Inspector Michaels was using an Infrared non-contact heat gun to record preheat temperature, this QAI verified readings using a Tempil Stick at random intervals throughout the day.

This QAI observed the welding of W12 West Corner Drop-In W2.1 deck splice by Welder Dan Ieraci (ID#3232) utilizing the Submerged Arc Welding Process in the 1G position to the following parameters Amps: 550, Volts: 32. 4 Wire Feed Speed: 381 which fall within the range dictated by the applicable Welding Procedure Specification.
