DEPARTMENT OF TRANSPORTATION
DIVISION OF ENGINEERING SERVICES
Office of Structural Materials
Quality Assurance and Source Inspection

WELDING INSPECTION REPORT

Report No: WIR-028239
Date Inspected: 21-Aug-2012

Project Name: SAS Superstructure
Prime Contractor: American Bridge/Fluor Enterprises, a JV
Contractor: American Bridge/Fluor Enterprises, a JV

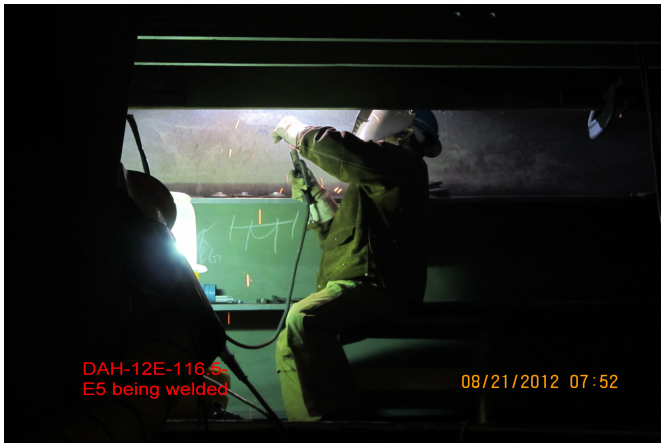
Welding 12E-116.5-E5 Deck Access Hole

The QA inspector randomly observed the in process Shield Metal Arc Welding being performed by ABF welding personnel Jin Pei Wang (7299) on Face B of Deck Access Hole 12E-116.5-E5. The welder spent the shift depositing the cap passes with approximately 100% being completed at the end of the shift. QC inspector Fred Michels was noted to be present in order to monitor the progress and ensure the welding was within the established Welding Procedure Specification (WPS) noted as ABF-WPS-D15-1110-A and supporting Procedure Qualification Records (PQR). Prior to initiating the welding at this location the QC inspector observed the preheat temperature, using a Raytek non-contact Thermometer, was sufficient and compliant to the above-mentioned WPS. Using a Tempil Stick, (temperature indicating crayon)the preheat and interpass temperature was then verified by this QA inspector to be greater than 150F and the parameters, using a Fluke brand Tong style meter, was verified to be 179

amps. See digital photo included in the body of this report for general information.
