WELDING INSPECTION REPORT

Report No: WIR-028932
Date Inspected: 15-Dec-2012

Project Name: SAS Superstructure
Prime Contractor: American Bridge/Fluor Enterprises, a JV
Contractor: American Bridge/Fluor Enterprises, a JV

Bridge No: 34-0006
Component: Tower

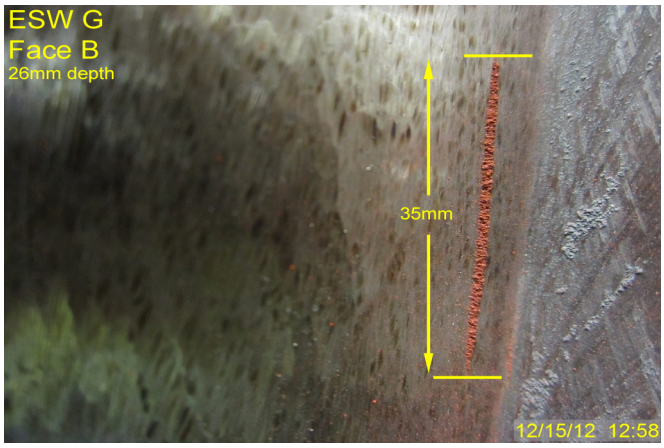
This QA performed observation of excavation of Electroslag Weld (ESW) designated as ESW G. Excavation was performed at location (Y= 7800mm~8200mm).

-24mm depth
One (1) longitudinal indication observed.
Y= 8045mm
X= -5mm
L= 35mm

-25mm depth
One (1) longitudinal indication observed.
Y= 8045mm
X= -5mm
L= 35mm

Excavation was performed by ABF welding personnel using a mechanical grinder removing approximately 1mm at a time. This QA observed Quality Control Inspector Andrew Keech performing visual inspection and Magnetic Particle Testing (MT) of this excavation between passes. This QA performed visual inspection and intermittent verification MT of this excavation between passes.
