IDENTIFICATION AND DELINEATION OF SINKHOLE COLLAPSE HAZARDS IN FLORIDA USING GROUND PENETRATING RADAR AND ELECTRICAL RESISTIVITY IMAGING

William L. Wilson and K. Michael Garman

Subsurface Evaluations, Inc.
8010 Woodland Center Blvd., Suite 100,Tampa, FL 33614
mgarman@direcway.com

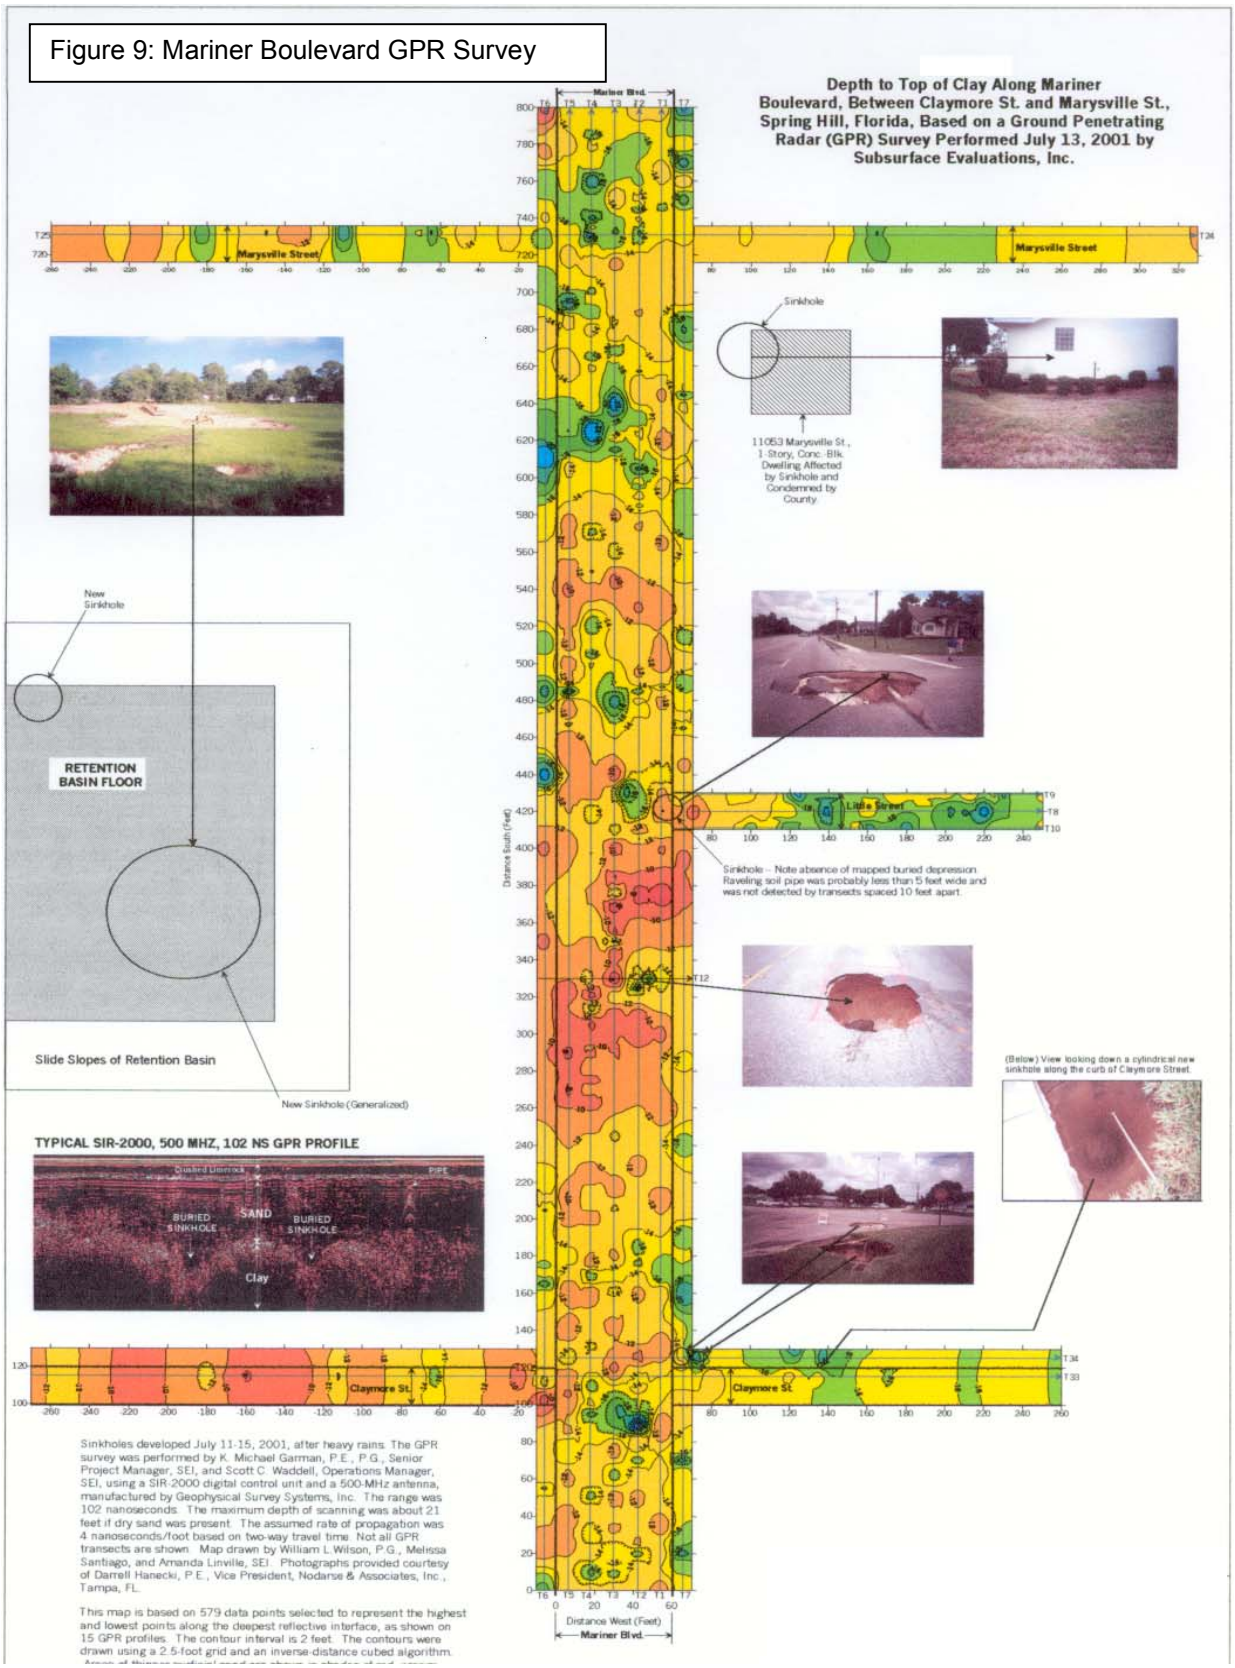
Figure 9. Mariner Boulevard GPR Survey

A GPR survey was performed along a three-block section of Mariner Boulevard adjacent to the retention basin. The survey identified approximately eight large buried depressions (Figure 9). These large buried depressions were compound buried depressions as each one contained multiple possible raveling soil pipes. Over 90 possible raveling soil pipes most of which were 5-feet or less in diameter were identified within the eight large buried depressions. Test borings were advanced at the centers of the large buried depressions and loose soil conditions were identified within three of these features.
