PERFORMANCE OF AN ASPHALT TREATED DRAINAGE BLANKET IN A FLEXIBLE PAVEMENT SECTION

RESEARCH REPORT

NO. M & R 632618

Prepared in Cooperation with the U.S. Department of Transportation, Bureau of Public Roads January, 1970

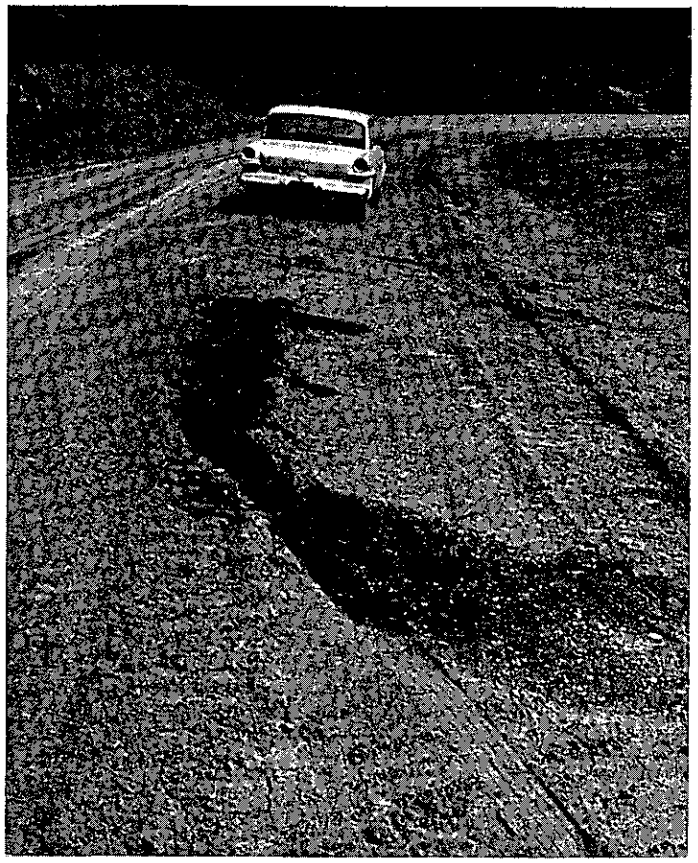
Figure 1

The cut material consisted of crushed metashale and sandstone of the franciscan formation. Annual rainfall for the five year period 1963-1968 averaged 69.2 inches. Examination of the site in the spring of 1968 subsequent to completion of the cut revealed numerous springs (Figure 1), the largest of which was located at the cut bank on the uphill or left side of the roadway. The locations of active springs and moist spots visible on the prepared subgrade are shown by Figure 2, a plan of the experimental section.

Natural Spring (wet area) in roadbed prior to paving.

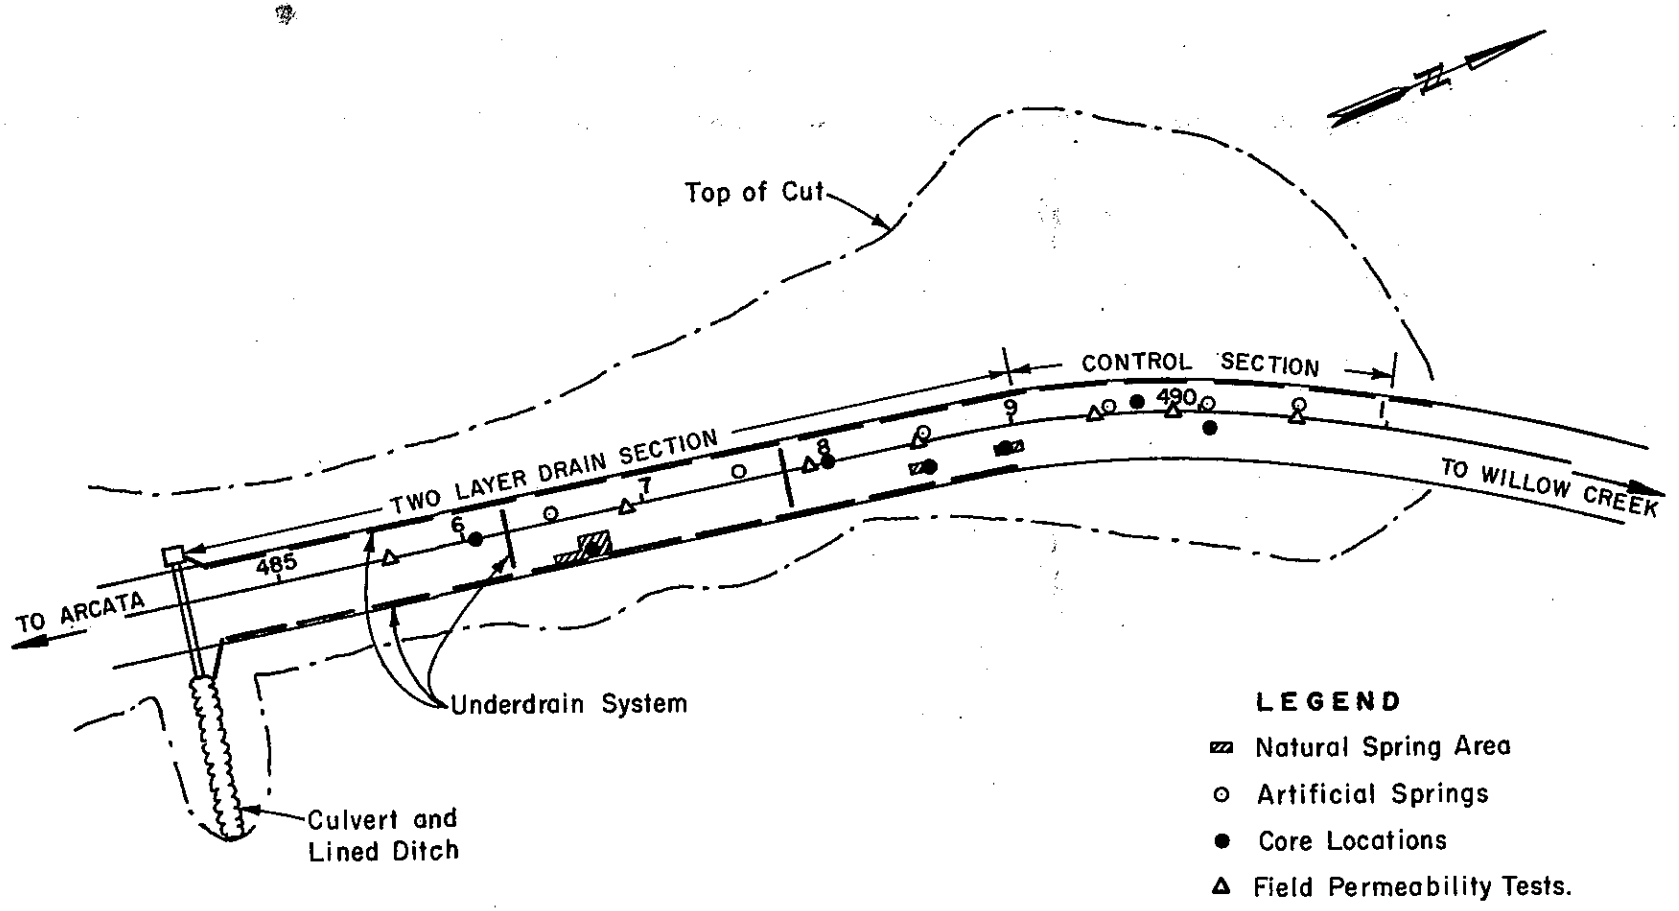
Figure 2

In May, 1969, at the conclusion of an unusually wet winter and spring, seven locations on the experimental section were cored as shown by Figure 2. Of particular interest were the moisture contents of the various elements of the structural section in the previously mapped natural spring areas. In addition to moisture samples, bulk samples were taken for grading and laboratory permeability tests. At three locations, 8- by 8-in. chunks of the asphalt treated permeable material were removed for density measurements, asphalt content determination and laboratory permeability testing.

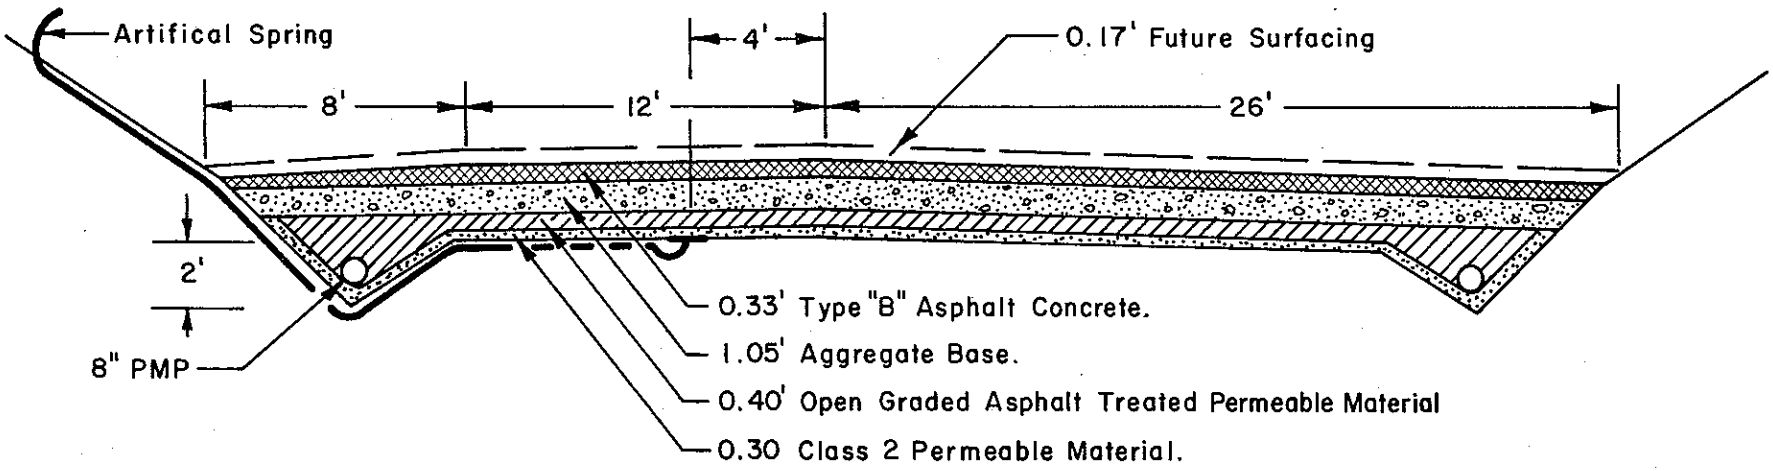
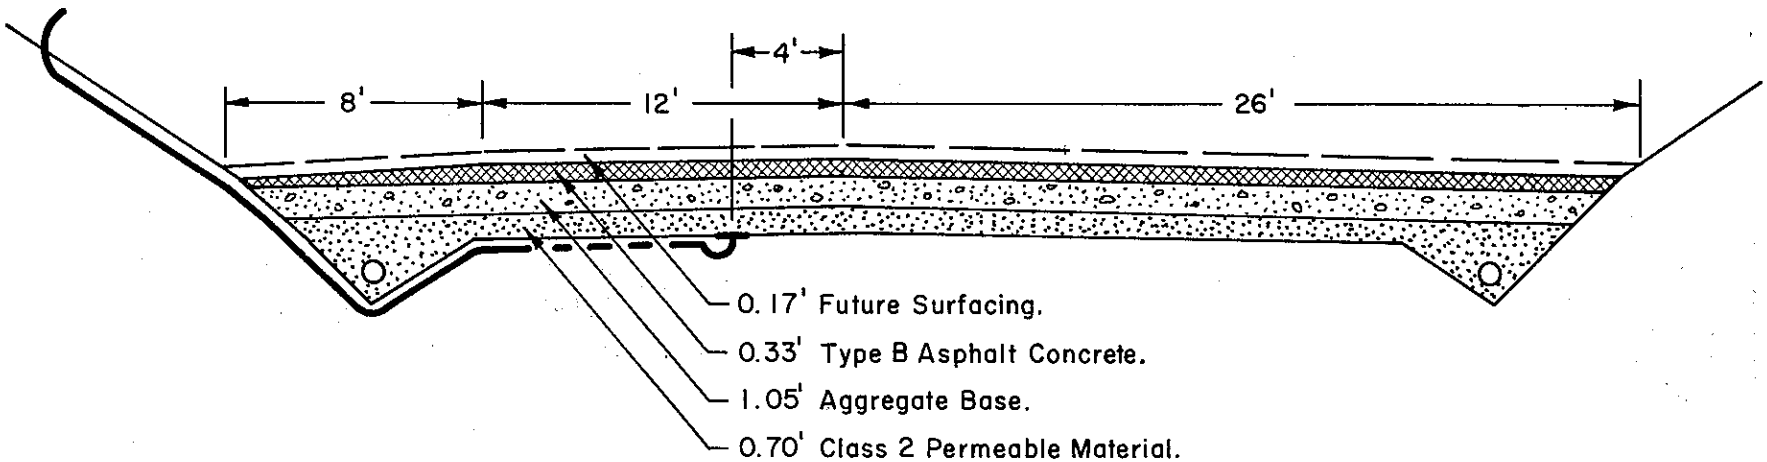
Figure 3

The 600 ft experimental section was eventually divided into two subsections. From Sta. 485 to Sta. 489, the two-layer subdrain was installed consisting of 0.3 ft of standard Class 2 permeable material for filtration and 0.4 ft of asphalt treated permeable material for drainage. The control section (Sta. 489 to 491) consisted of a single layer of standard Class 2 permeable material, 0.7 ft thickness (See Figure 3). Eight-inch diameter PMP longitudinal collector pipes were placed along both shoulders. Based upon the results of laboratory permeability tests on the asphalt treated permeable material of several thousand feet per day reported by Lovering and Cedergren,[6] a rational design of the underdrainage system was considered unnecessary. The capacity of even 0.2 ft of uncontaminated asphalt treated permeable material was calculated to be up to 100 times greater than the seepage capacity of the basement soil even assuming a 5-ft head and a relatively high basement permeability value of 0.01 ft per day. Thus, 0.4 ft of asphalt treated permeable material was selected to allow for inevitable variations in thickness as a result of the construction operation and a certain amount of contamination by the filter material and the overlying aggregate subbase material. In a like manner, a 0.7 ft single drainage layer in the control section was selected simply to permit a direct comparison of the two systems.

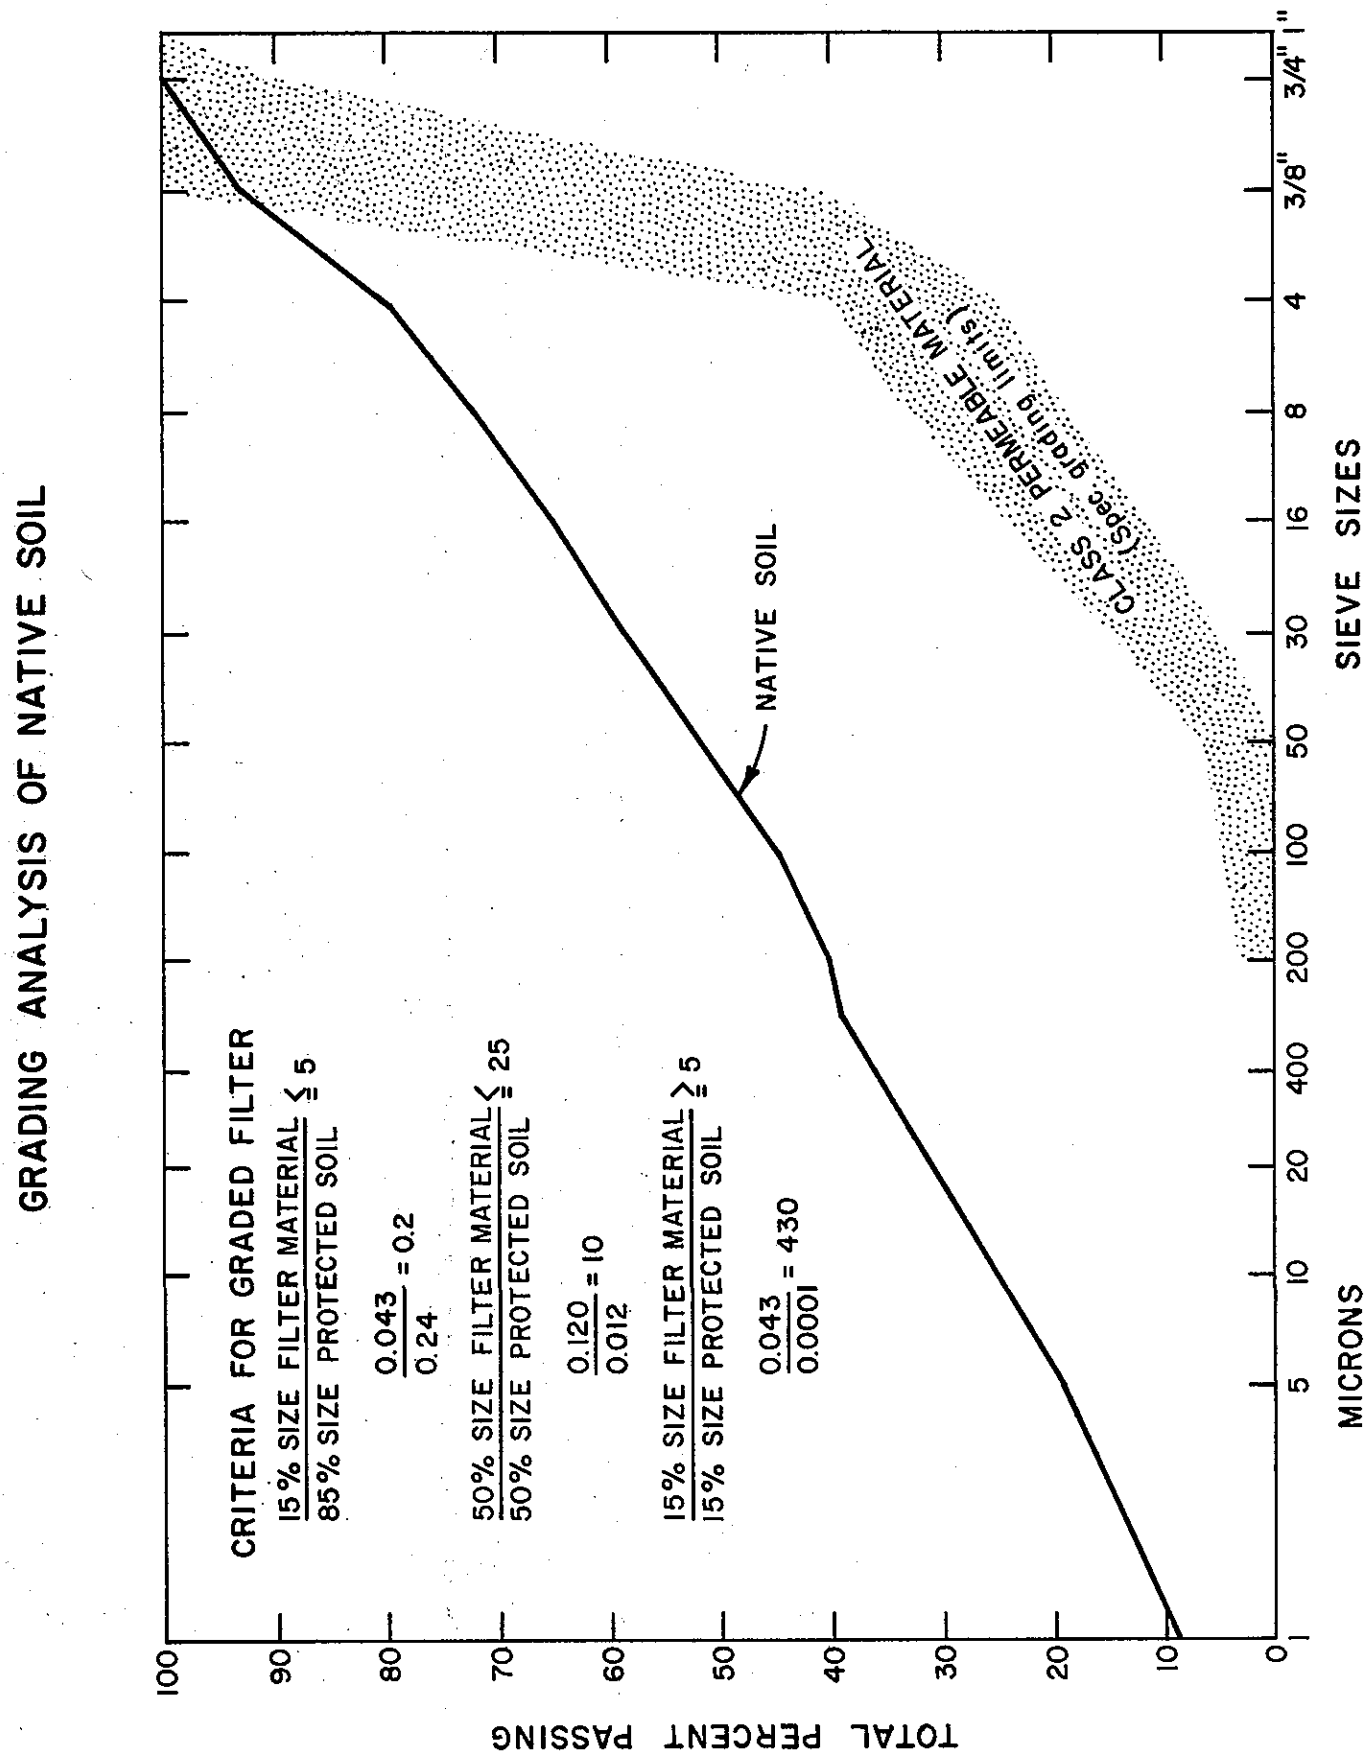
Figure 4

Based upon a representative basement soil grading curve and the calculations shown by Figure 4, it was concluded that the standard Class 2 permeable material would serve satisfactorily

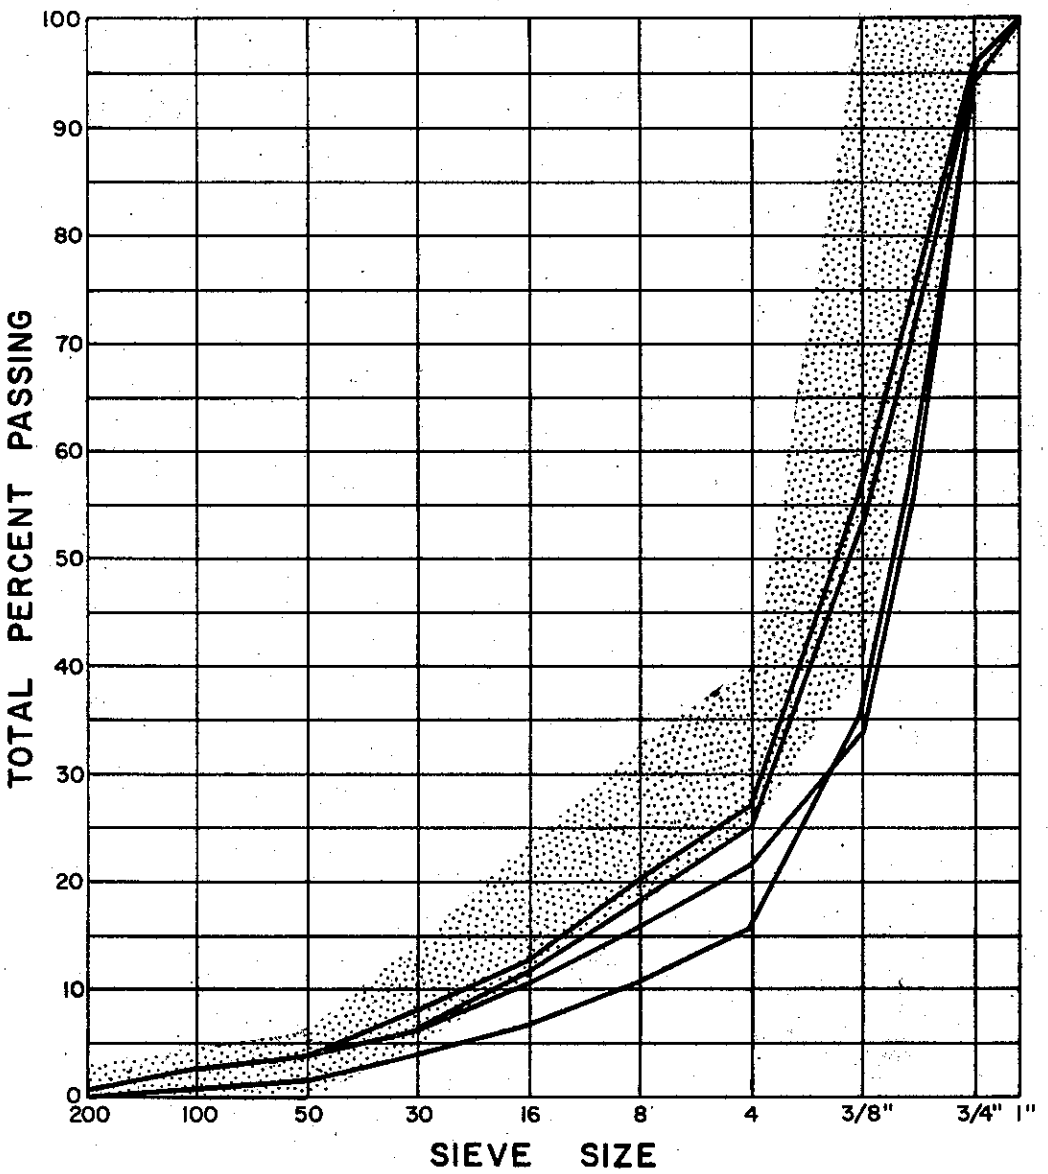
Figure 5

Drainage materials were obtained from local commercial sources in the Arcata area, a distance of 25 miles. The gradings of individual Class 2 permeable material samples taken during construction superimposed upon the specification limits are presented by Figure 5. These plots show general compliance with specifications with a tendency to be slightly coarse in the No. 16 to 3/8-in. sieve sizes. The grading curves of samples taken subsequent to construction during the coring operation, are presented by Figure 6. They again show general compliance with one of the four samples on the fine side of the specification grading curve.

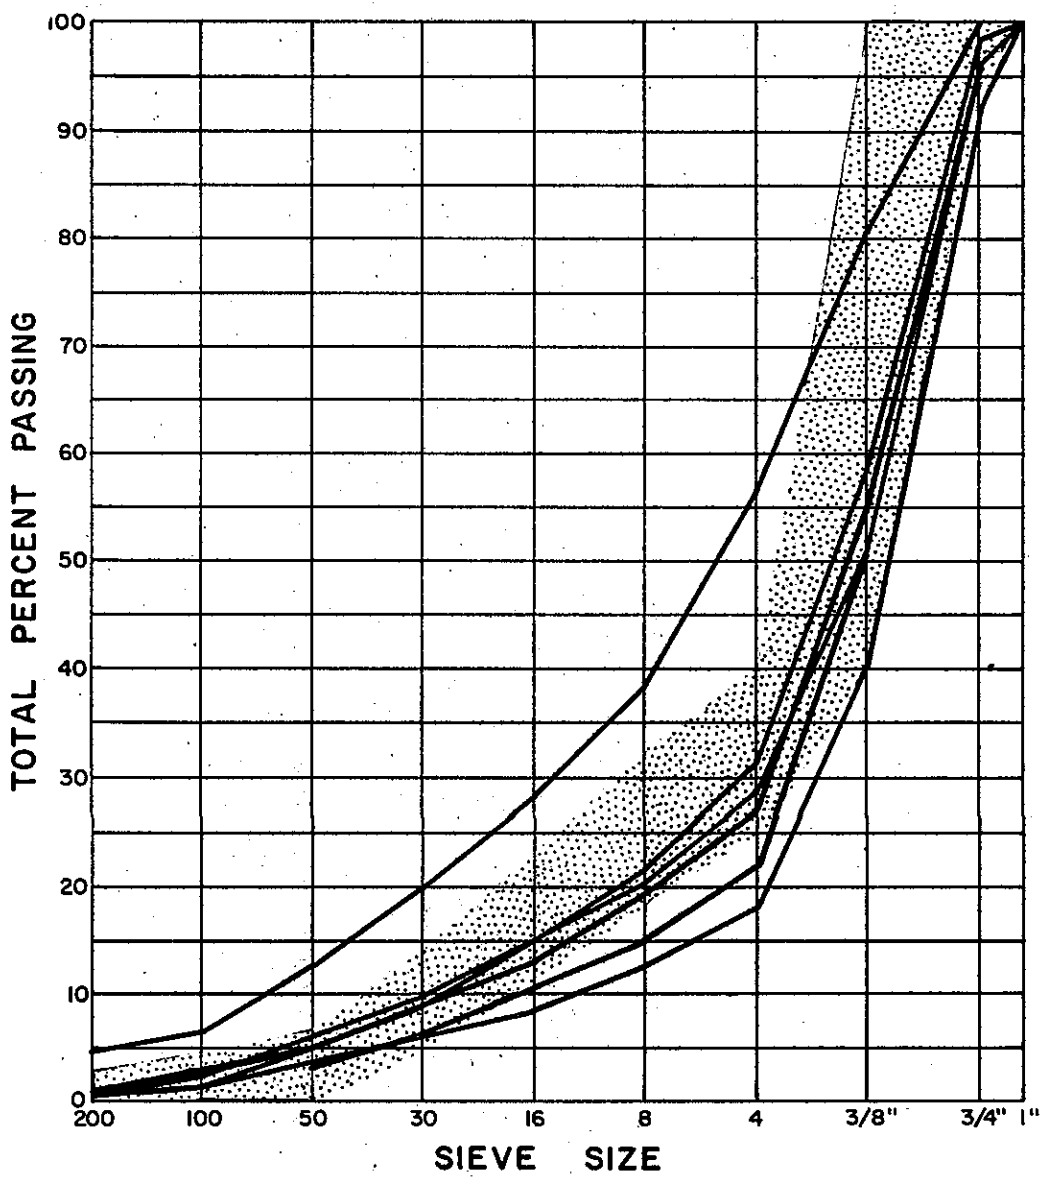
CLASS 2 PERMEABLE MATERIAL
SAMPLED AFTER CONSTRUCTION

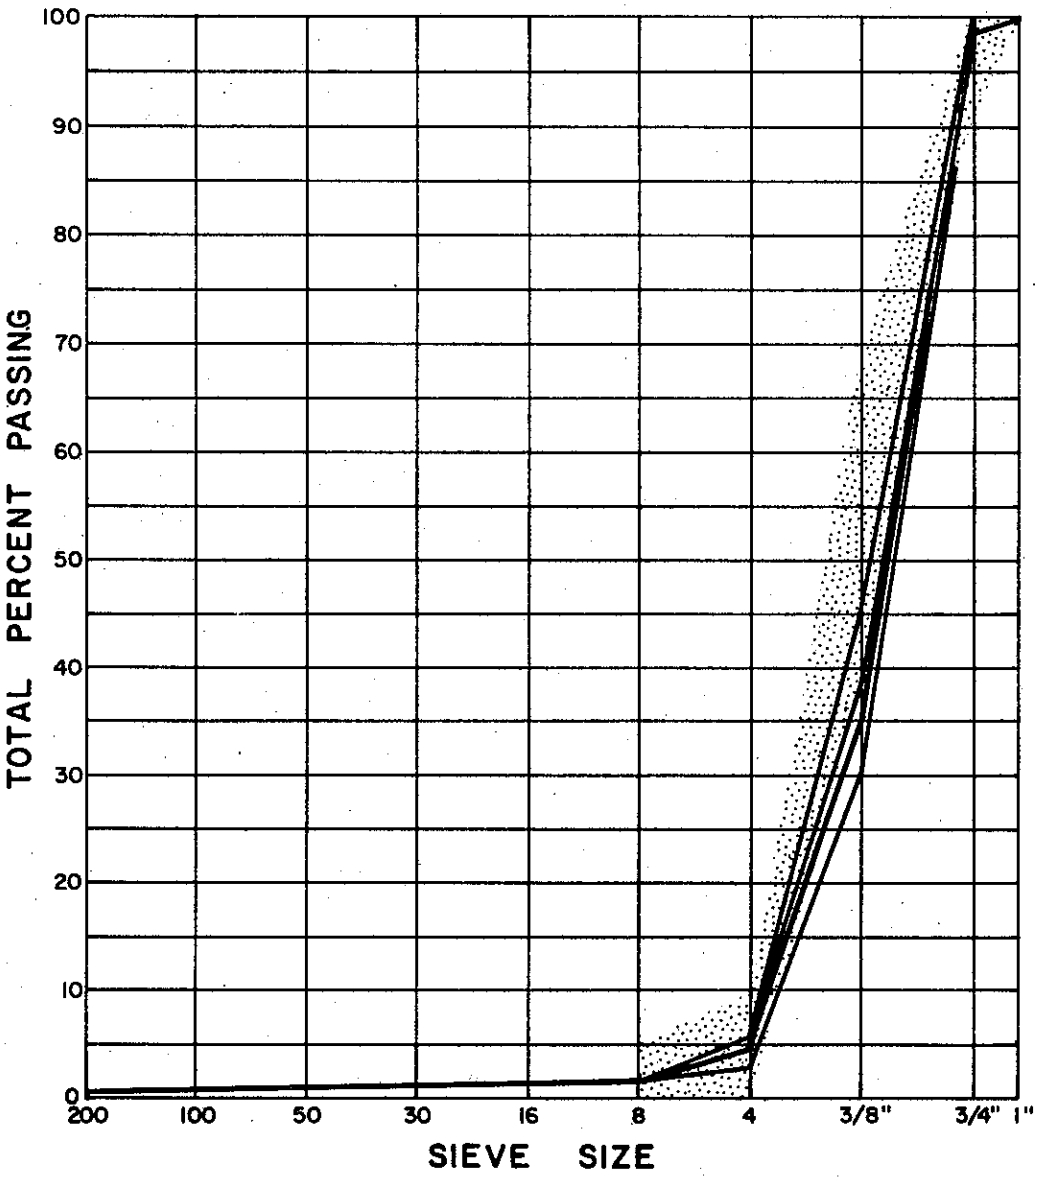
Figure 7

The aggregate used for the asphalt treated permeable material was a relatively uniform 3/4 in. to No. 4 size material as shown by Figures 7 and 8 which present grading curves of individual samples taken during and after construction. Significant breakdown did not occur as a result of the construction operation. The asphalt treated permeable material was plant mixed with the design asphalt content of two percent 85-100 penetration asphalt. Placement was made in two lifts of 0.2 ft each. The haul distance was 25 miles. Air temperatures ranged from 60 F to 74 F during placement. Upon delivery, mix temperature varied from 215 F to 250 F. No problems were encountered in putting the asphalt

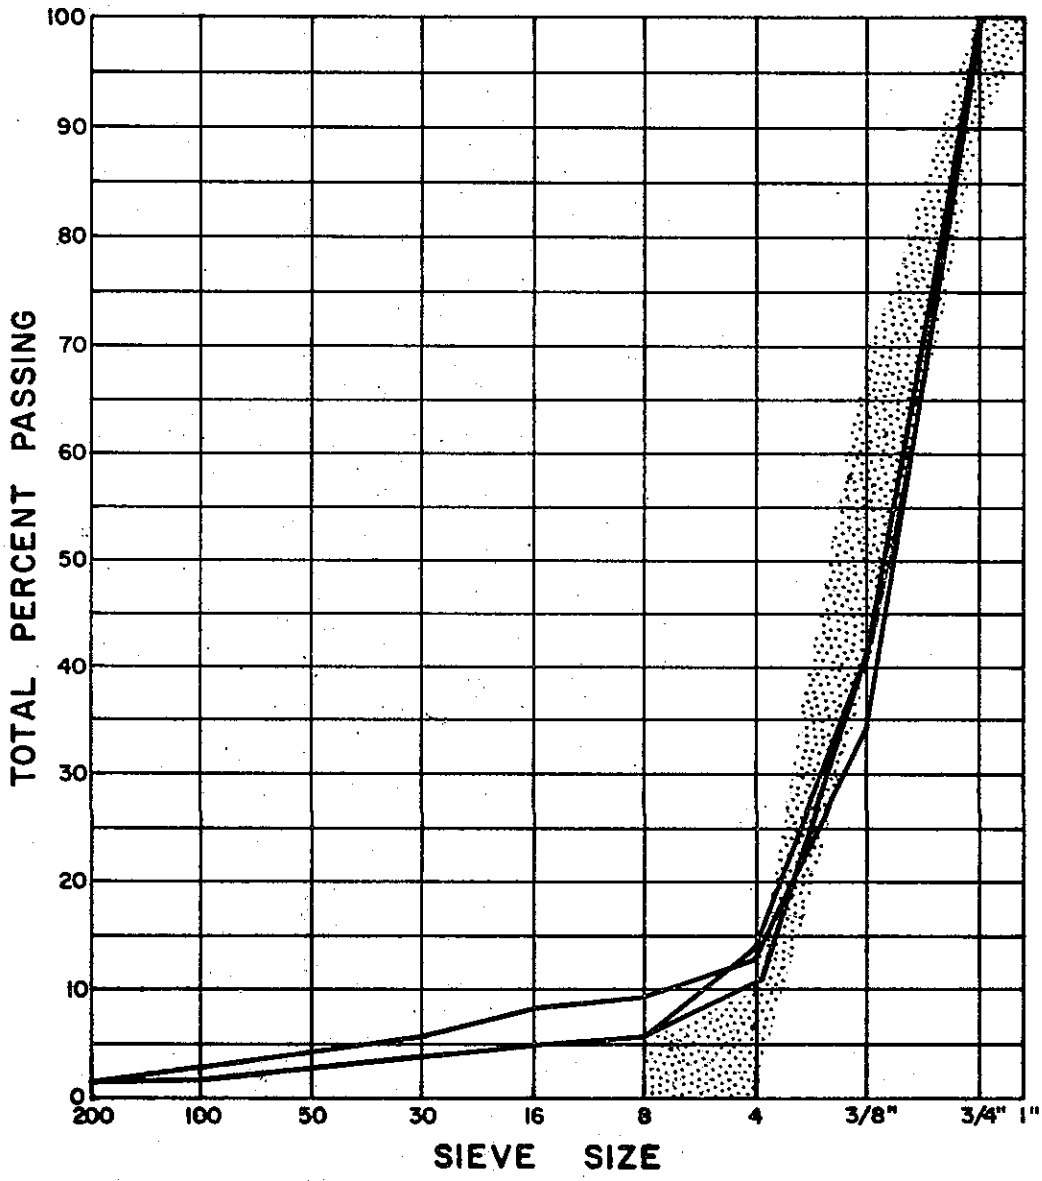
ASPHALT TREATED PERMEABLE MATERIAL SAMPLED AFTER CONSTRUCTION

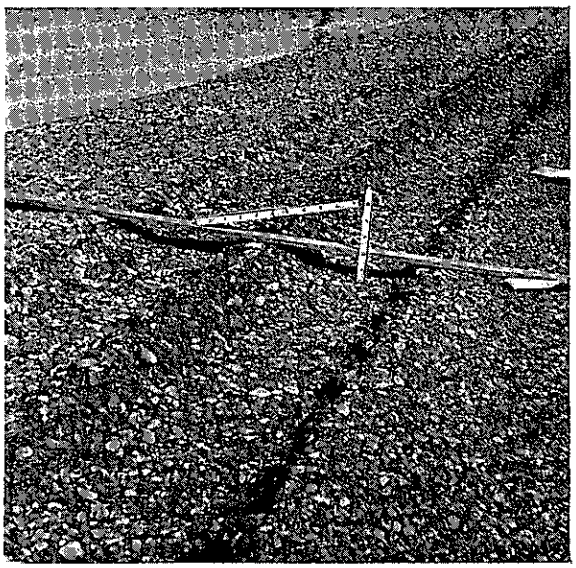
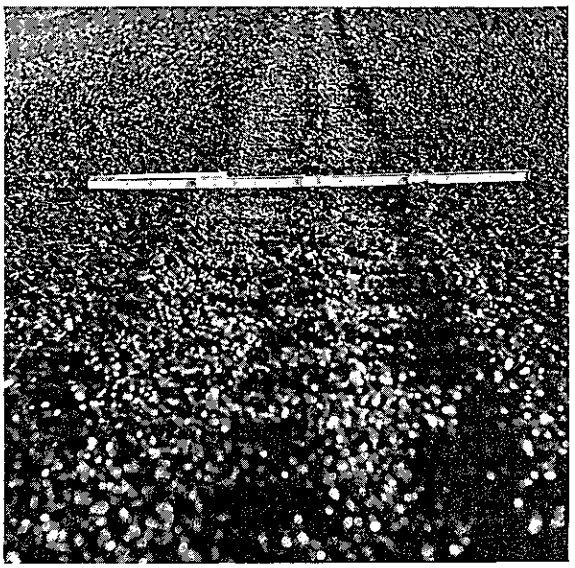
Figure 9

treated permeable material through the paver at these temperatures. The placement of the initial lift of asphalt treated permeable material over the Class 2 permeable filter blanket in its uncompacted state did present some difficulties due to the relatively clean cohesionless nature of the Class 2 permeable material. The tendency to rutting and displacement within the filter blanket required continual adjustment of the paver in order to maintain a relatively uniform thickness. Placement of the final asphalt treated permeable lift proceeded smoothly. As shown by Figure 9, displacement of the asphalt treated permeable material, shortly after placement, by loaded trucks was approximately 1/4 in. as compared to displacement up to 4 in. on the untreated permeable material. After initial set, no measurable displacement was observed in the asphalt treated permeable material by construction equipment. On future projects, it may be desirable to construct the filter layer utilizing permeable material of somewhat lesser quality, i.e., a higher percentage of fines and a greater compactive effort in order to construct a working table more suitable for the paving operation. As indicated by the filter criteria, calculations on Figure 4, basement soil conditions at this site would have permitted a much lower quality filter layer, since it need only be as permeable as the native soil to function effectively.

5. Placement of the asphalt treated permeable material over the filter layer was somewhat difficult as a result of rutting and displacement of the filter layer. These results indicate that an increase in the fines, the addition of water, and some compactive effort may be desirable for the construction of a two-layer system even at the cost of lower filter blanket permeability with the provision that filter criteria are still met.

Wheel tracks in uncompacted permeable material (Class 2 permeable on left. Asphalt treated permeable on right) showing relative displacement under similarly loaded tracks.

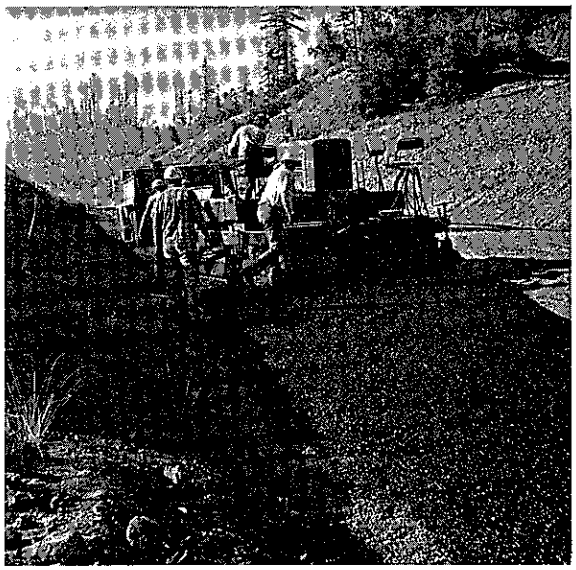
Figure 10

Placement of asphalt treated permeable material over Class 2 permeable material.

Placement of aggregate base on asphalt treated permeable material.

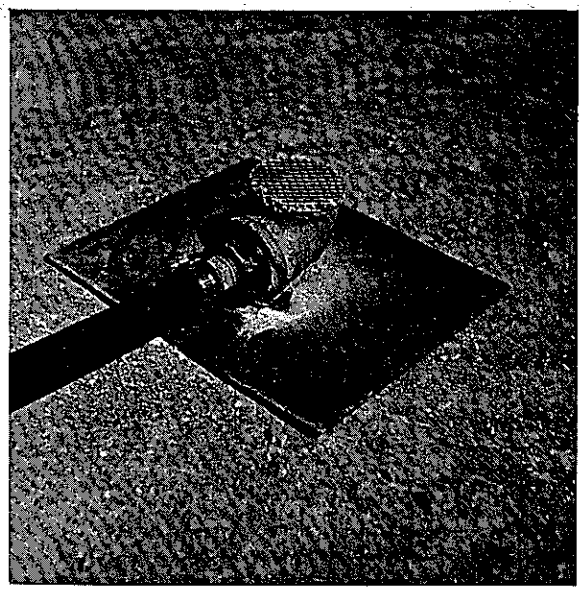
Figure 11

devices consist of standard 2-in. pipe elbows welded to a steel base plate. To prevent clogging, the outlet ends were covered with a 200-mesh screen reinforced with a No. 4 screen. These units were then connected to 1 in. plastic tubing which was extended to the shoulder. In the roadway the tubing was buried in a small trench to prevent constriction by construction equipment. The outlet ends were placed directly at the bottom of the Class 2 permeable material layer. Photographs of the "artificial springs" and their installation are shown by Figure 11. The relative positions of these devices are shown schematically by Figure 3. Upon completion of the structural section in September, 1968, field permeability tests were run at each of the six test locations. At each location, a constant head was maintained with water being introduced into the structural section until a steady state flow condition was reached. At this point, the time required for the introduction of five gallons of water was recorded.

Artificial spring ready for installation

Installed artificial spring prior to covering.

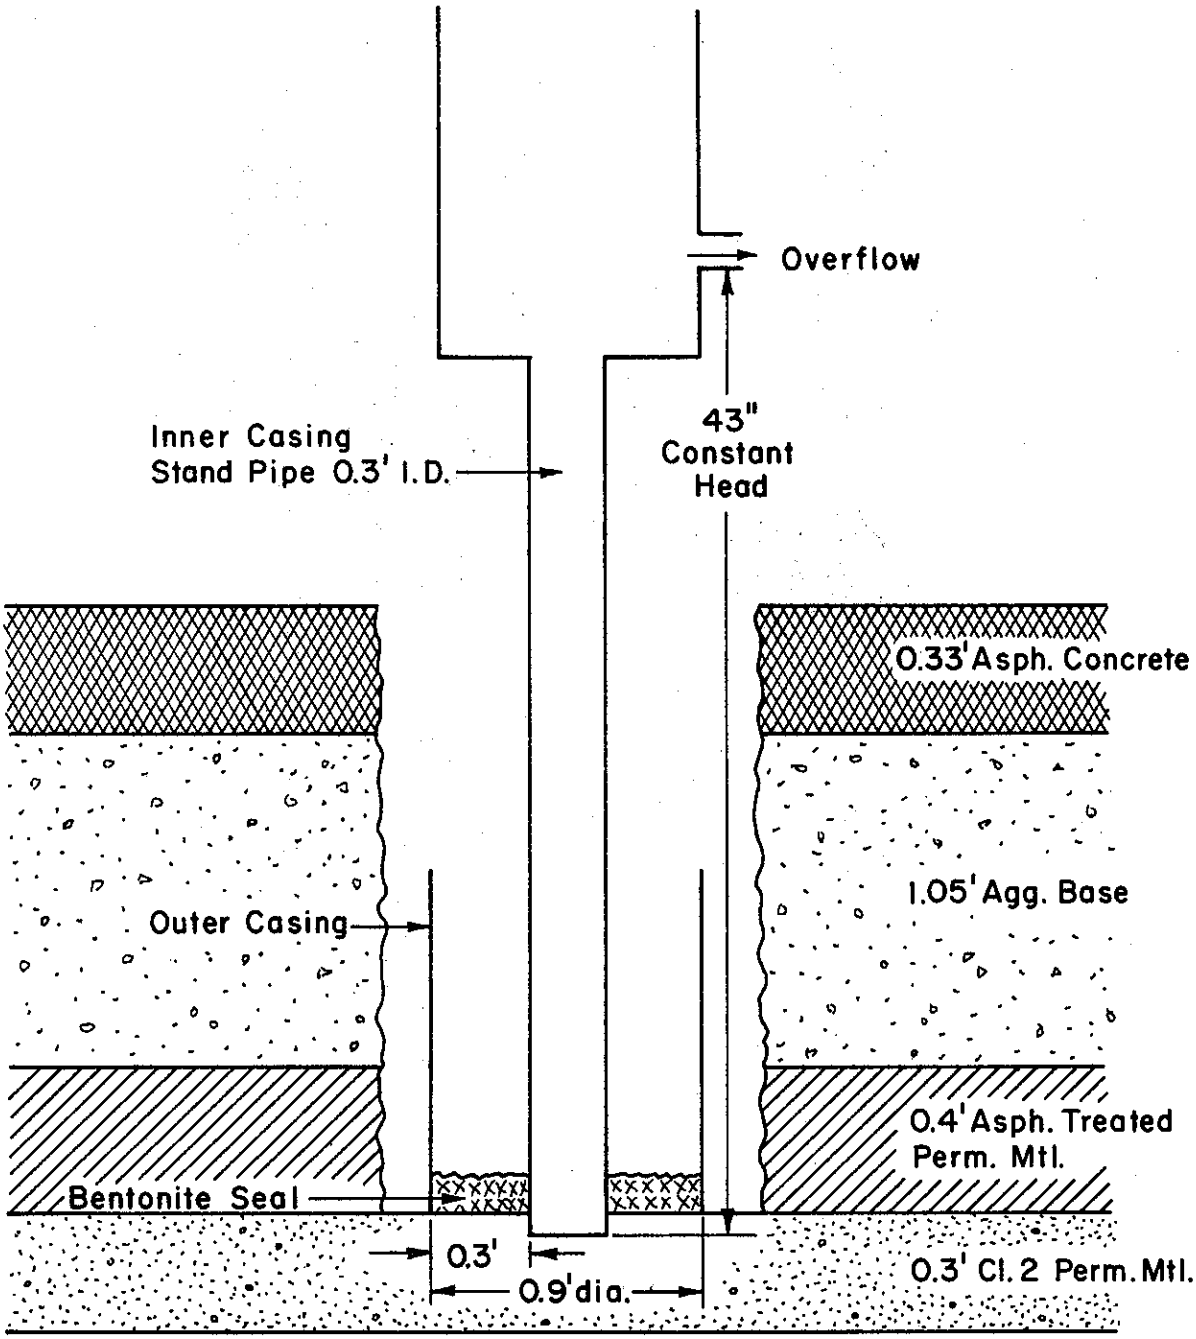
CONSTANT HEAD FIELD PERMEABILITY TEST

In a further attempt to measure the relative drainage capacities of the two subdrain systems, a constant head permeability apparatus of substantially higher capacity was designed and fabricated. The schematic diagram of the device and its installation is shown by Figure 12. Figure 13 is a photograph of an actual test installation.

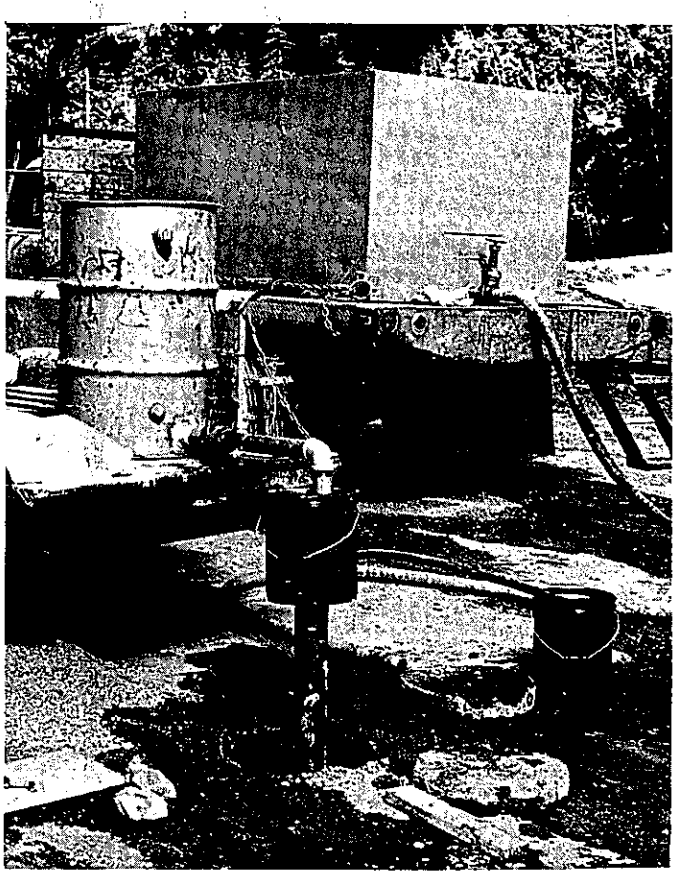
Figure 13

The constant head test applied directly to the asphalt treated permeable material resulted in flows of 31.8 to 33.0 gallons per minute which indicated an in situ capacity of the asphalt treated permeable material of from 11.4 to 33.8 of

Field Permeability Test

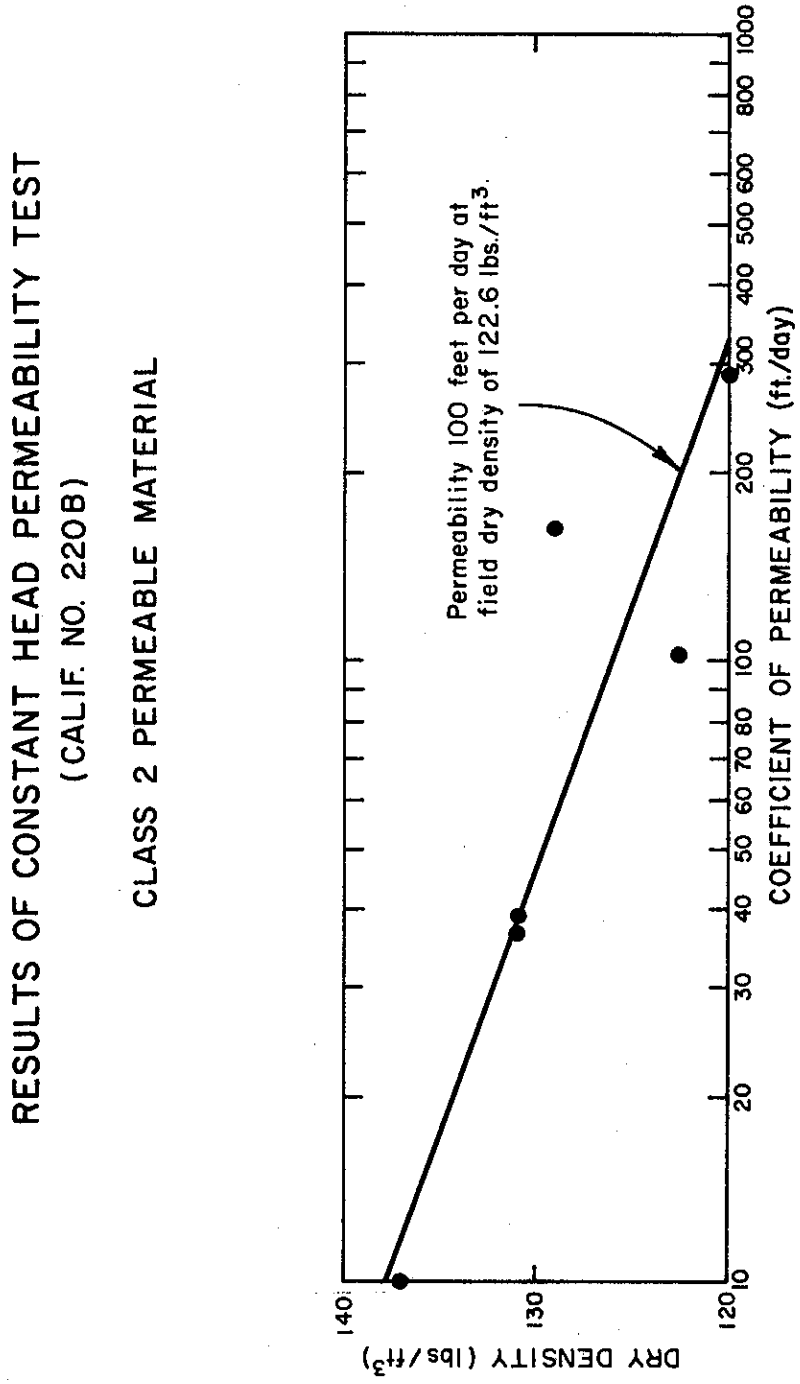
Figure 14

of the Class 2 permeable material shown by Figure 14. The laboratory specimen compacted to field density was found to have a permeability of 200 feet per day. Based on past experience, this is considered to be an unusually high permeability for this type of material, possibly due to careful handling, effective quality control, low degradability, and the absence of compaction by either rolling or traffic.
