A FACTFINDING STUDY ON THE EFFECTS OF GROOVED AND TEXTURED PAVEMENTS ON MOTORCYCLISTS

March 1973

EFFECT OF BROOM TEXTURE ON MOTORCYCLE RIDEABILITY

INTERIM REPORT

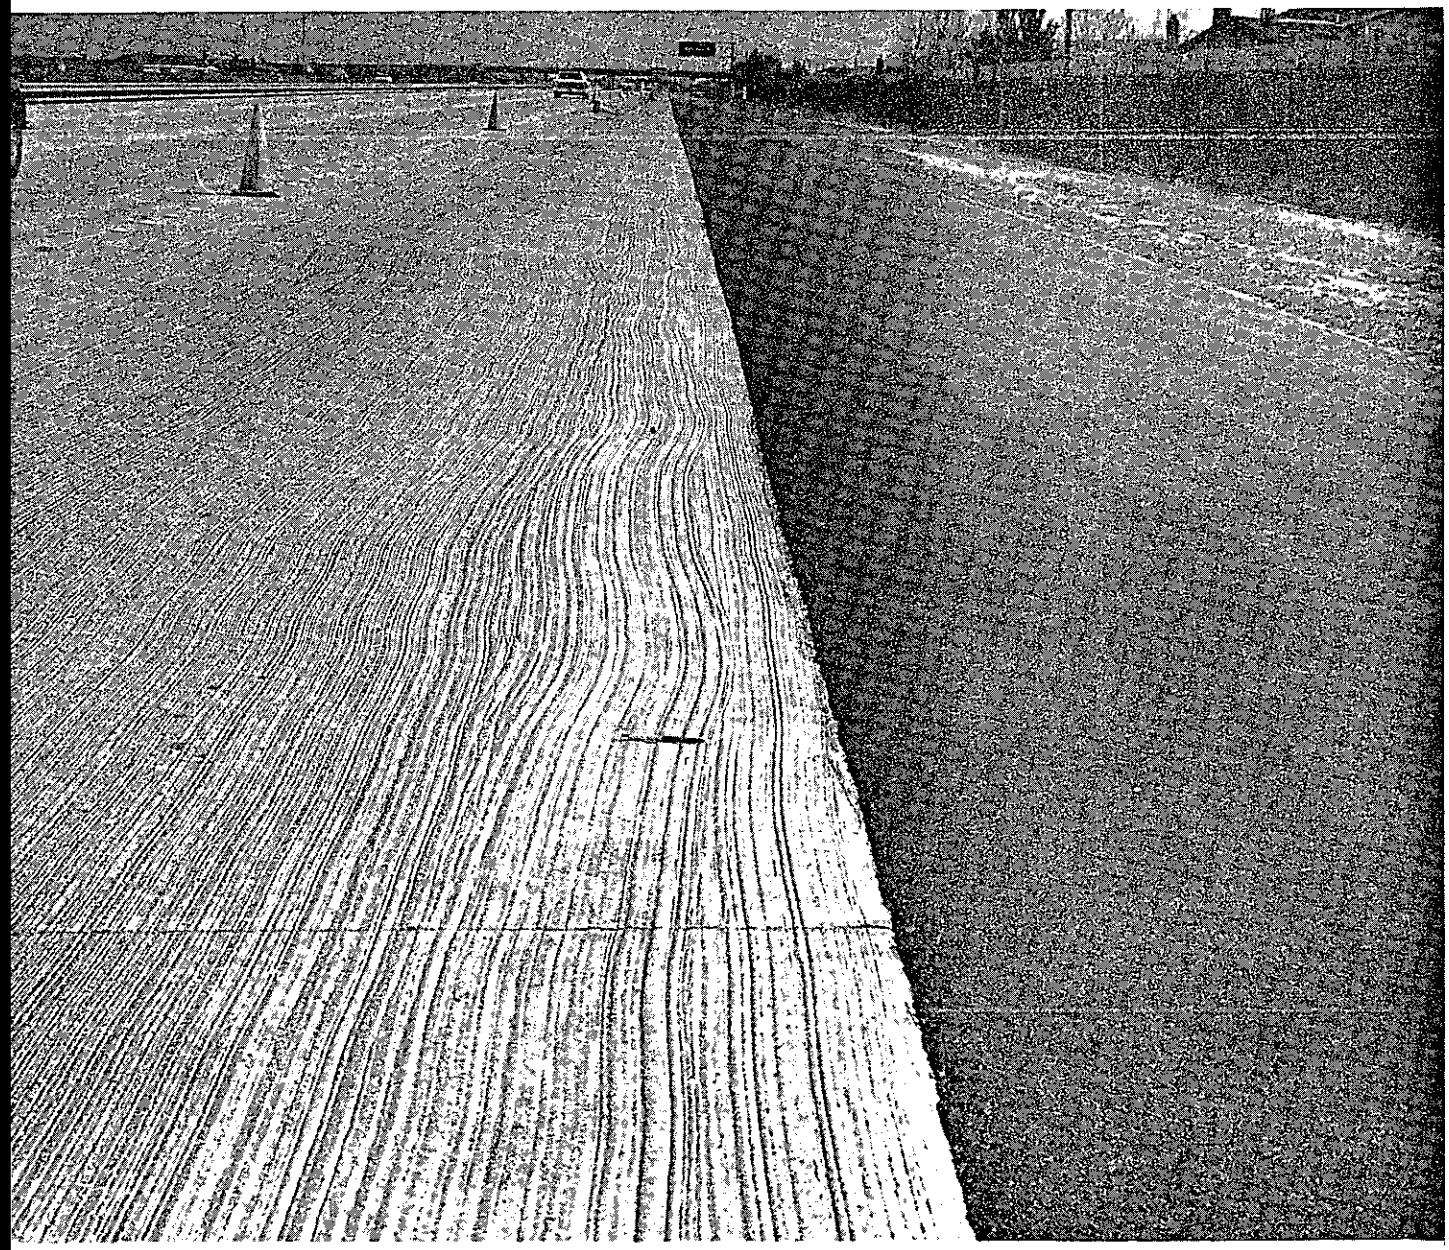
In addition to the skid measurements, photographs of the surface texture were made at each skid test location in order to evaluate the texture depth. Typical conditions of surface texture are shown in Figures 1 and 2.

Figure 1. Typical condition of surface texture

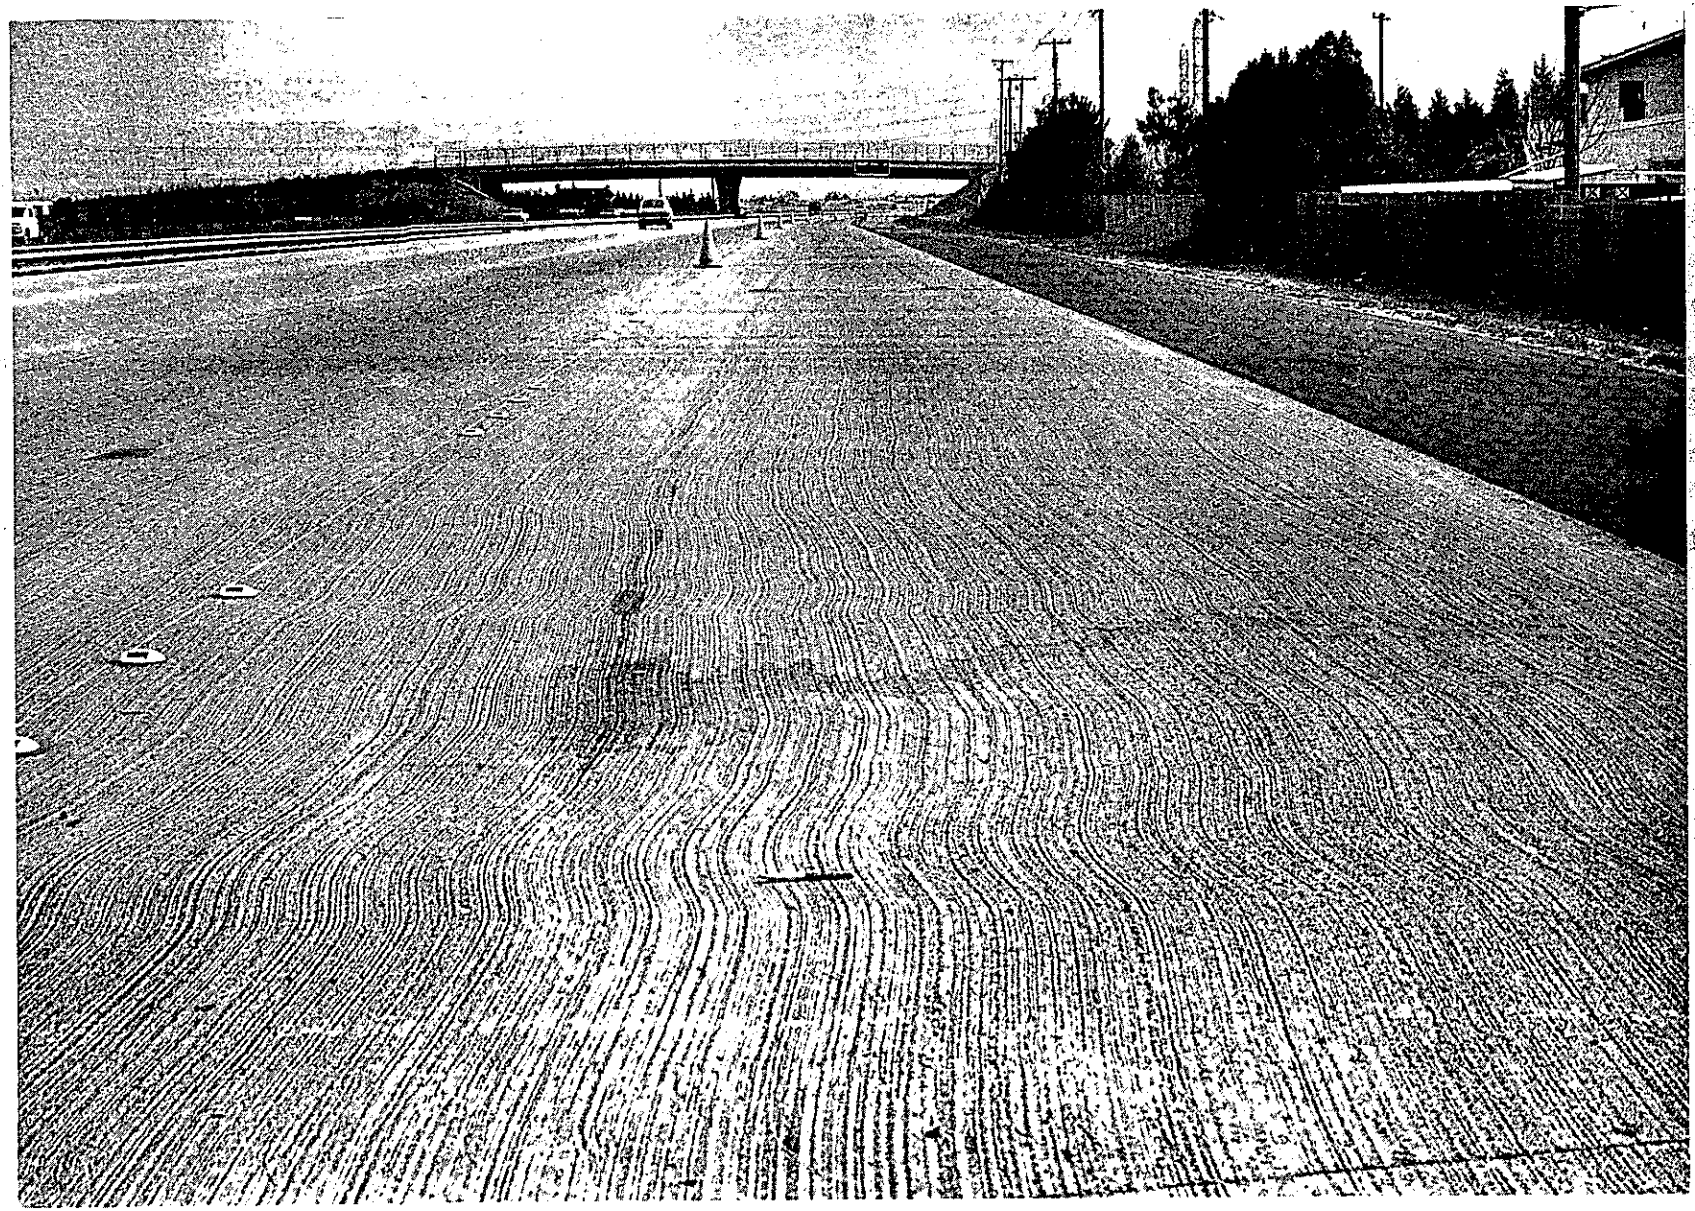
Figure 2. Typical condition of surface texture

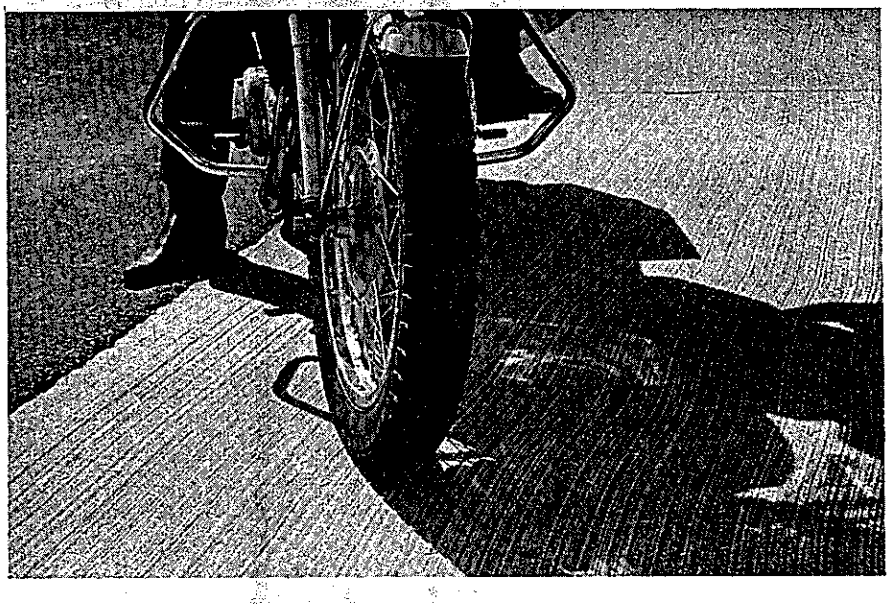
In addition to the three sizes of motorcycles with standard street tires, evaluations were made with the 250 cc and 500 cc bikes equipped with semi-knobby tires on both the front and rear wheels (see Figures 9 and 10).

There was some slight oscillation with the semi-knobby tires on the 500 cc bike, and a moderate amount with the 250 cc bike. Although this oscillation was more apparent using the 250 cc bike, it presented no problems in controlling the machine at the test speeds.

Figure 9. 500 cc Bike with Semi-knobby Tires

Figure 10. 250 cc Bike with Semi-knobby Tires
