STATE OF CALIFORNIA
DEPARTMENT OF TRANSPORTATION
DIVISION OF ENGINEERING SERVICES
OFFICE OF TRANSPORTATION LABORATORY

EXPERIMENTAL AC OVERLAYS OF PCC PAVEMENT

1. REPORT NO FHWA/CA/TL-83/07	2. GOVERNMENT ACCESSION NO.	3. RECIPIENT'S CATALOG NO
4. TITLE AND SUBTITLE EXPERIMENTAL AC OVERLAYS OF PCC PAVEMENT		5. REPORT DATE November 1983
		6. PERFORMING ORGANIZATION CODE
7. AUTHOR(S) Roger D. Smith, P.E.		8. PERFORMING ORGANIZATION REPORT NO. 57324-633352
9. PERFORMING ORGANIZATION NAME AND ADDRESS Office of Transportation Laboratory California Department of Transportation Sacramento, California 95819		10. WORK UNIT NO
		11. CONTRACT OR GRANT NO. F81TL03
12. SPONSORING AGENCY NAME AND ADDRESS California Department of Transportation Sacramento, California 95807		13. TYPE OF REPORT & PERIOD COVERED Interim
		14. SPONSORING AGENCY CODE

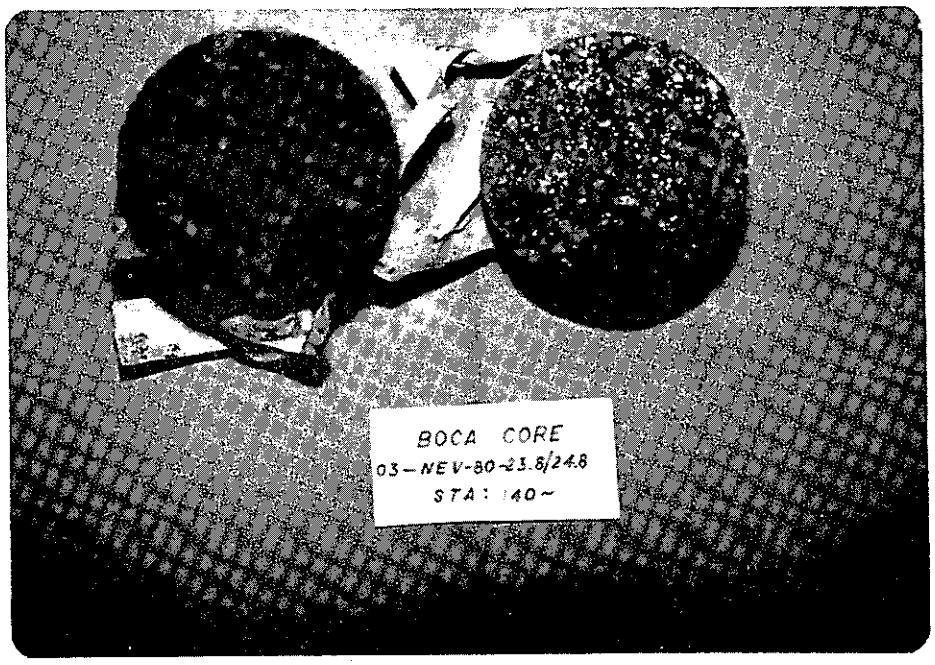
Cores taken at stations 134+00, 140+00 and 147+00 separated during coring at the interface of the OGAC(R) interlayer and the PCC with only about 25% of the PCC surface exhibiting any asphalt adhesion. This condition suggests a bond problem between the AC overlay and the PCC surface and will be further discussed later in this report.

Photo 10. Rubberized OGAC/PCC interface, Station 140. Note lack of adhesion to PCC.

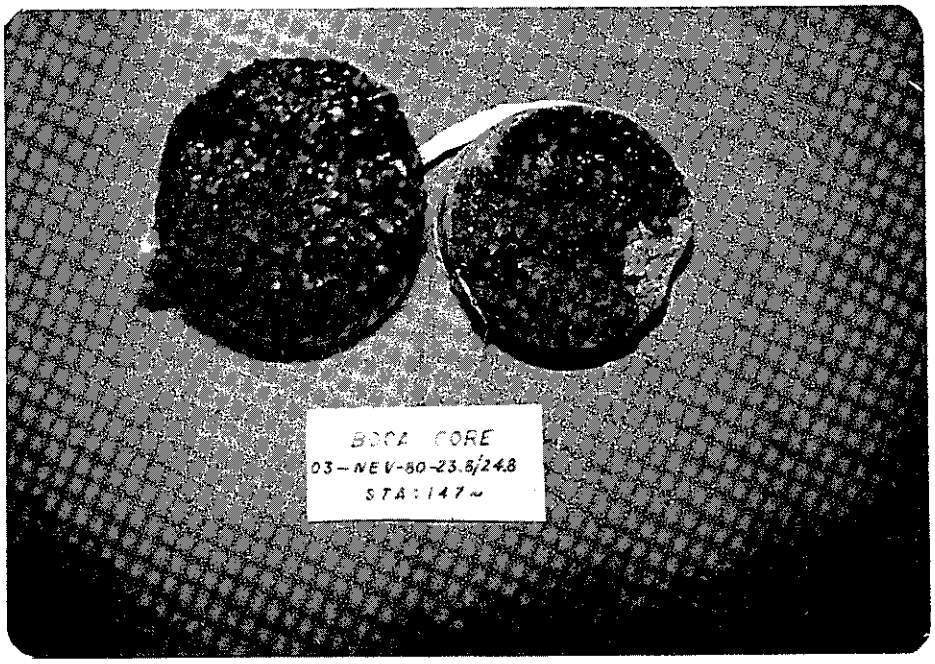
Photo 11. Rubberized OGAC/PCC interface, Station 147. Note lack of adhesion to PCC.
