STATE OF CALIFORNIA
DEPARTMENT OF TRANSPORTATION

EFFECTS OF CORROSION ON THE BARE WEATHERING STEEL IN THE ANTIOCH BRIDGE

FINAL REPORT # FHWA/CA/TL-93/09

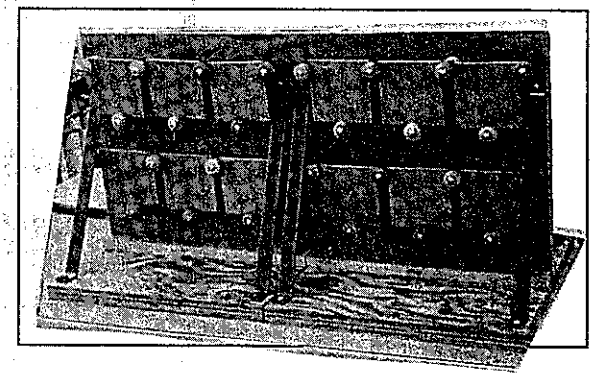
Figure 2

Racks With ASTM A588 Steel Samples

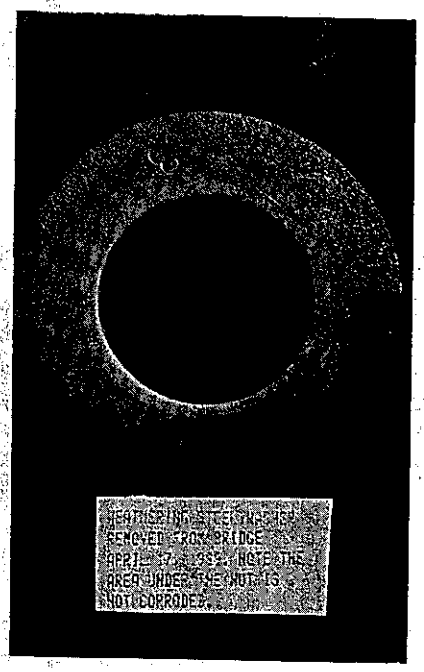
Figure 6

The washer shown in figure 6 is pitted around the outer edge and shows little pitting in the area that was under the nut. The average pit depth in the pitted area is 0.0027 inch. This would be approximately 0.22 mils/year.

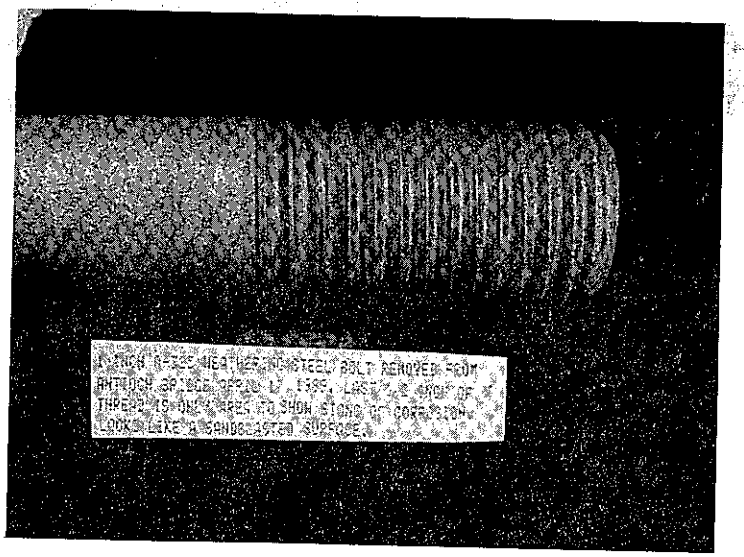
Figure 7

The bolt shown in figure 7 is pitted on the exposed threaded end and had an average pit depth of 0.0033 inch in the pitted area for an average of 0.28 mils/year.

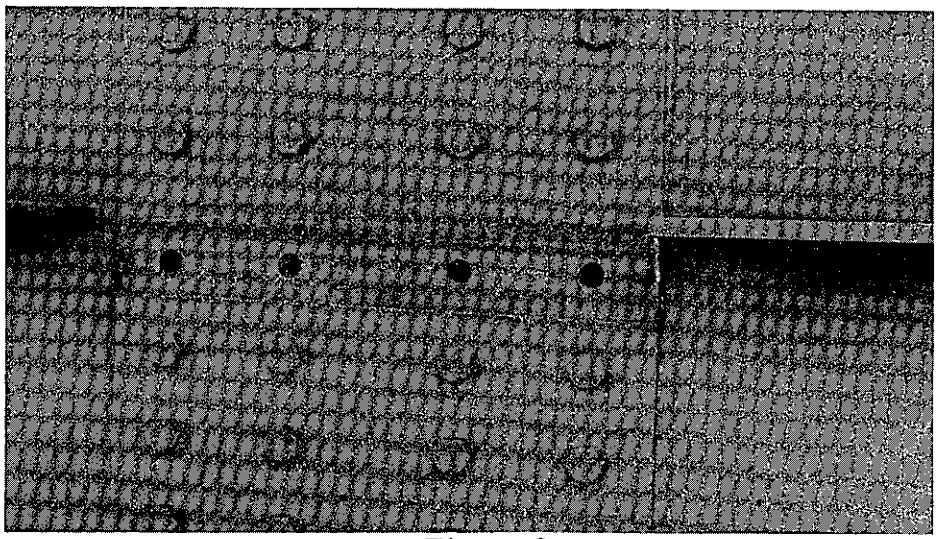
The area where the bent stiffener splice plate and the girder splice plate come together shows active corrosion on both the girder splice plate and the stiffener splice plate. The bent plate provides a recepticle for debris of all kinds which tends to hold moisture. Figure 8 is a view of the girder splice plate with the stiffener splice plate removed.
