SEAM STRENGTH OF ASPHALT COATED STRUCTURAL PLATE PIPE

RESEARCH REPORT

NO. M & R 636407

Prepared in Cooperation with the U.S. Department of Transportation, Bureau of Public Roads February, 1968

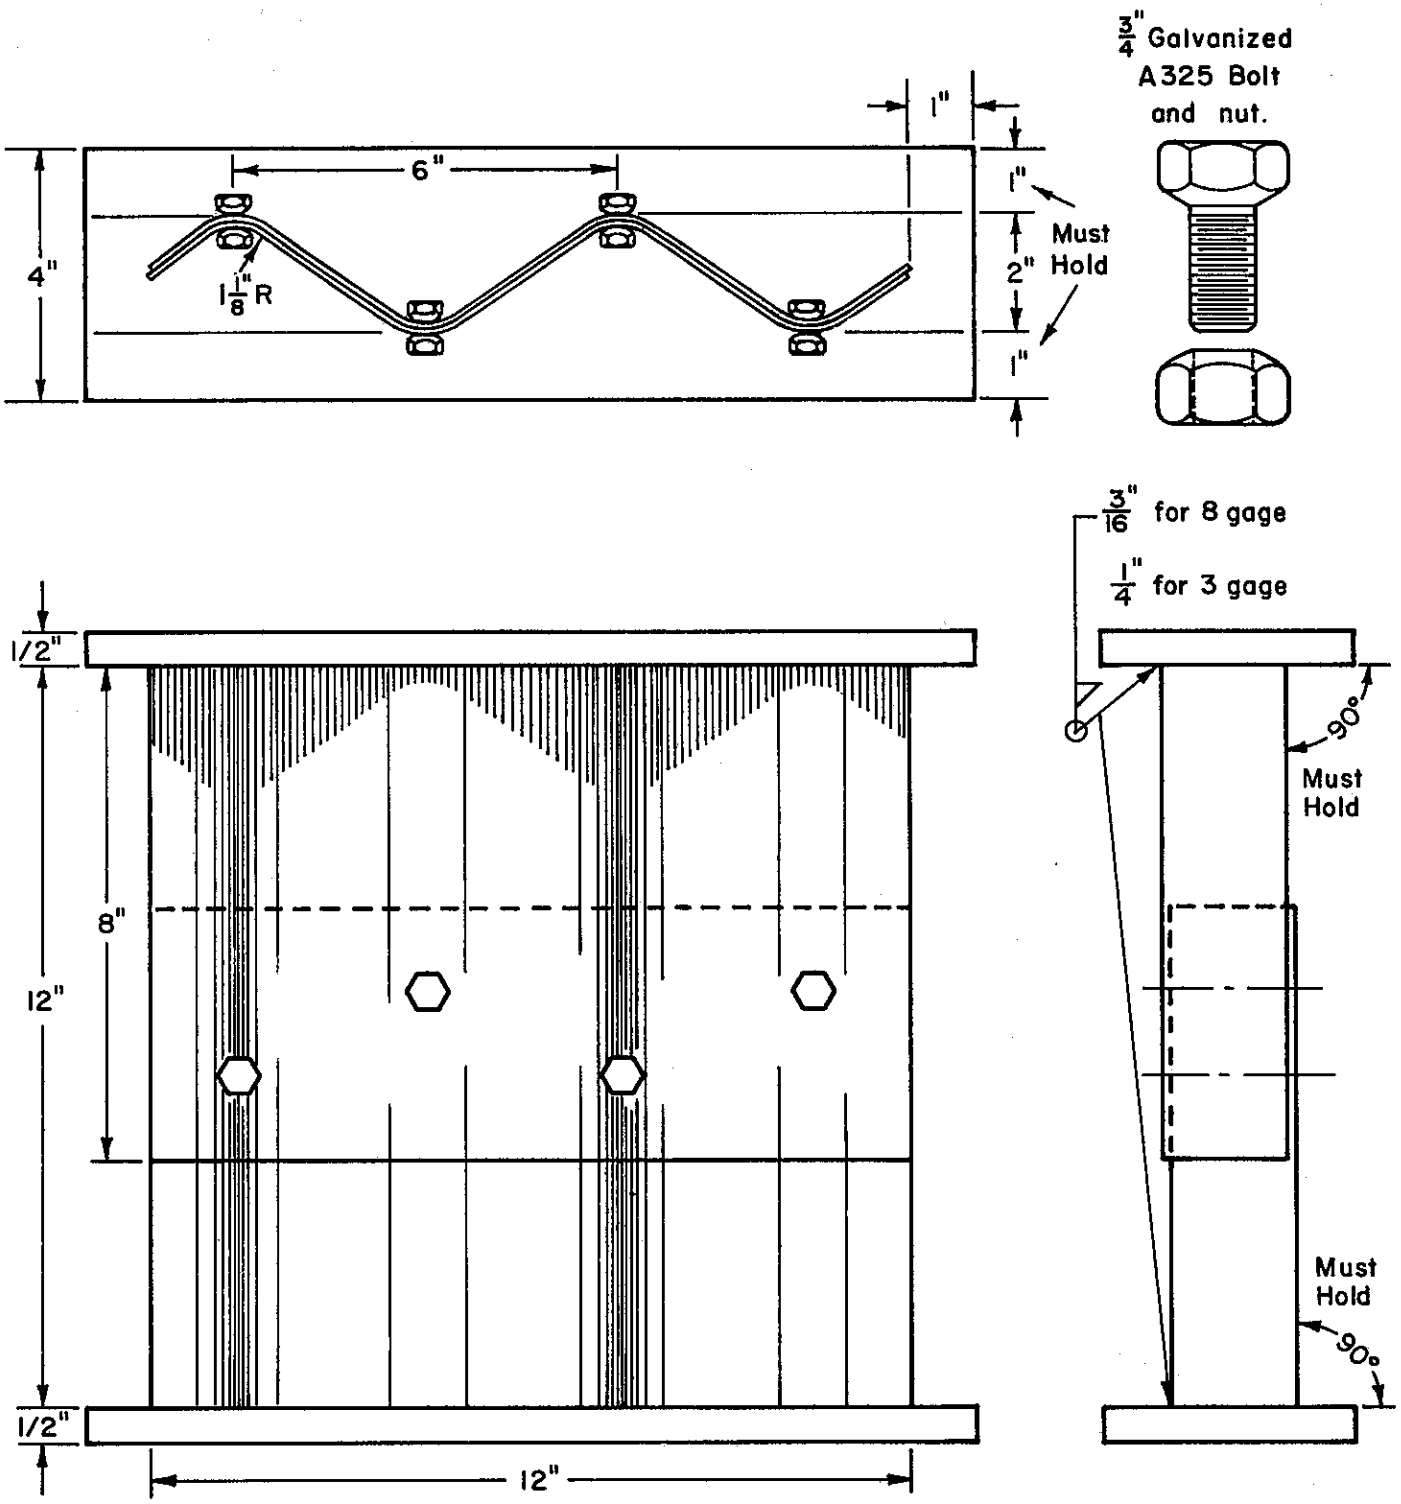
Figure 1

Twenty-four one-foot test specimens, including twelve eight-gage and twelve three-gage, were fabricated as shown in Figure 1. These gages represent the upper and lower range of gage sizes used by the California Division of Highways for galvanized structural steel plate pipe culvert. It was felt that data obtained from tests on these gage sizes would yield information that would be useful for all gage sizes within the presently used range.

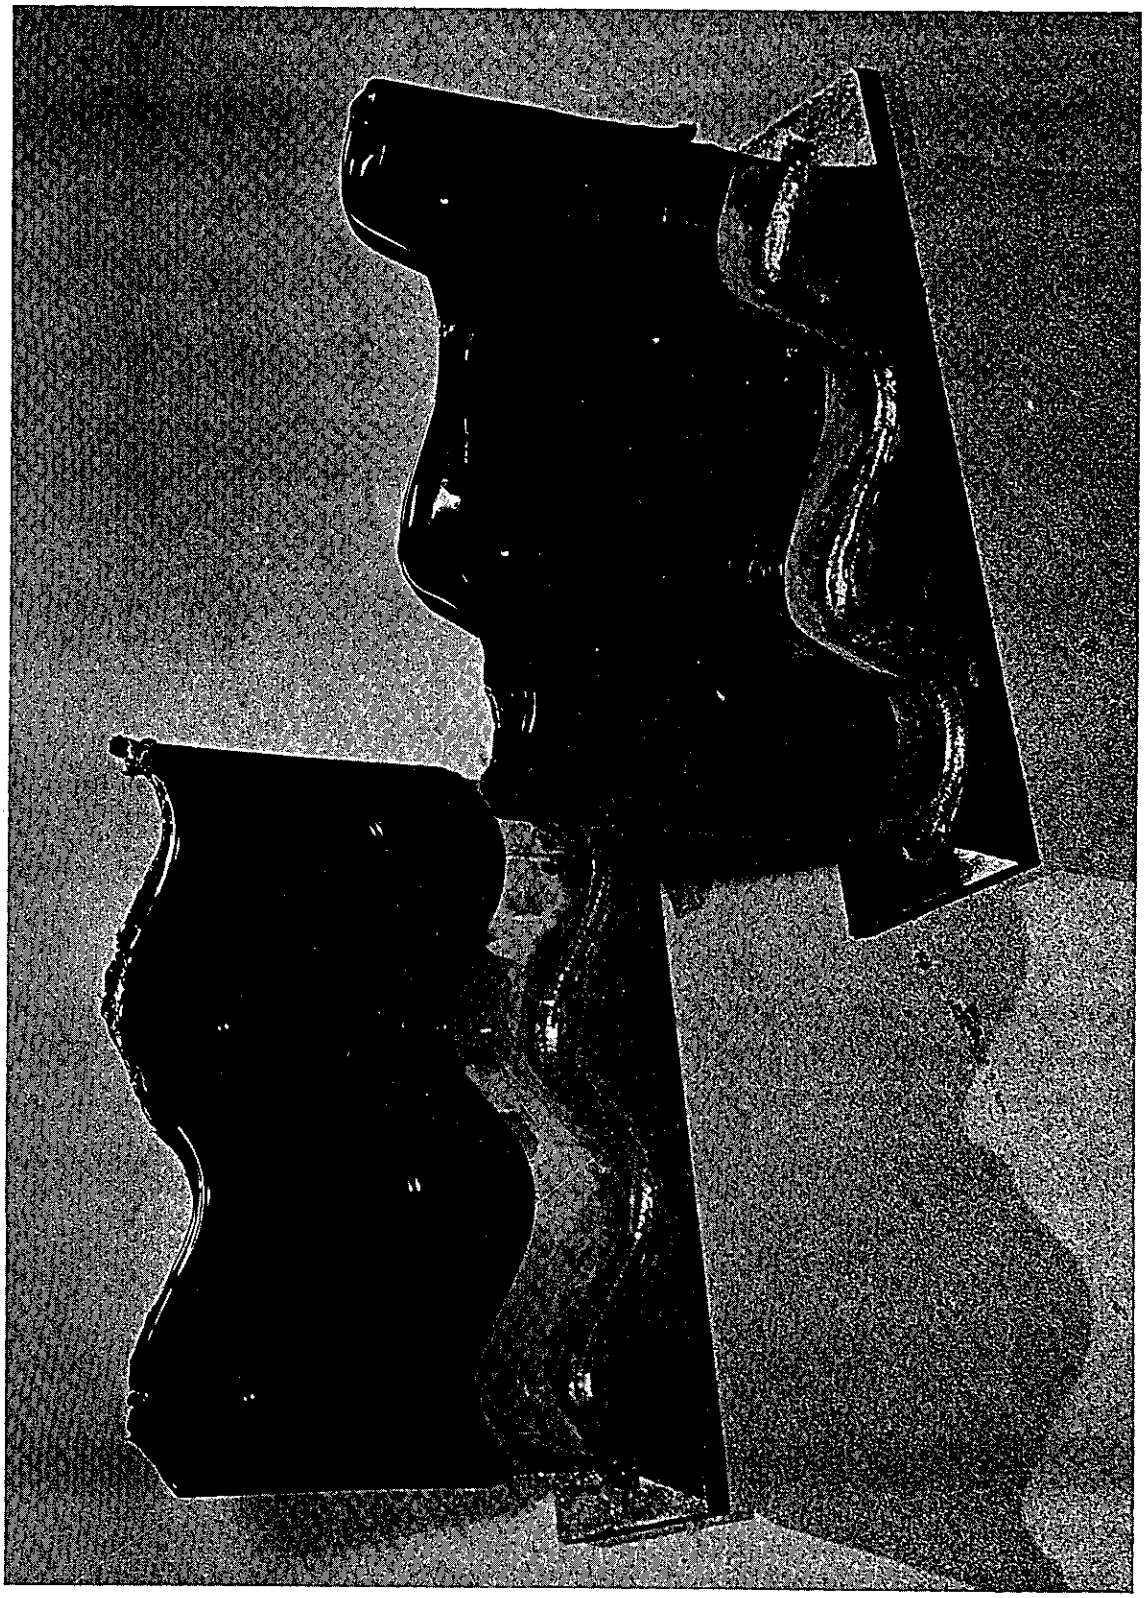
Figure 2

Six test specimens, from each gage, were coated with paving grade asphalt prior to assembly (Figure 2). The remaining six, from each gage, had a standard hot-dip galvanized surface, only.

A typical coated specimen is shown here before assembly

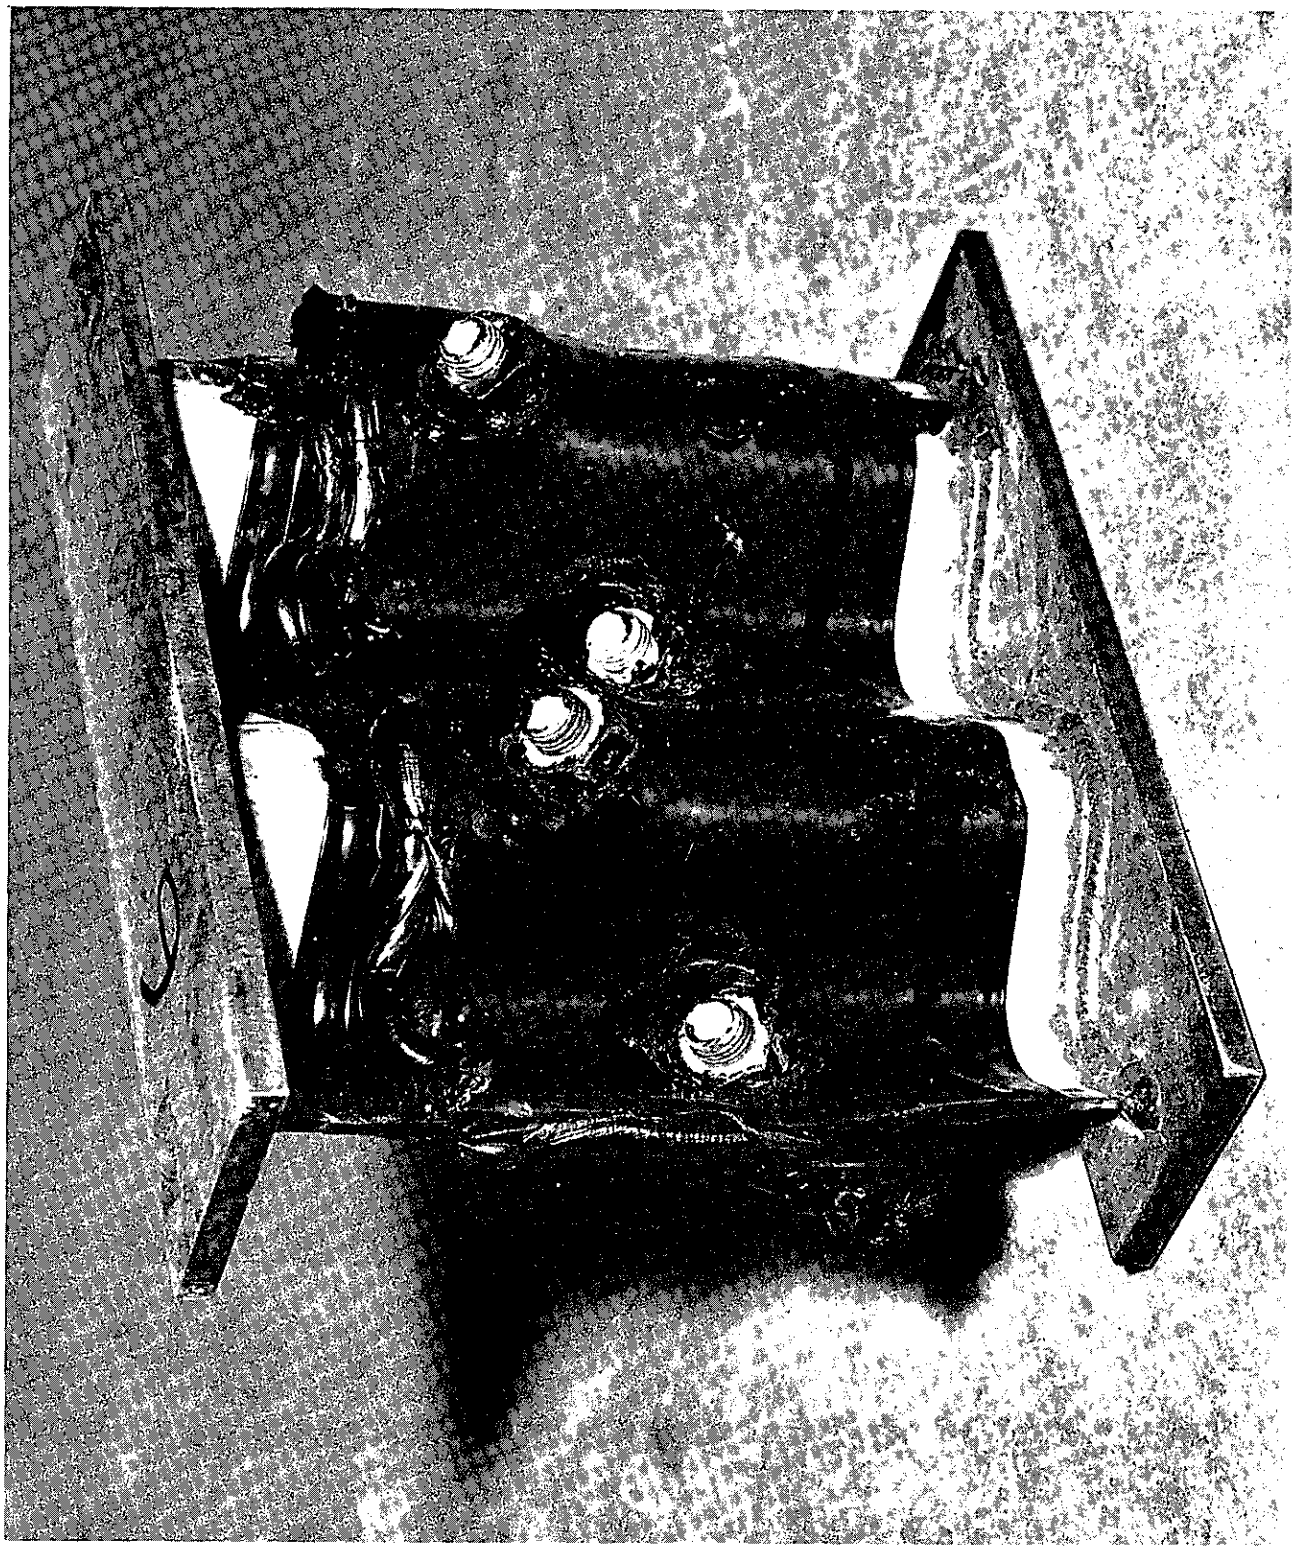
Figure 4

The mode of failure in most cases was a combination of plate bearing (at the bolt holes) and buckling (Figures 4, 5, and 6). The rotation of the bolt axis, as seen in Figure 5, indicates plate bearing failure. In two cases, some bolt shearing failure was also observed.

Coated specimen after being tested to ultimate load. Note bolt tipping.

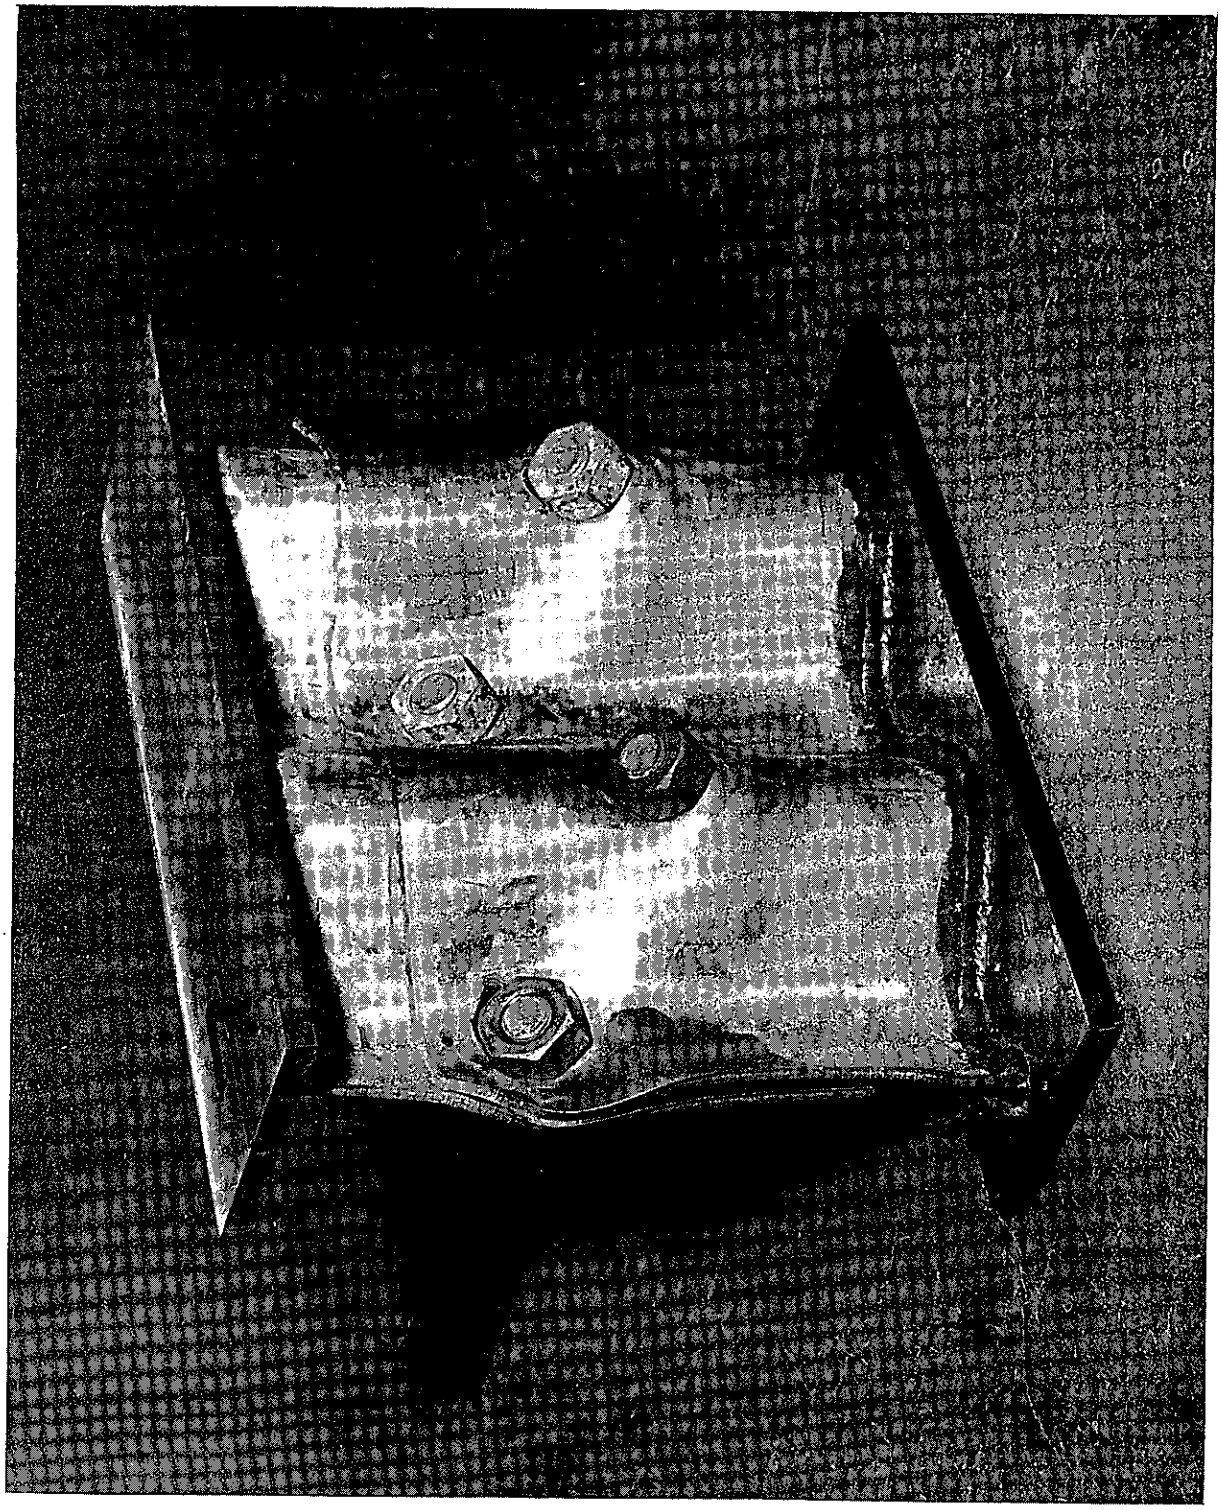
Figure 5

Uncoated specimen after being tested to ultimate load. Buckling of plates can be seen.

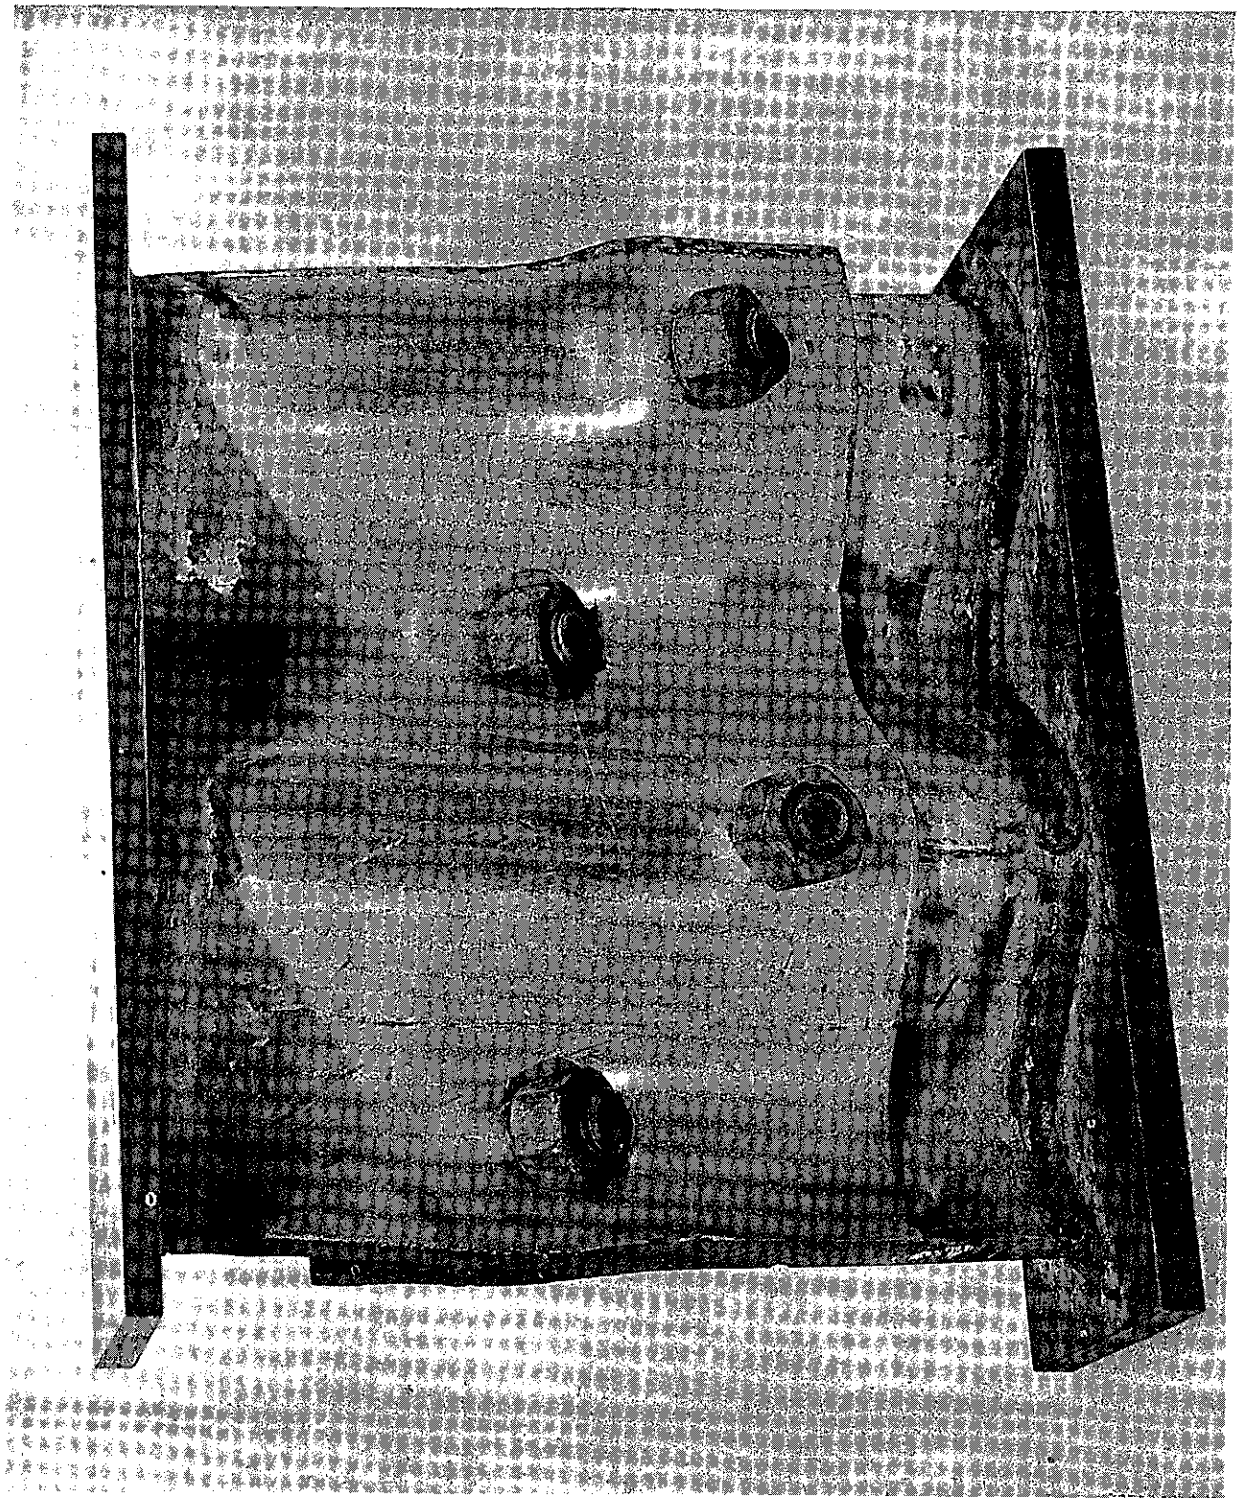
Figure 7

A comparison of individual ultimate seam strengths within some test cells indicated that some values were considerably lower than others. Subsequent visual observations of the test specimens, exhibiting low seam strengths, revealed that the angle of bolt tip varied among the four connecting bolts (Figure 7). This indicates that proper alignment of the bolt holes, in order to assure a uniform distribution of bearing forces along the seam, is critical to ultimate seam strength. The effect of minor misalignment of bolt holes in field installations would probably be less significant due to the much wider plate widths used. The phenomenon of improper hole alignment is a random variable and is included in the error term of the model equation.

Specimen showing differential bolt tipping. This is caused by poor hole alignment and results in unequal bearing forces along the seam, which results in low ultimate seam strength.

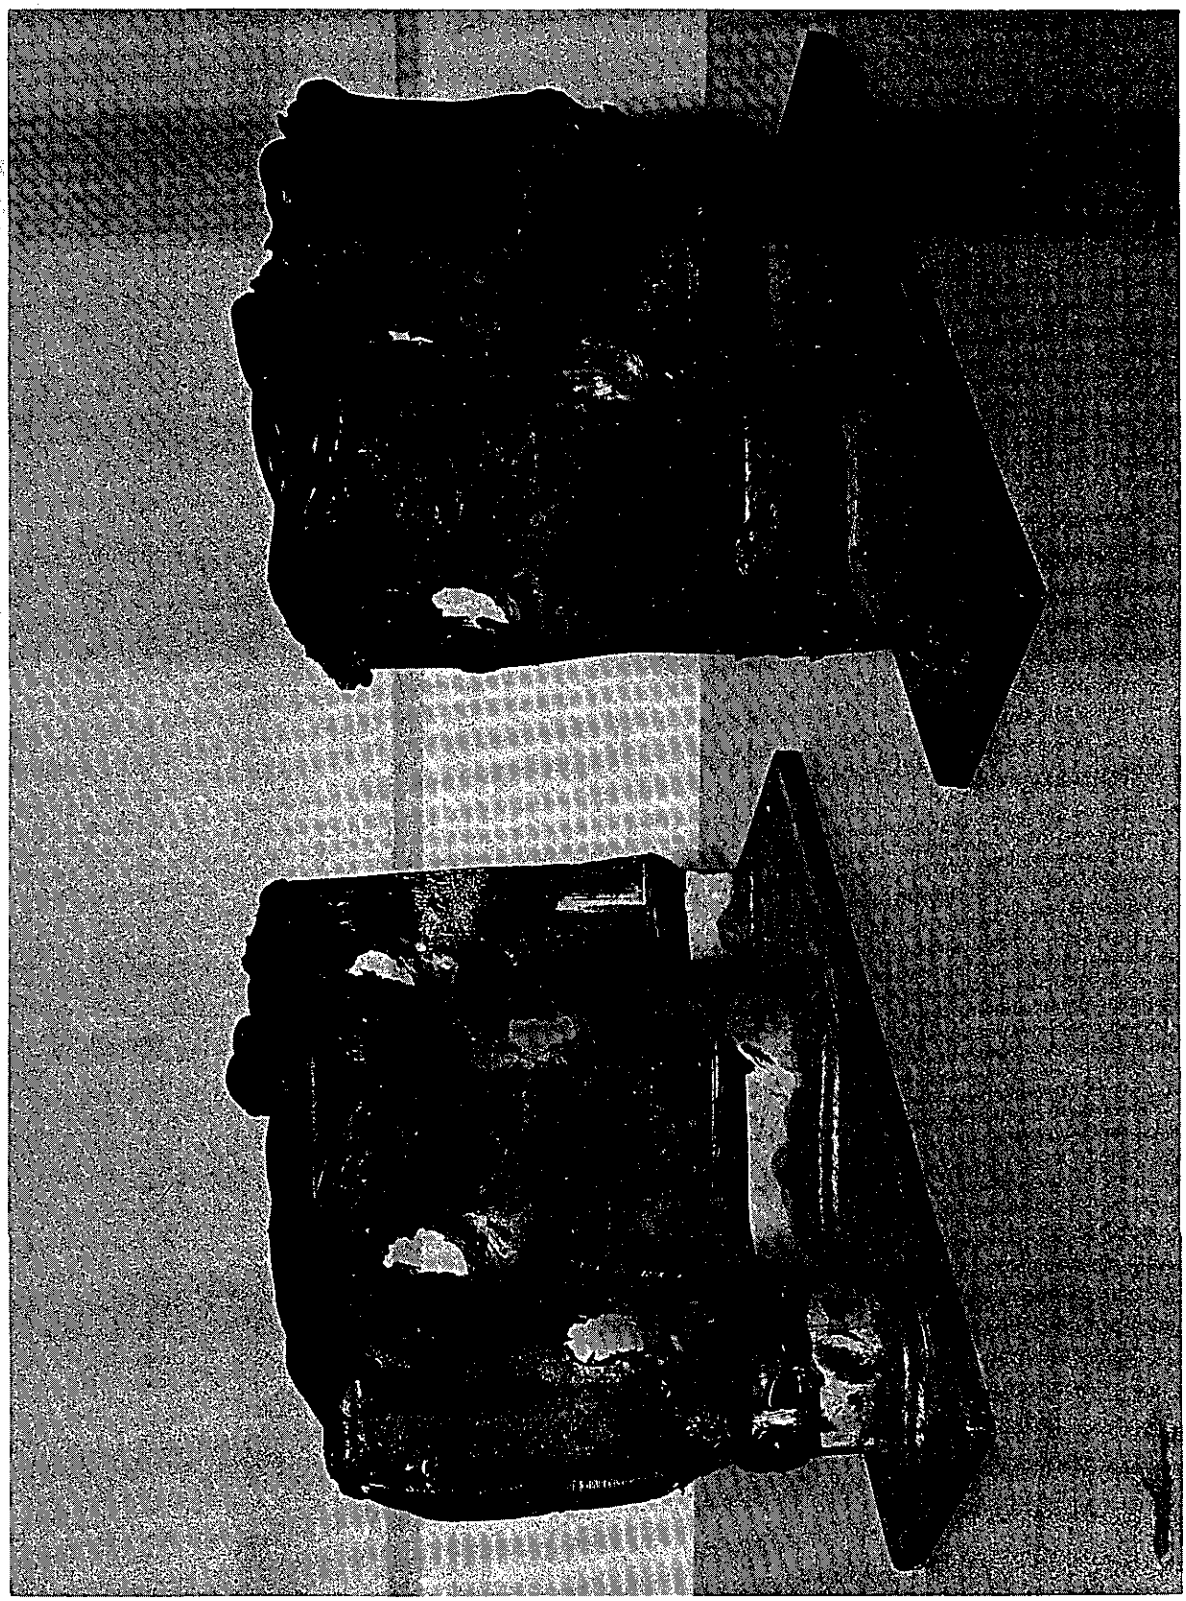
Figure 8

An attempt was made to separate two of the failed specimens to determine the thickness of the bituminous coating after torquing. Two were successfully separated and both showed an average of 0.03" of coating between the bolted surfaces. Within an area of approximately one inch around the bolt hole, the coating thickness was nil (Figure 8).

Disassembled coated specimen after testing. Sparsity of coating in the vicinity of the bolt holes can be noted.
