SEAM STRENGTH OF ASPHALT COATED STRUCTURAL PLATE PIPE

RESEARCH REPORT

NO. M & R 636407

Prepared in Cooperation with the U.S. Department of Transportation, Bureau of Public Roads February, 1968

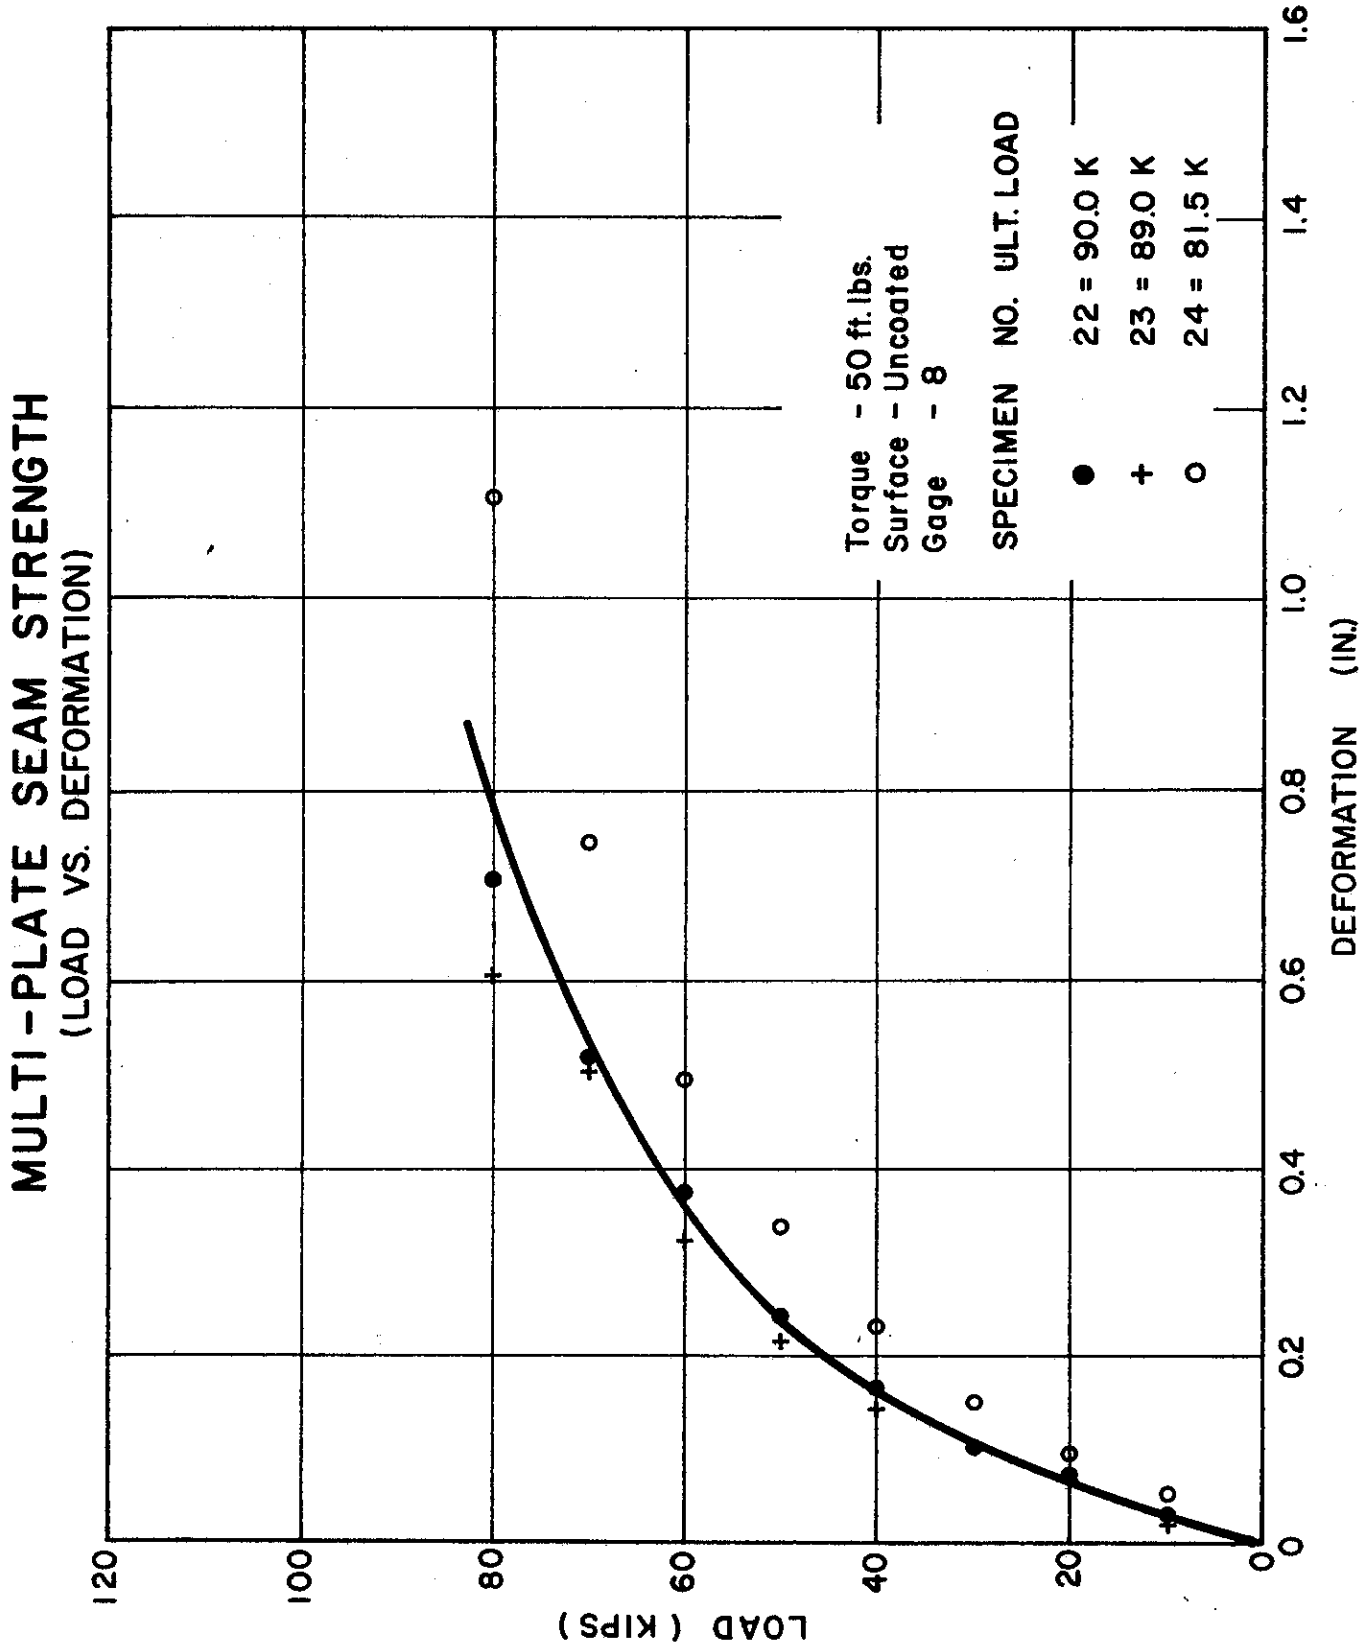
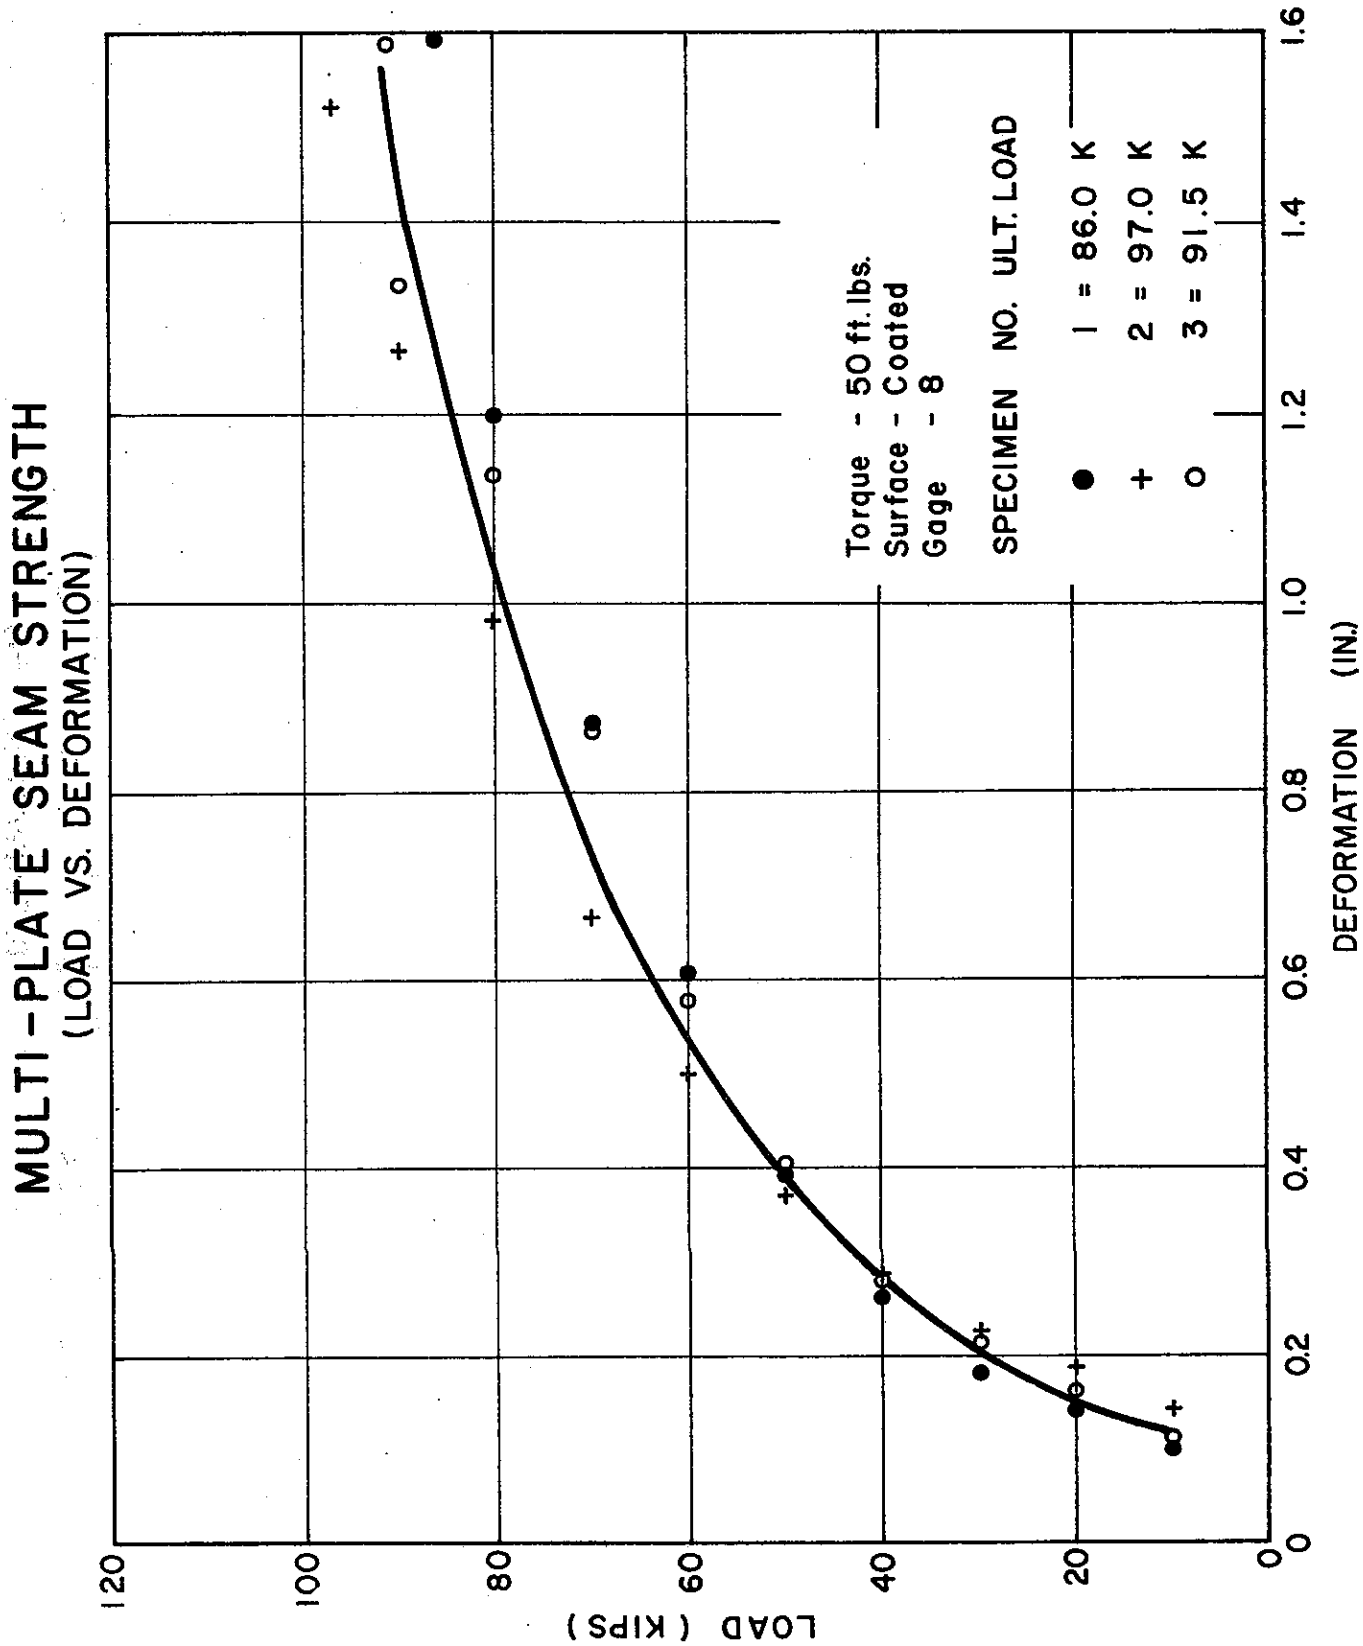
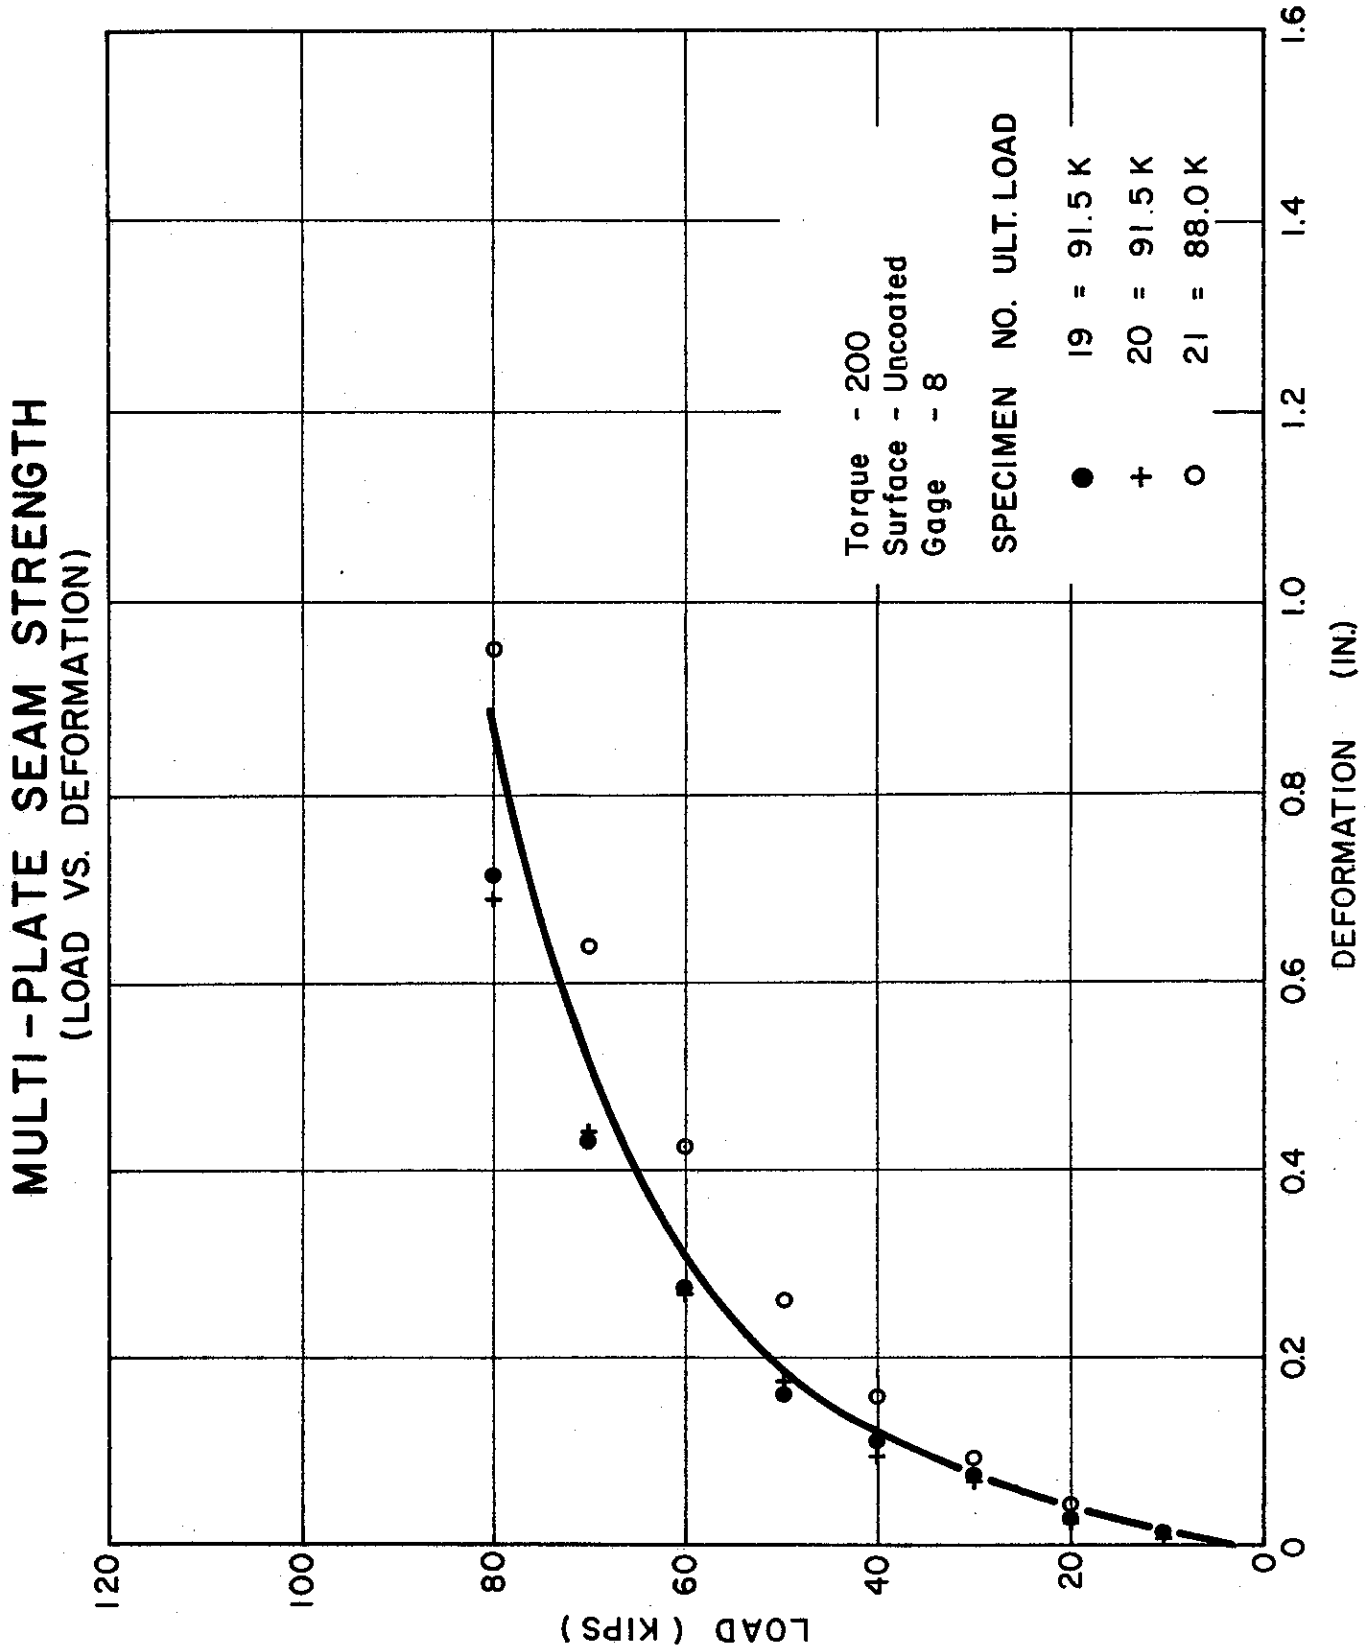
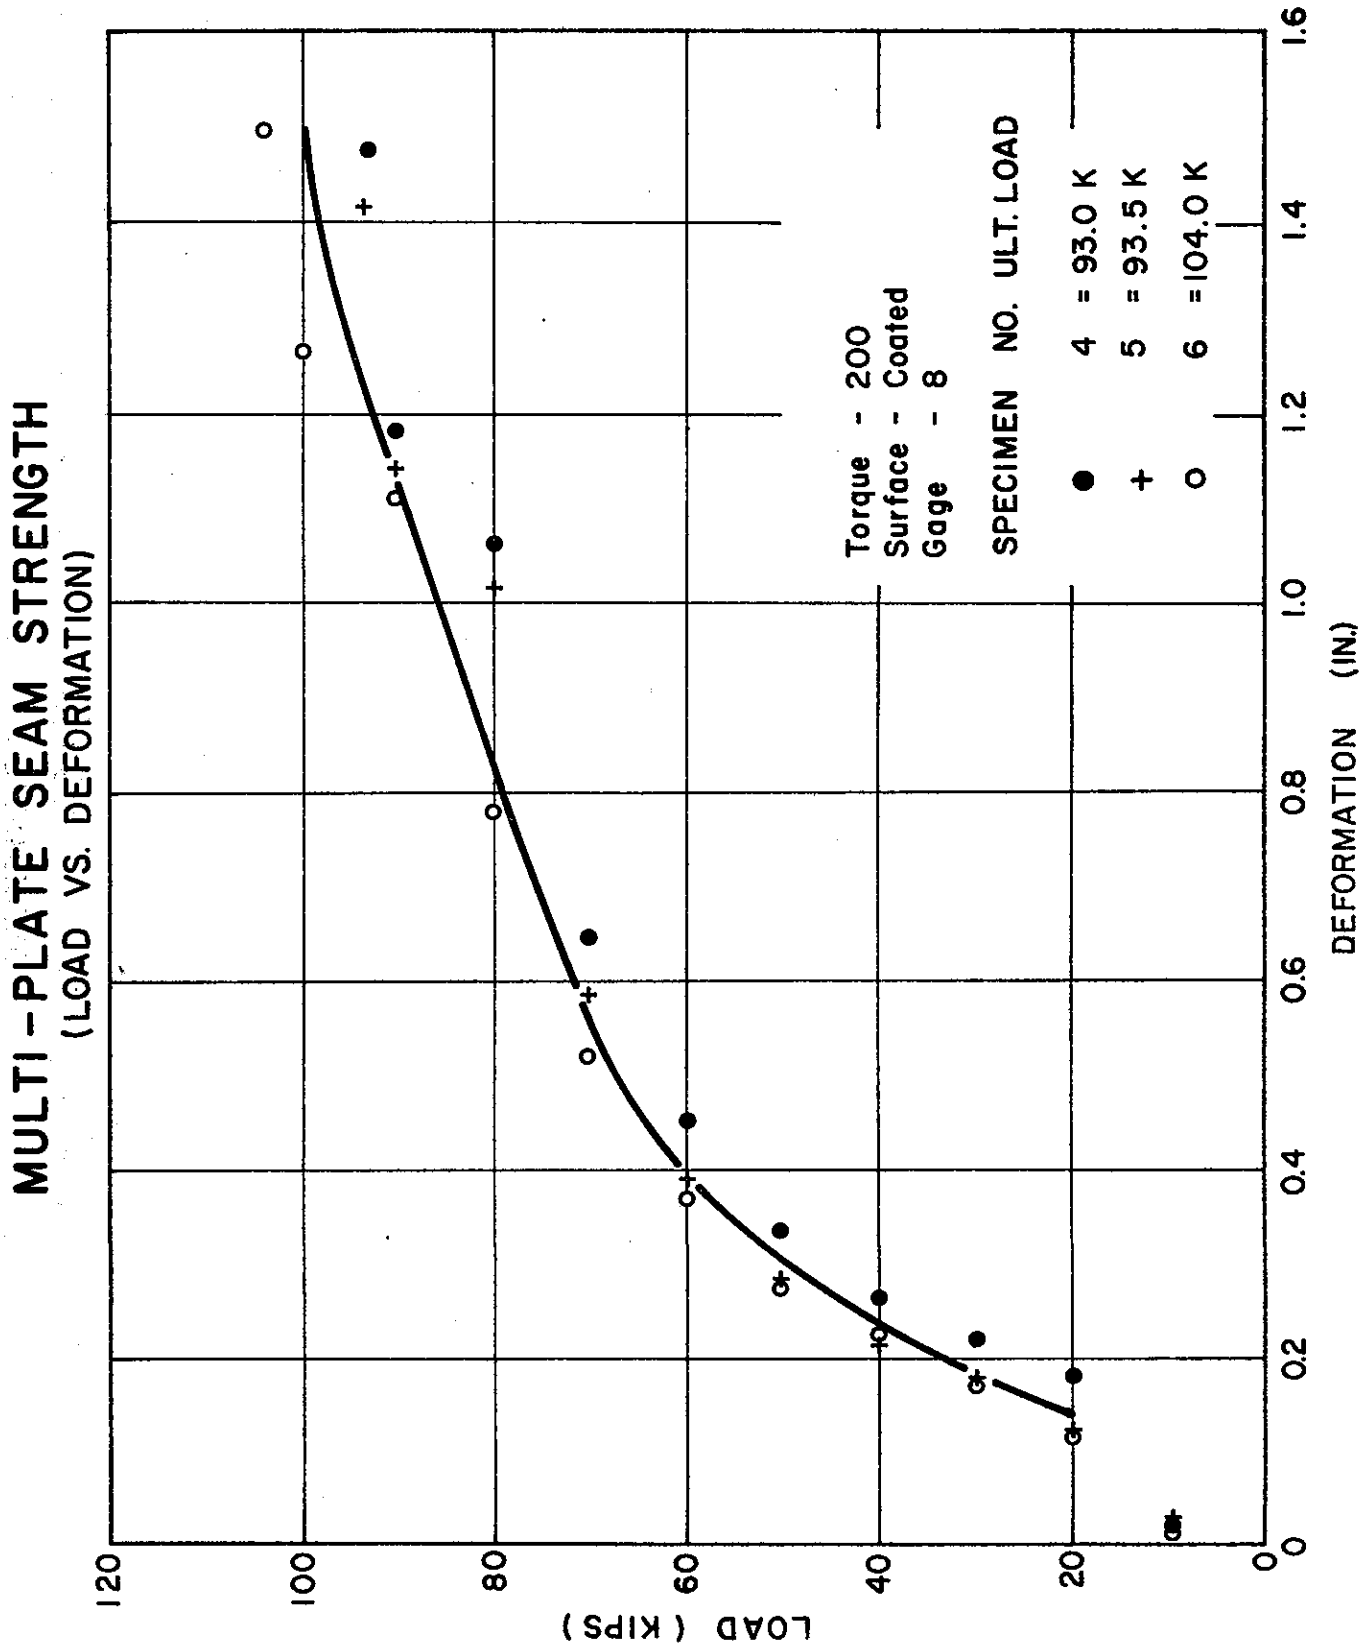
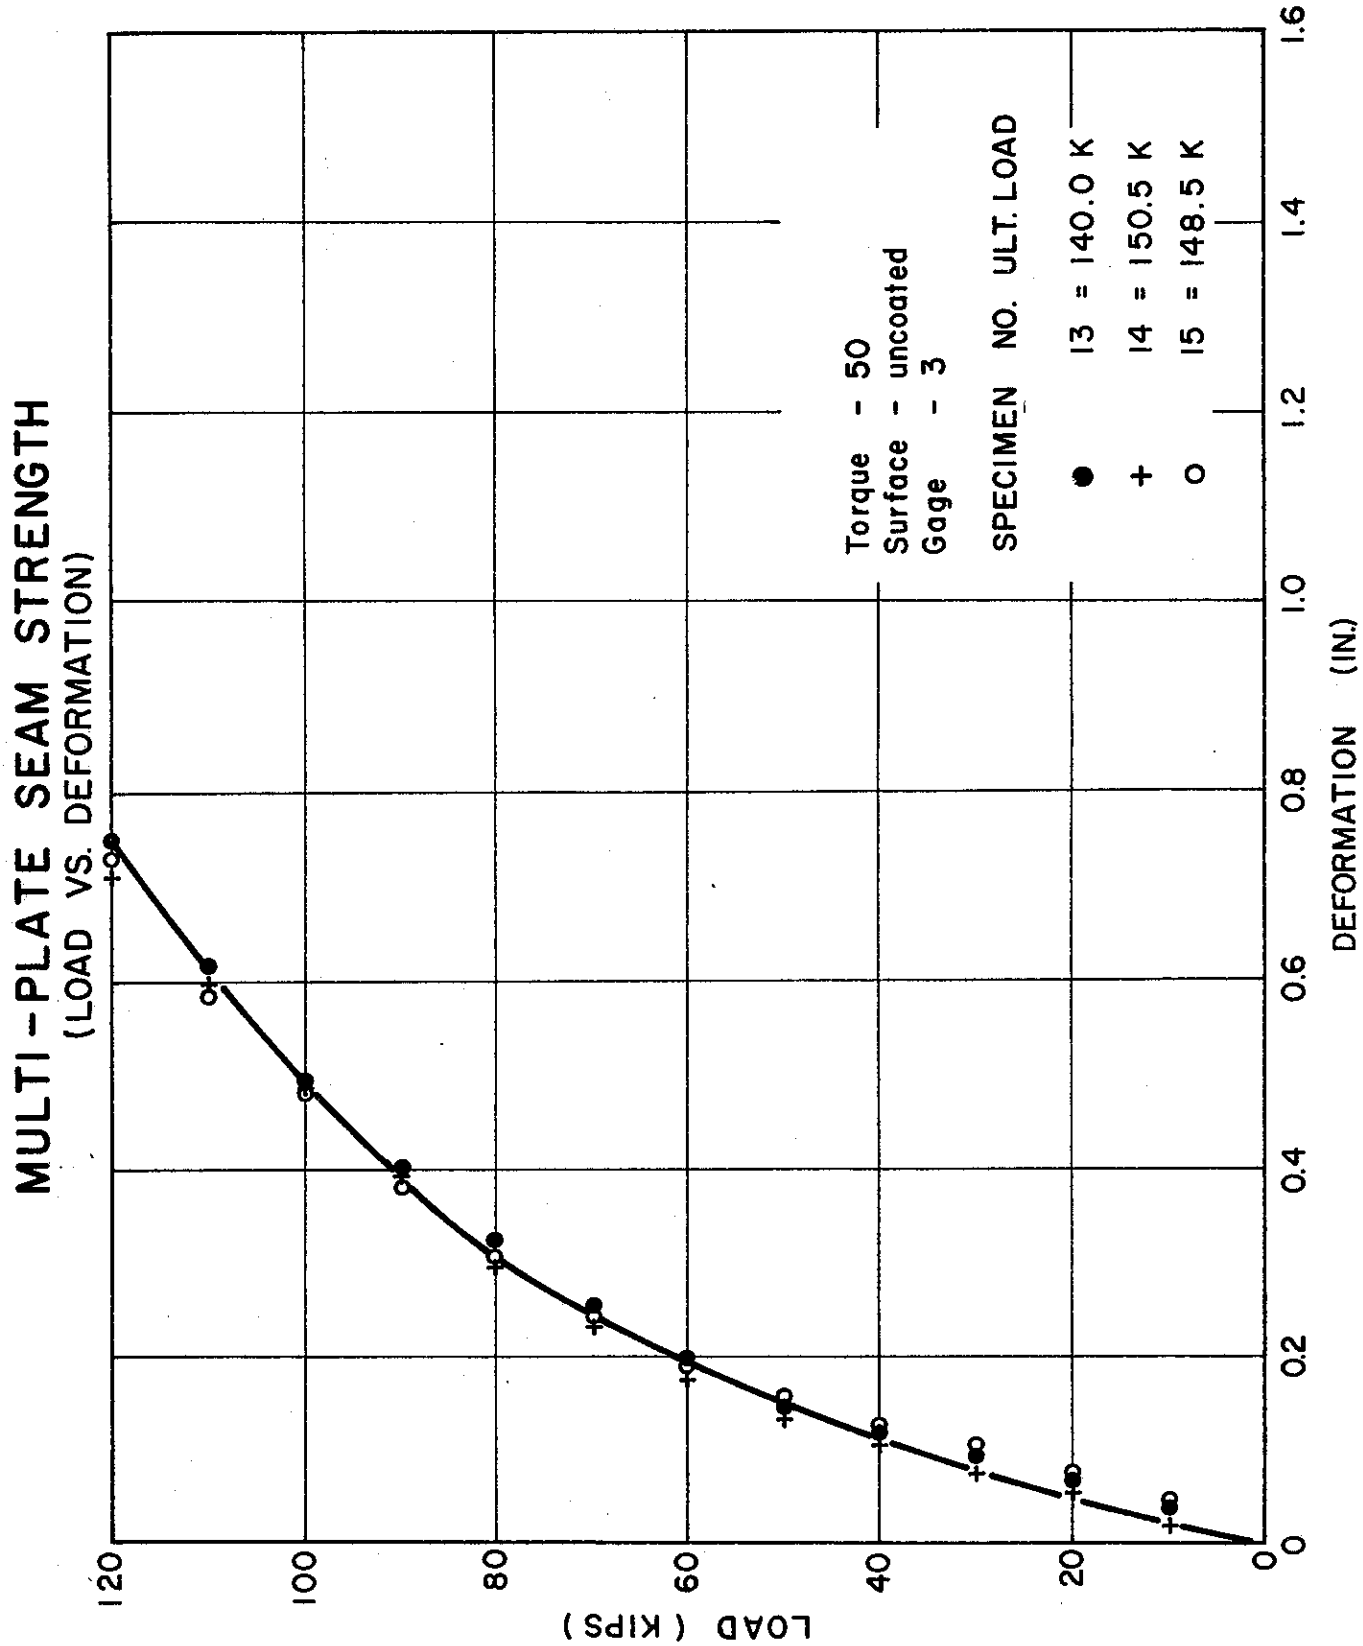
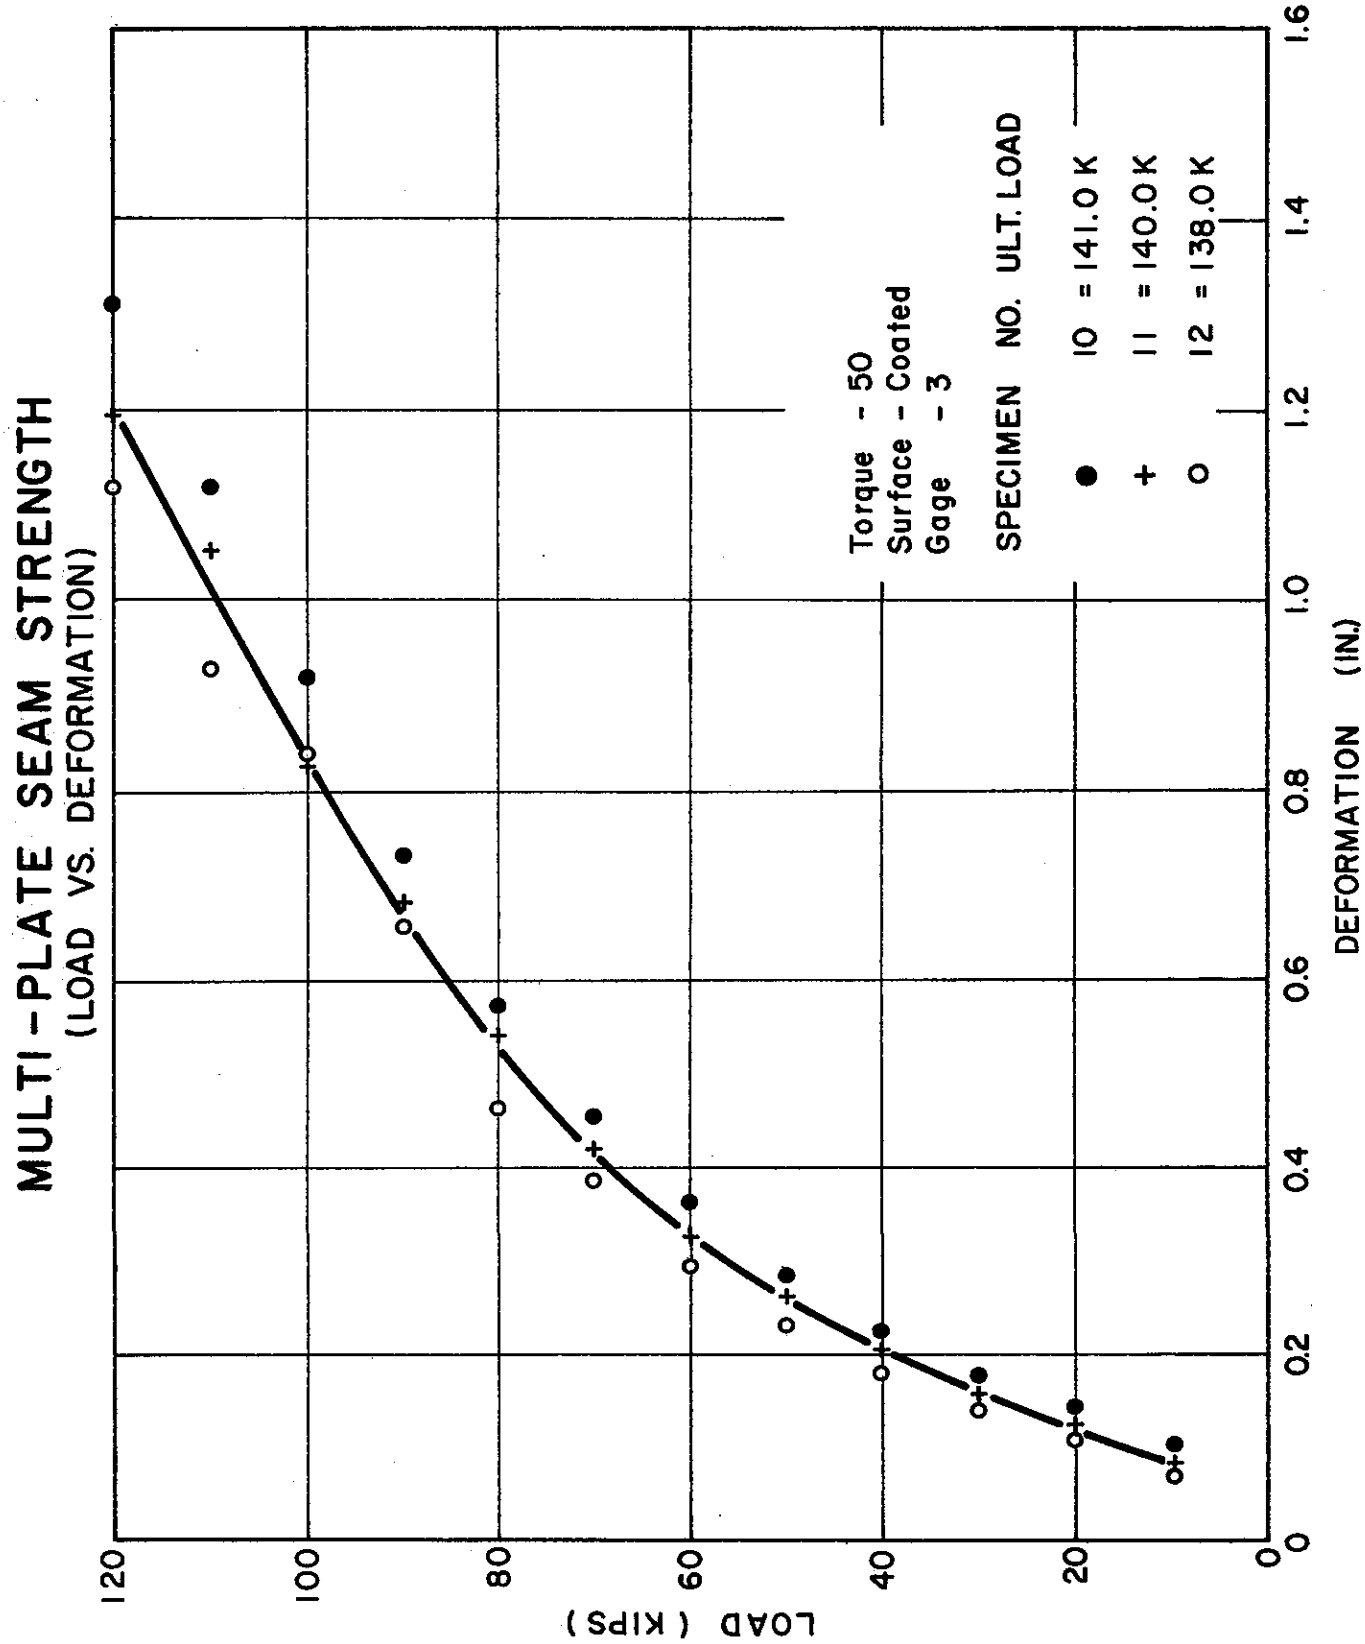
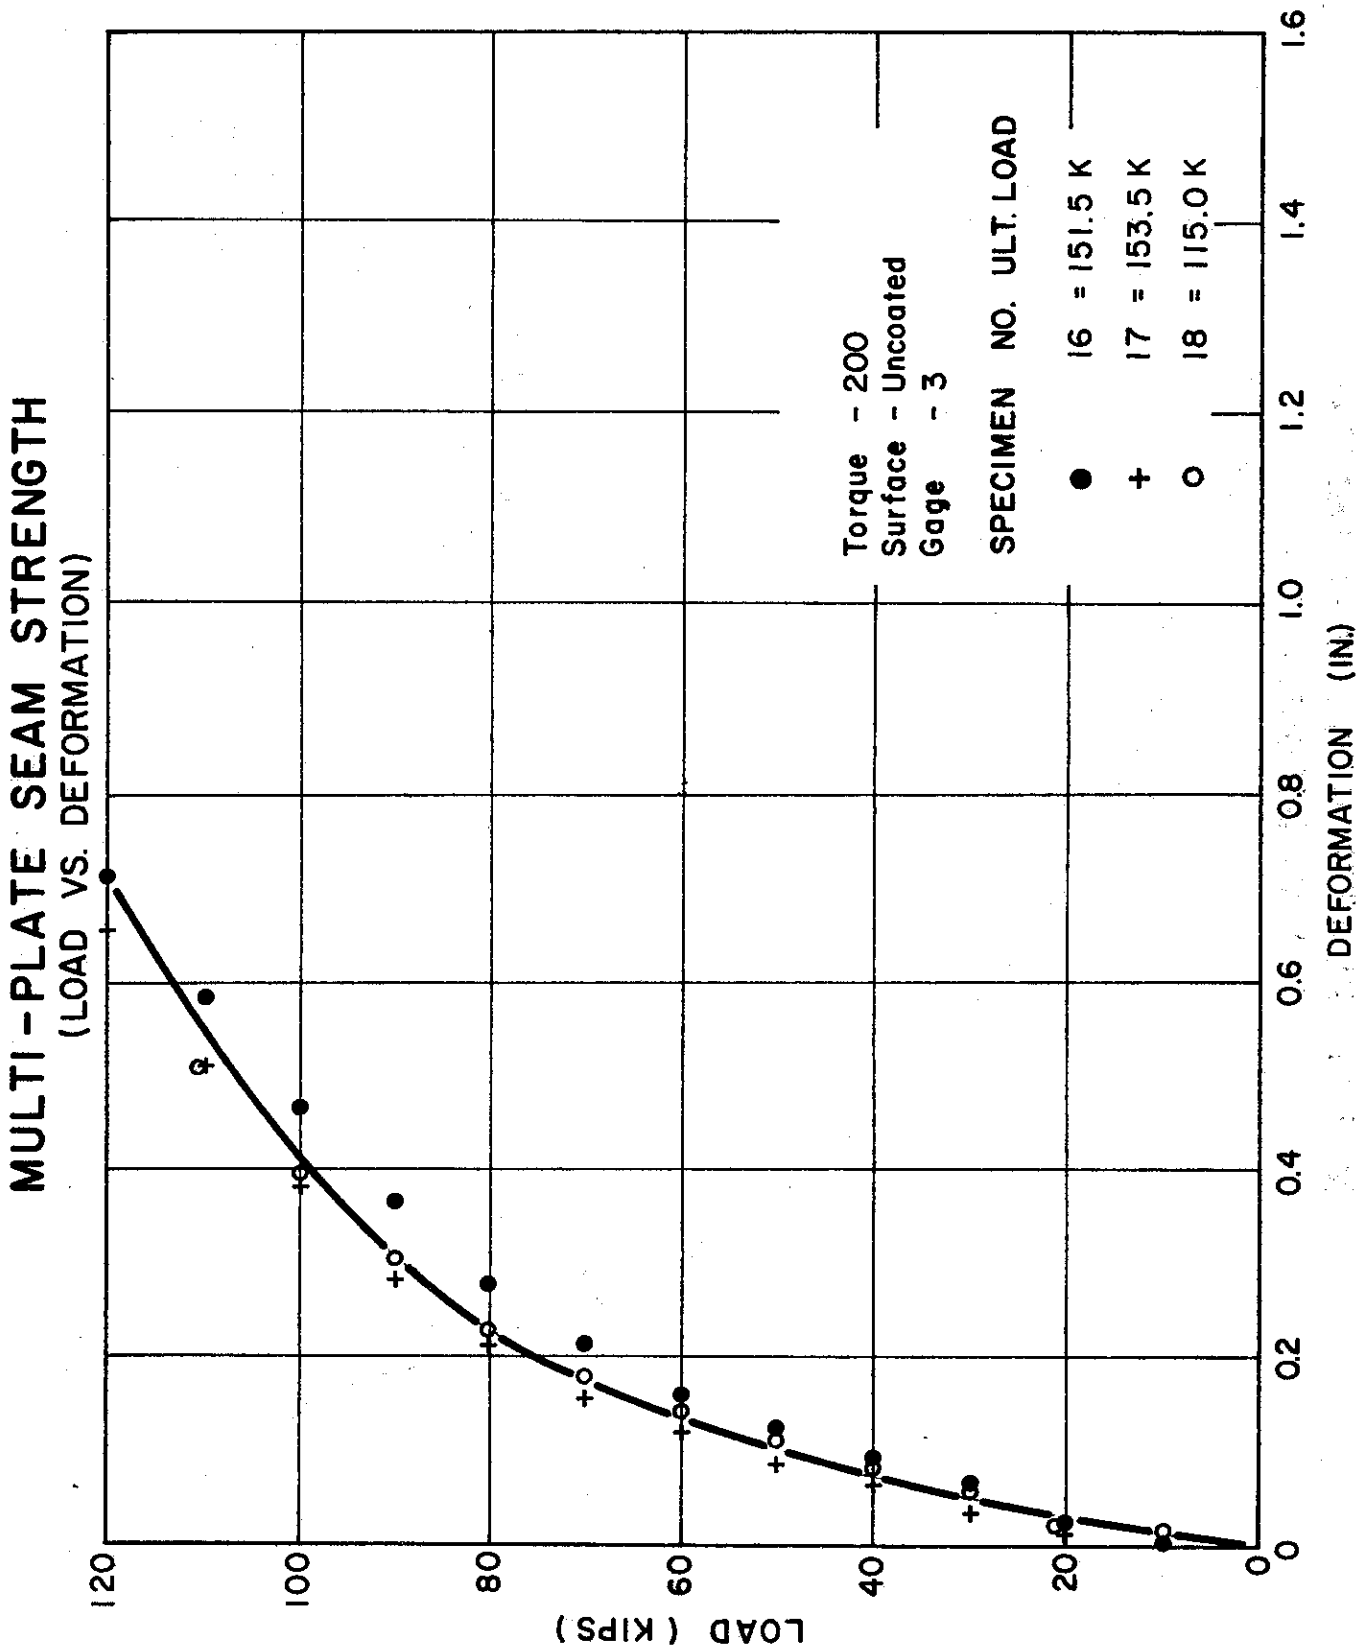
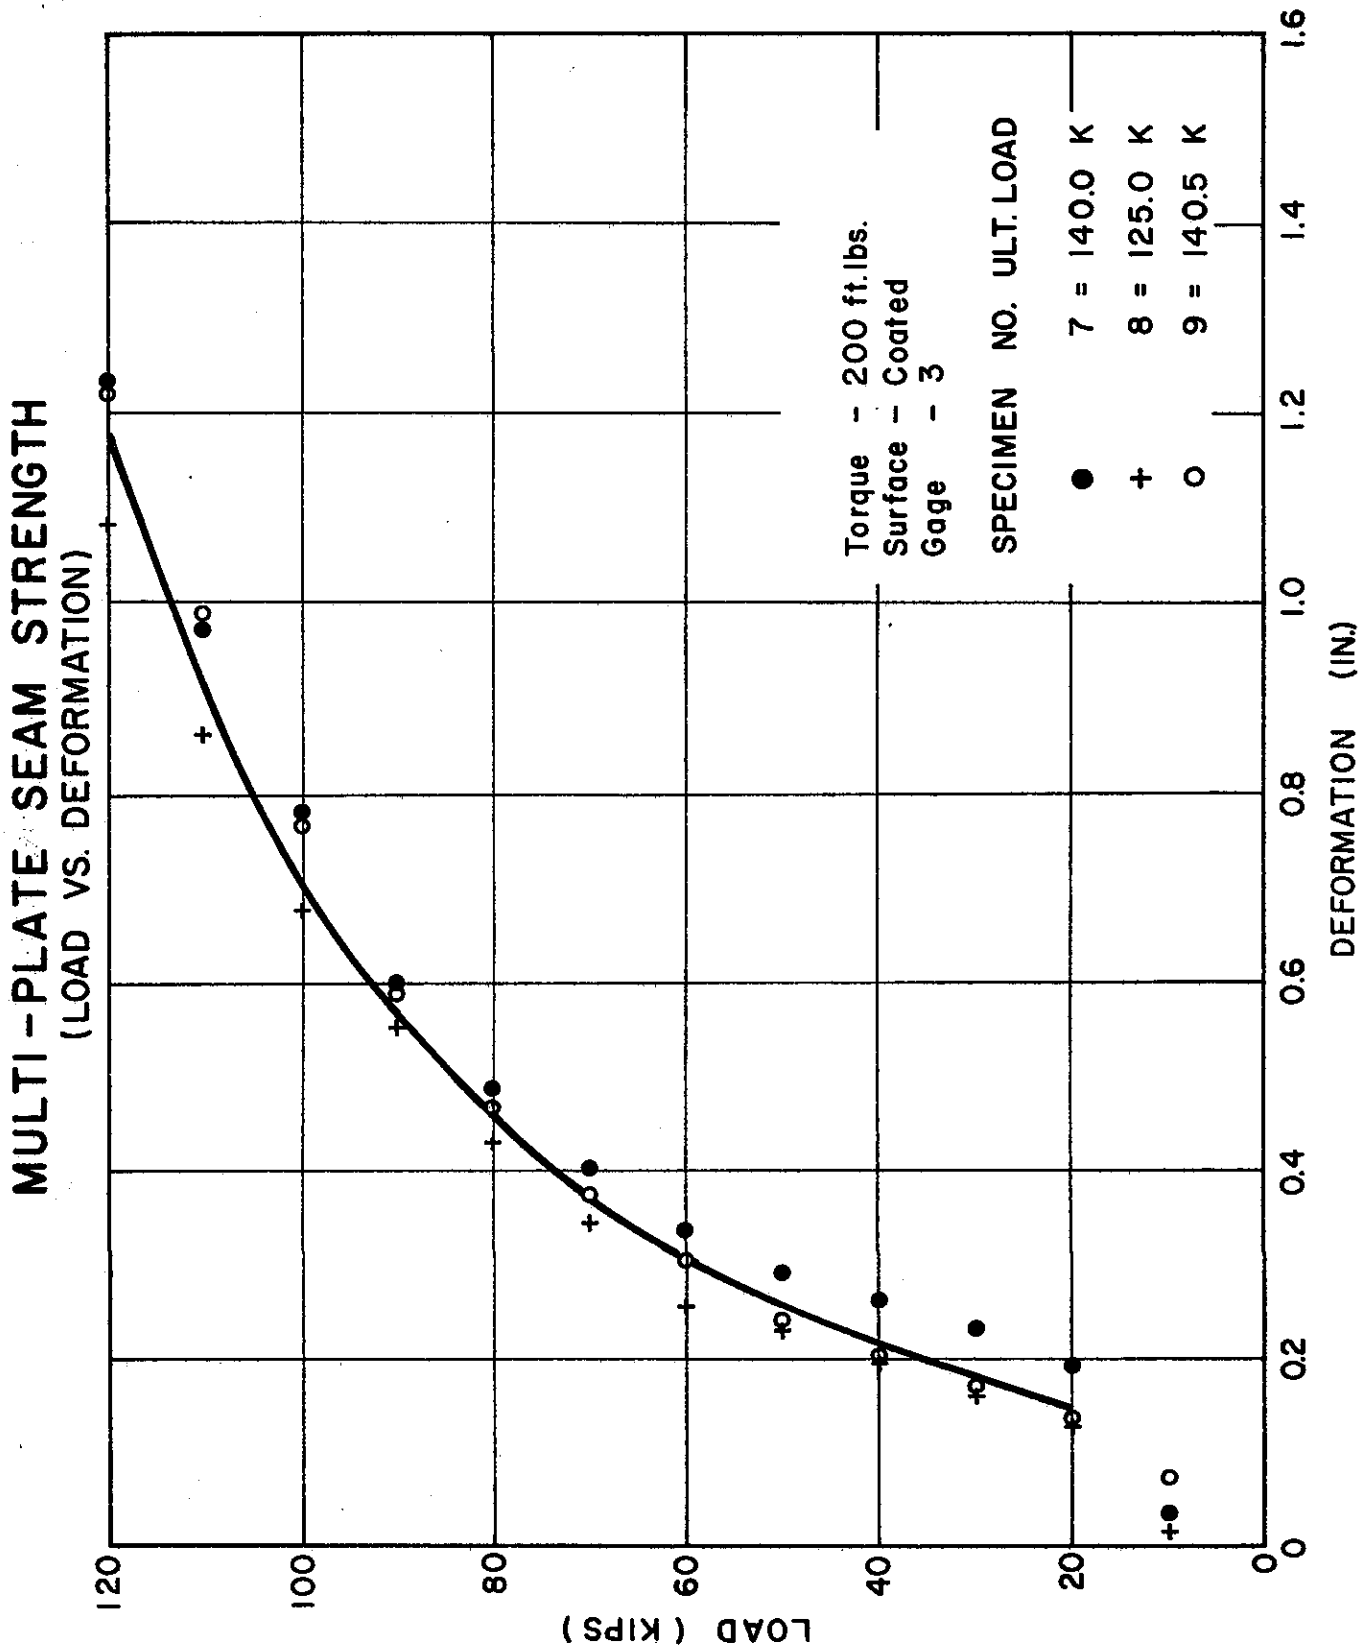
Load deformation curves are shown in Figures 9 through 16. These curves indicate the joint's capacity for considerable movement before ultimate load is reached. This movement is shown by the bolt tipping seen in Figures 3, 4, 5, and 6. This indicates that the specimens retained their structural integrity while the deformations took place. It appears, therefore, that under field conditions the pipe would have the capacity to relieve itself of load by bolt tipping and subsequent sliding of the plates.
