AN INVESTIGATION OF THE CAUSES and RECOMMENDATIONS FOR CORRECTION of the PINOLE SLIPOUT ROAD 04-CC-80

JUNE 1969

69-29

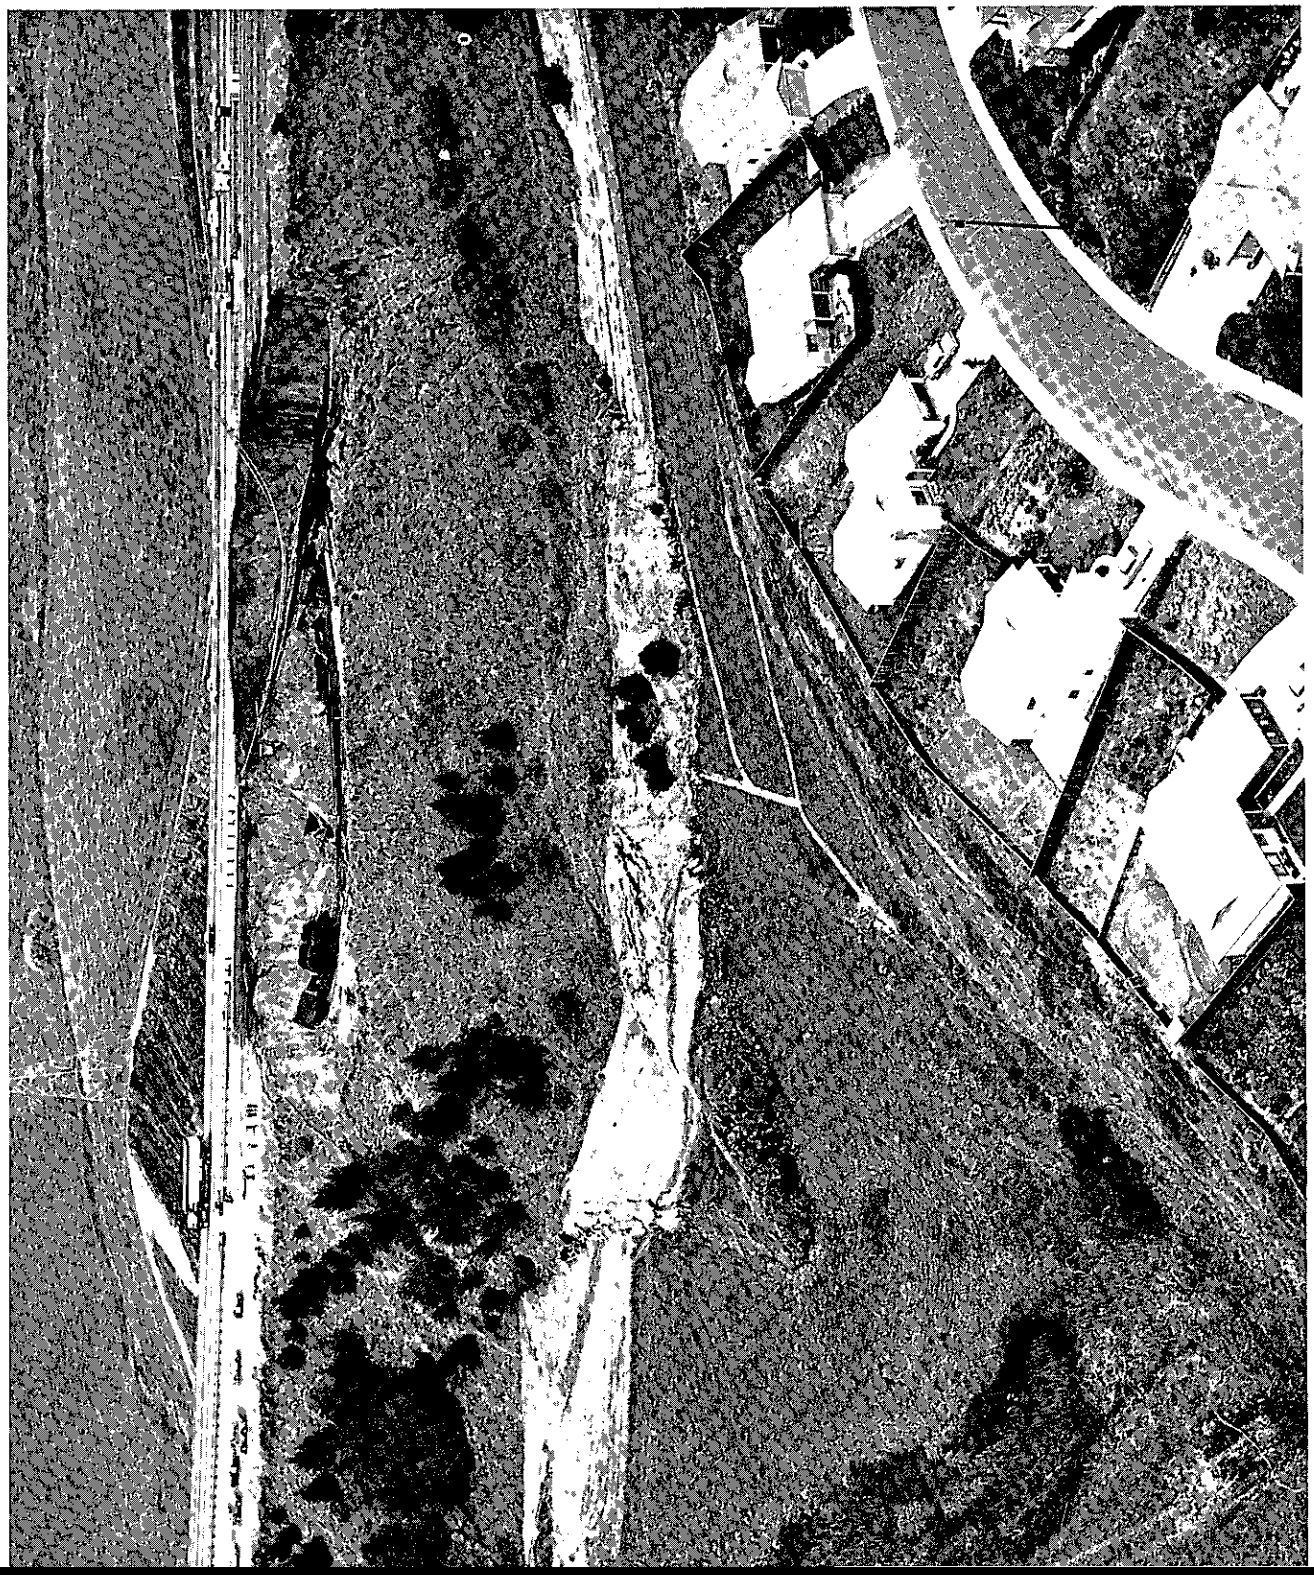
Figure 1

subdivision. The Pinole Fire Department responded immediately and applied chemical foam as a precaution against possible fire. Minor sloughing on the west escarpment face of the slide continued after the major movement took place on Sunday, May 11, to a point where, in the interest of public safety, it was best not to route traffic adjacent to the slide area. The single northbound lane was closed at 9:45 AM on Wednesday, May 14, thereby completely closing all six lanes in both directions to traffic. An overall view of the slide is presented by Figure 1.

channel which converged approximately 380 feet from the right of way line. The possibility of a raise in the water table as a result of subdivision fill construction is indicated by a series of aerial photographs taken at the site between 1956 and the present (Figure 3). In the 1956 photo, prior to the construction of either the subdivision or the highway, the terrain has a smooth and barren appearance. In 1961, four years after construction of the fill, but prior to the construction of the subdivision, we note very little change in the appearance of the terrain with the exception of fill slope vegetation. In 1965, one year after the construction of the subdivision fills, there is evidence of an increase in both highway embankment and subdivision fill slope vegetation. The 1969 photograph taken immediately after the occurrence of the slide in May, reveals areas of relatively lush vegetation at the base of the subdivision fill slopes. This more recent vegetation is shown more clearly in relation to the subdivision fill slopes by Figure 1.

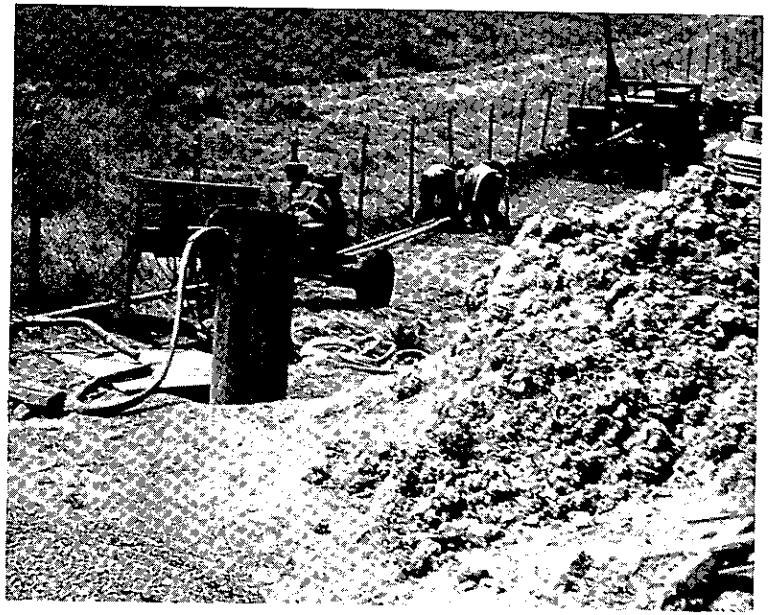
Pumping from cased 3' Dia. Auger Holes

In order to provide immediate relief, 18" diameter slotted steel pipes were inserted in 2 of the 3 foot diameter bucket holes in the vicinity of the detour embankment toe. These were subsequently back-filled with permeable material and pumped dry six times a day. In addition, immediate steps were taken to have a contract let for the installation of horizontal drains. A private horizontal drilling contractor moved a crew and equipment into the lower part of the slipout and commenced horizontal drain installation work on Thursday, May 22, 1969. To date, ten horizontal drains have been installed. These were 700 to 800 feet in length and several have intercepted large quantities of groundwater. This work is still in progress. It is estimated that six to ten additional horizontal drains will be installed under this contract. Dewatering activities at the Pinole slipout are shown by Figure 14.

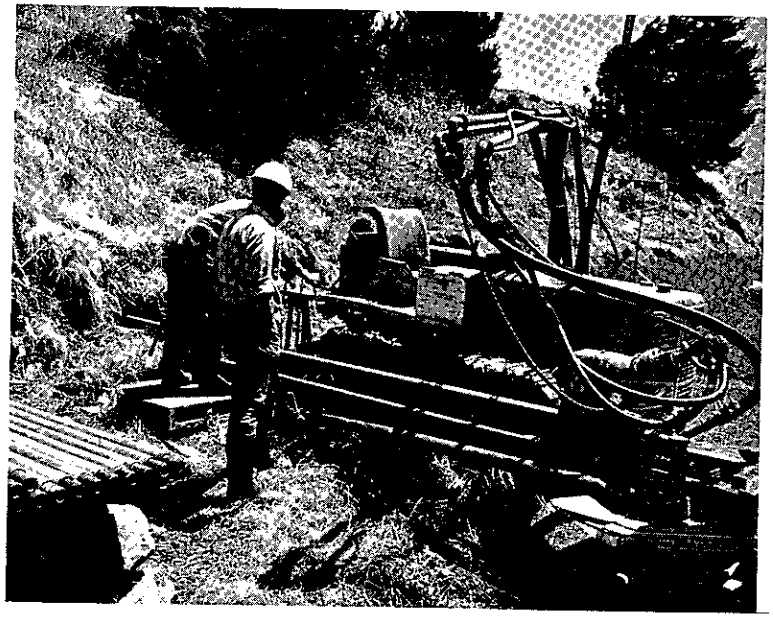
Horizontal Drain Installation

At present, water is being removed from the fill by a series of drilled-in horizontal drains so as to stabilize the detour fill. Replacement construction will consist of a comprehensive subsurface drainage system followed by rebuilding the fill in its same position and reinforcing it with a counterweight fill along its downstream side.

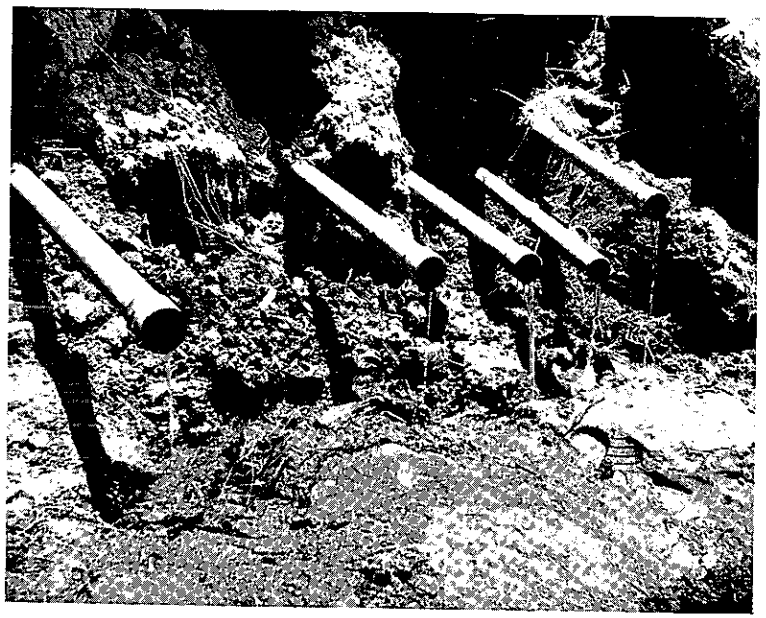
Horizontal Drains

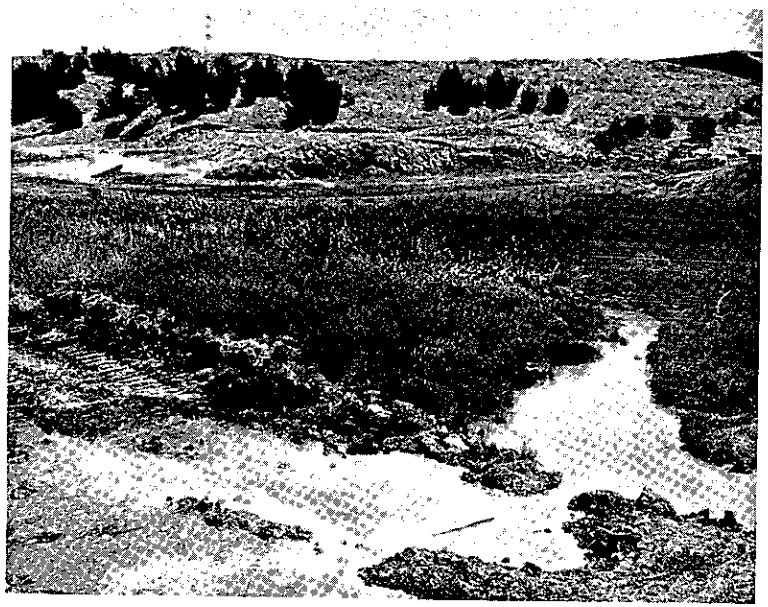
By Monday, May 19, 1969, it was evident that a large amount of groundwater was present in the slipout area. The early borings revealed groundwater at from 20 to 25 feet from the ground surface in the area near the toe of the detour embankment which would rise from 10 to 15 feet upon being encountered. Groundwater near the toe of the slide was observed at original ground level and under a slight amount of head.

Free Water at Slide Toe
