State of California
Department of Public Works
Division of Highways
Materials & Research Department

June 2, 1965

Project No. 33211

SKID RESISTANCE CHARACTERISTICS

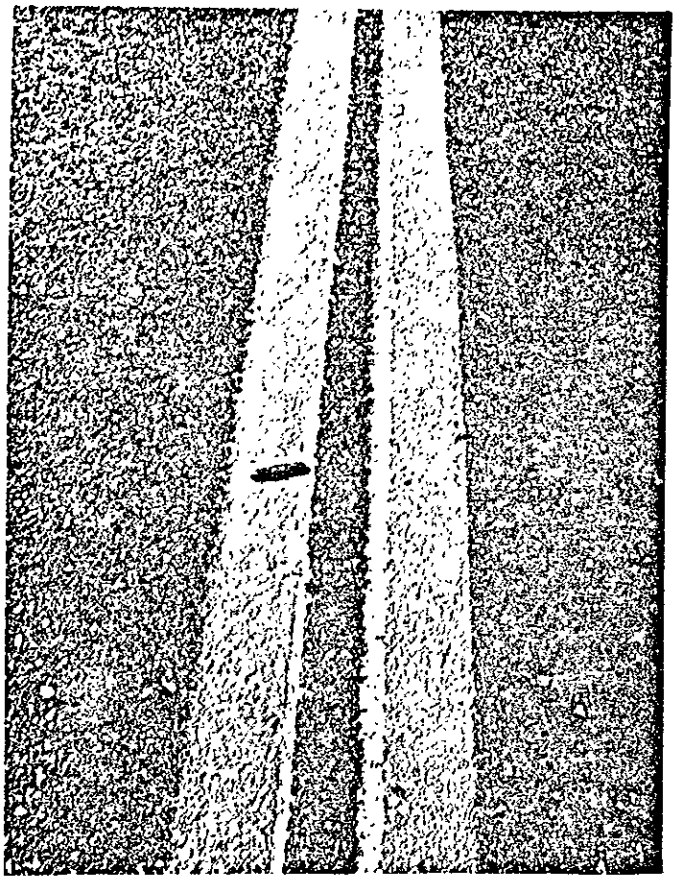
As shown in Table A the skid resistance test results of the thermoplastic stripe are all well below this tentative minimum requirement. Skid resistance test results of the normal painted stripes are quite variable and at two locations the average values are above the minimum requirement. The average values obtained on the 8" wide normal painted stripe are below the minimum requirement both in the tangent and curve test areas. It is apparent from these tests that the frictional resistance of a normal painted stripe is dependent on initial pavement surface texture. Therefore, the skid resistance characteristics of painted stripe are dependent on the amount of pavement surface texture remaining after painting which in turn is controlled by initial surface texture and quantity of paint applied.

Close up of double paint stripes in tangent test area. Note the rough pavement texture and the fact that road surface texture is showing through the paint film.

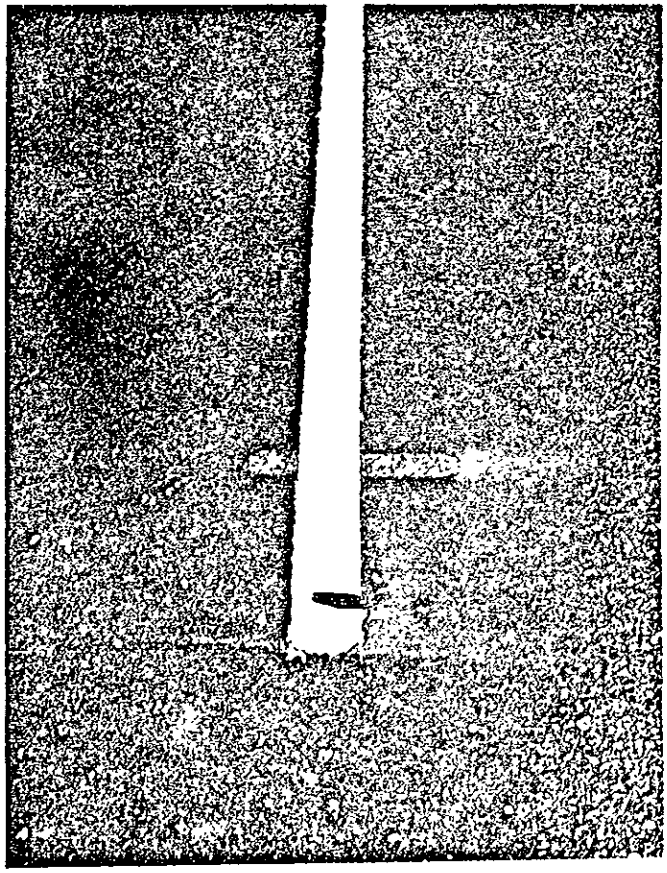
Close up of single 4" wide thermosplastic stripe. Note the rough pavement surface texture does not show through this thick coating.

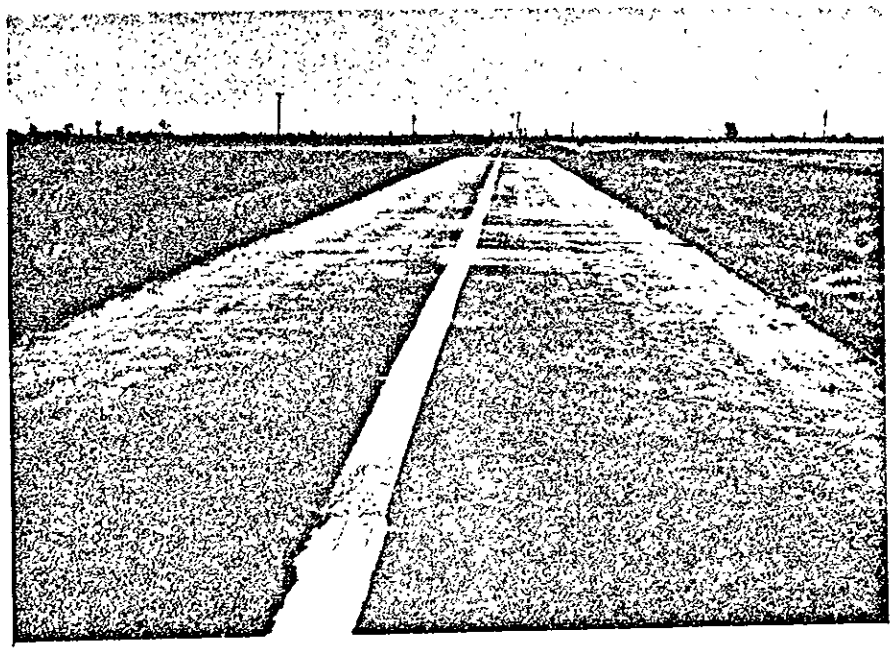
Typical of pavement in tangent test area in a wet condition

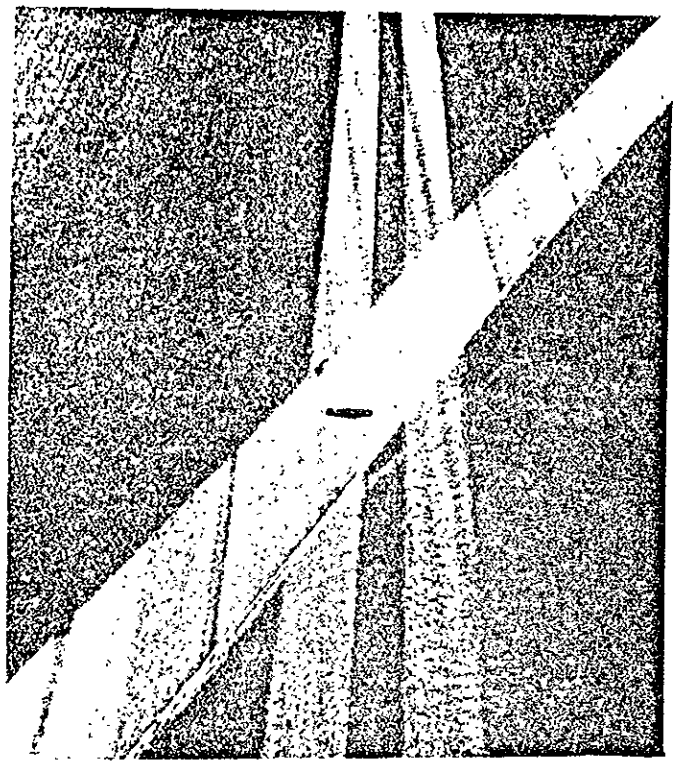
Close up of yellow paint stripe in curve section. The surface texture of this pavement was much smoother than the tangent sections and the paint film had a tendency to fill the surface texture of the pavement.

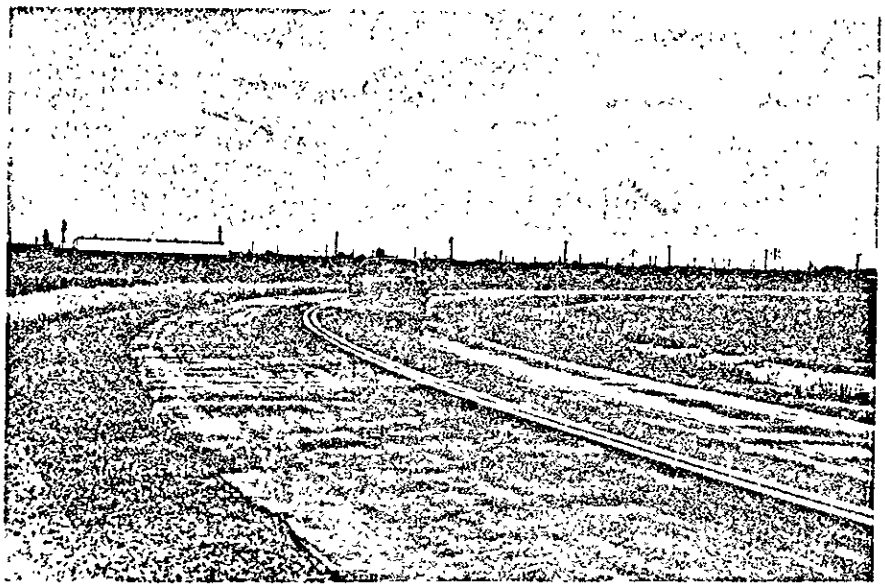
Showing curve test section in wet pavement condition.

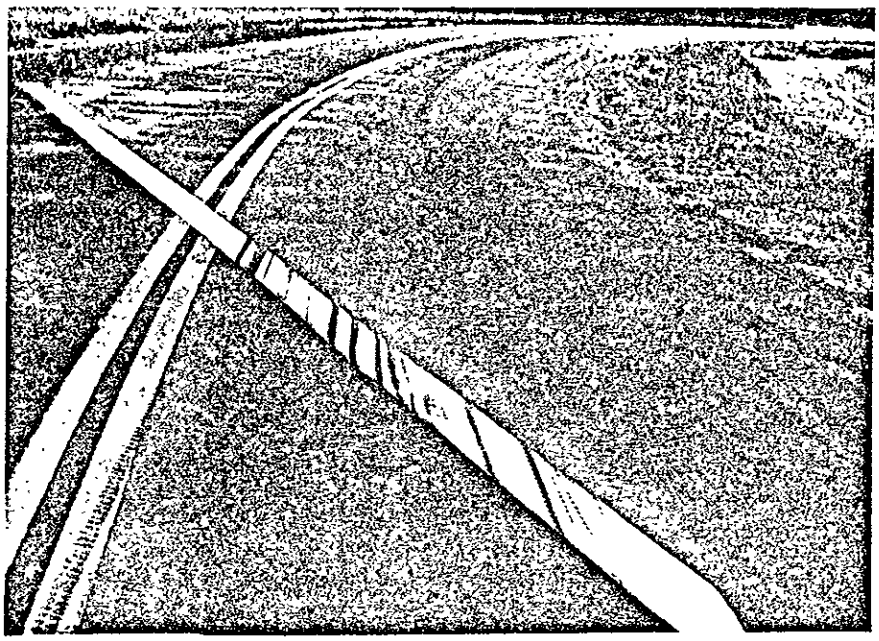
Driver reaction and visual observations of the weaving tests indicated no apparent difference in driver control between the thermoplastic and painted stripes. There was definitely more tire noise when the vehicle passed over the thermoplastic stripe. In the stopping tests with two side wheels on the stripe the vehicle stopped relatively straight regardless of stripe type, however, there appeared to be a greater deposit of black rubber on the thermoplastic stripe.

Showing tire deposits over thermoplastic stripe caused during dry tests. Note that in general the tire deposits on the black pavement and over the stripe follow in the same line which indicates that no skid porblem involving the stripes would exist during dry weather.
