STATE OF CALIFORNIA
DEPARTMENT OF TRANSPORTATION
DIVISION OF CONSTRUCTION
OFFICE OF TRANSPORTATION LABORATORY

TENSAR REINFORCED SOIL

88-05

This report presents the results of a 3-year study of the performance of geogrid reinforced soil embankments constructed with oversteepened slopes using on-site, native material. Two embankments were replaced in late 1985 which had failed as a result of undercutting by La Honda Creek of Route 84 near La Honda in San Mateo County. Both sites had right-of-way restrictions which prevented roadway relocation. Two-way traffic was maintained during construction. These restrictions dictated that the embankments be reconstructed at slopes of approximately 0.75 to 1.

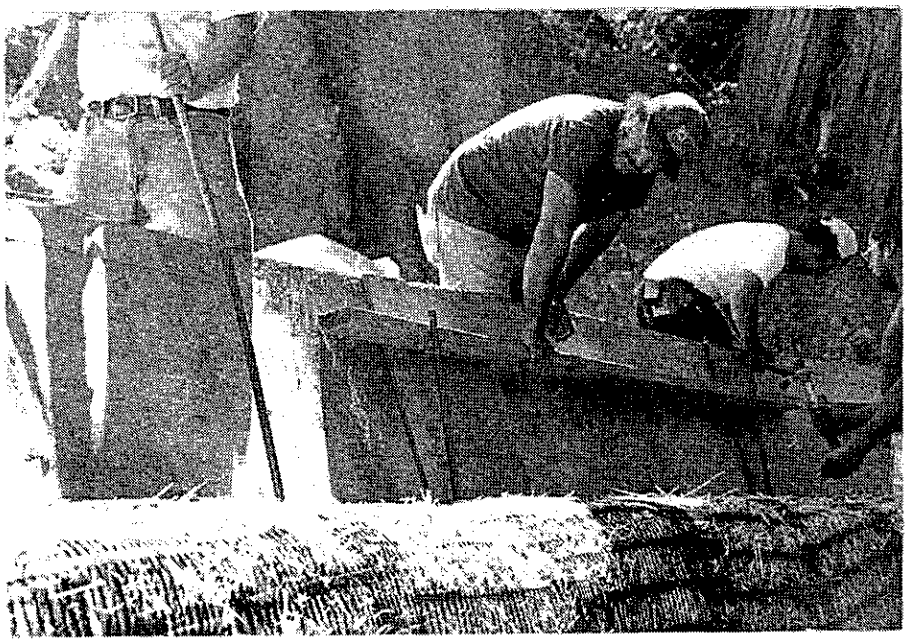
Photograph #05.

Plywood batter.

Restrains compacted backfill until the geogrid is lapped and fastened.

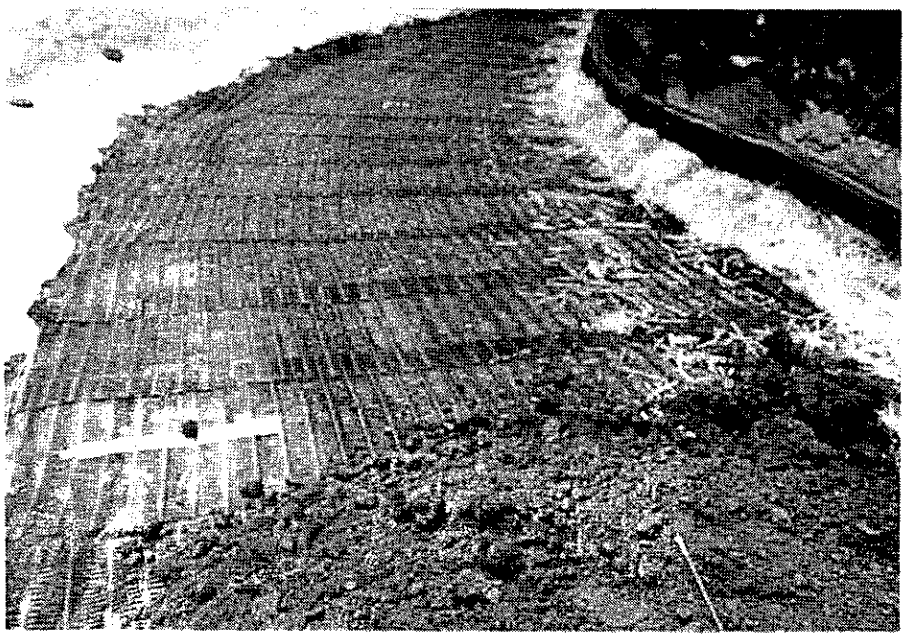
Photograph #06.

TENSAR SR2 was then laid from the face of the cutslope, across the width of the foundation, up the inside face of the plywood and allowed to overhang the plywood to a length of four feet. Straw was placed against the base of the plywood and the lift backfilled, Photographs #06 and #07. Straw was added as backfilling progressed, until the backfilling was completed to the top of the temporary form. The geogrid was then laid back over the embankment, pulled taut with the backhoe or frontend loader and staked to the ground and fastened at the overlap to the adjacent geogrid, Photographs #07 to #09.

Backfilling.

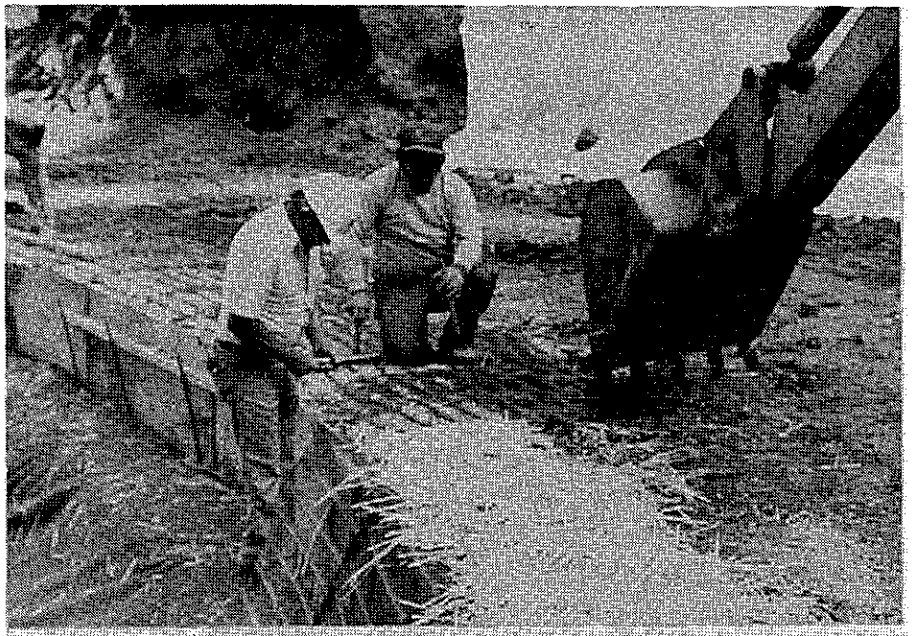
Photograph #07.

Lift completion.

Geogrid is lapped over the top of the step and held by backhoe until secured by hand.

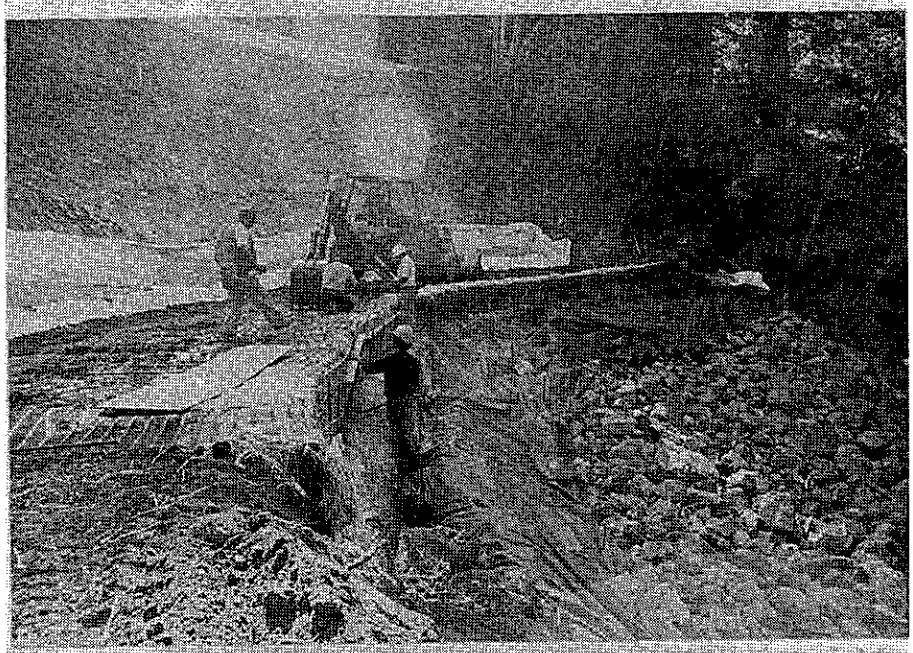
Photograph #08.

The unreinforced section was placed from the foundation to a height of fifteen feet, Photograph #04, and protected from stream erosion by a rock slope. The rock slope, which can be seen in Photographs #08 and #09, was keyed into the original ground to a minimum depth of five feet adjacent to the creek. The Resident Engineer extended the limits of the rock slope protection at both embankments to increase rigidity and stability.

Lift completion.

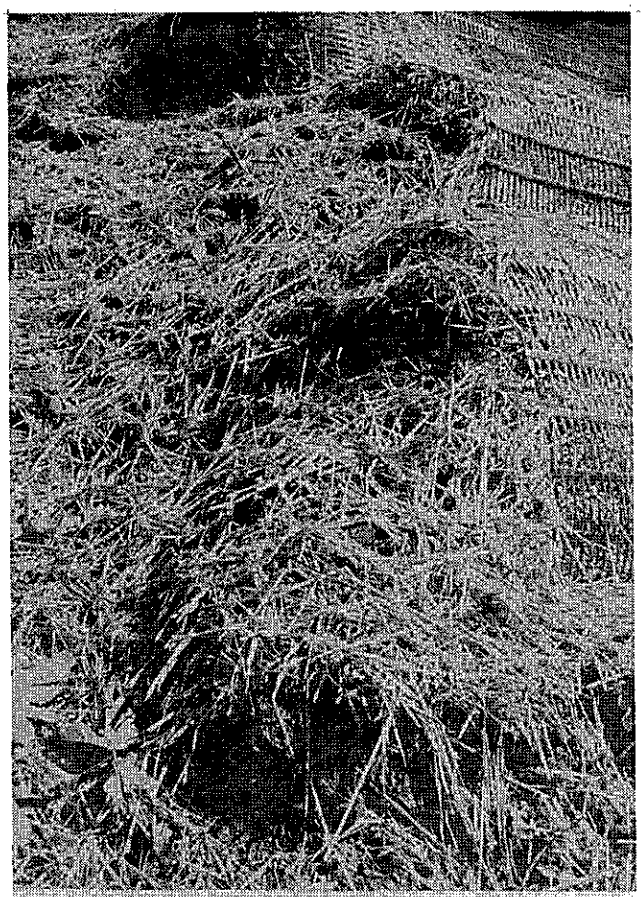
Photograph #10.

End of step.

Untucked end of step.

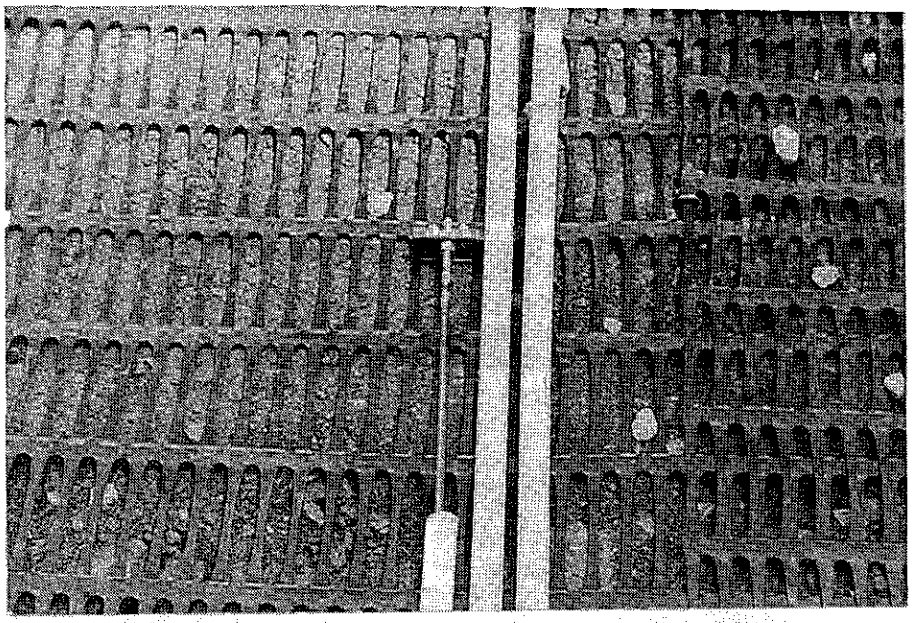
Photograph #12.

Extensometer installation.

End of extensometer rod secured to geogrid.

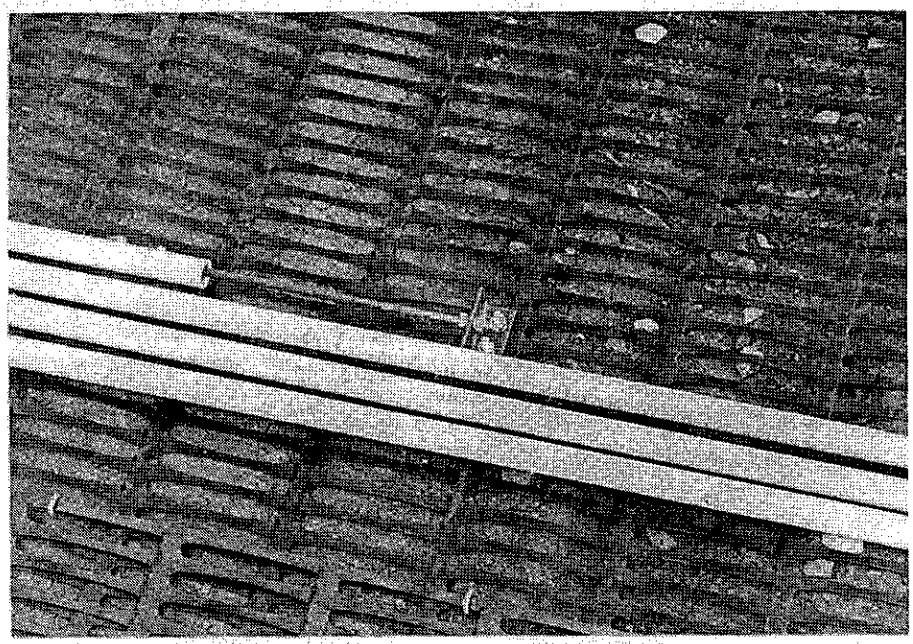
Photograph #13.

The extensometers measure horizontal or outward movement of the embankment. They are constructed by fastening rods to the geogrid, Photographs #12 and #13, at various distances from the face of the embankment. The rods pass through PVC pipe, Photograph #14, and extend out the face of the embankment. The PVC pipe isolates the rods from the effects of potential skin friction that could be imposed on the rods by the moving soil mass. The anchor rod is laid alongside the extensometer rods. This rod is firmly fastened, Photograph #15, in the original ground behind the drainage blanket and passes through PVC pipe to the face of the terrace. The ends of the rods are cut off evenly, Photograph #16, and thereafter, any outward movement within the embankment is reflected as a progressive increase in the distance, Photograph #17, between the ends of the rods fastened to the geogrid and the end of the anchor rod fastened in the original ground.

Extensometer installation.

Same as previous photo.

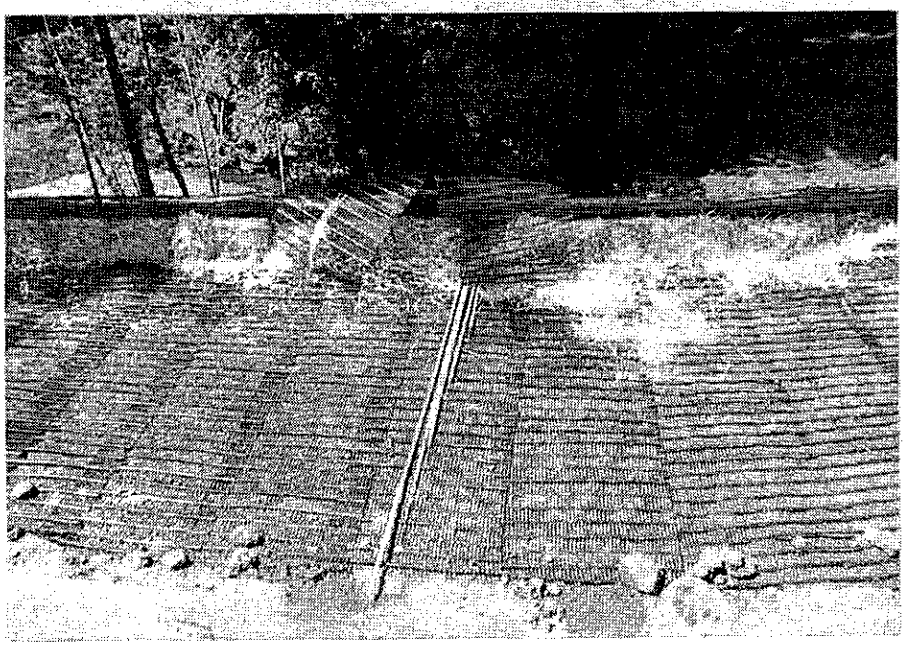
Photograph #14.

Extensometer installation.

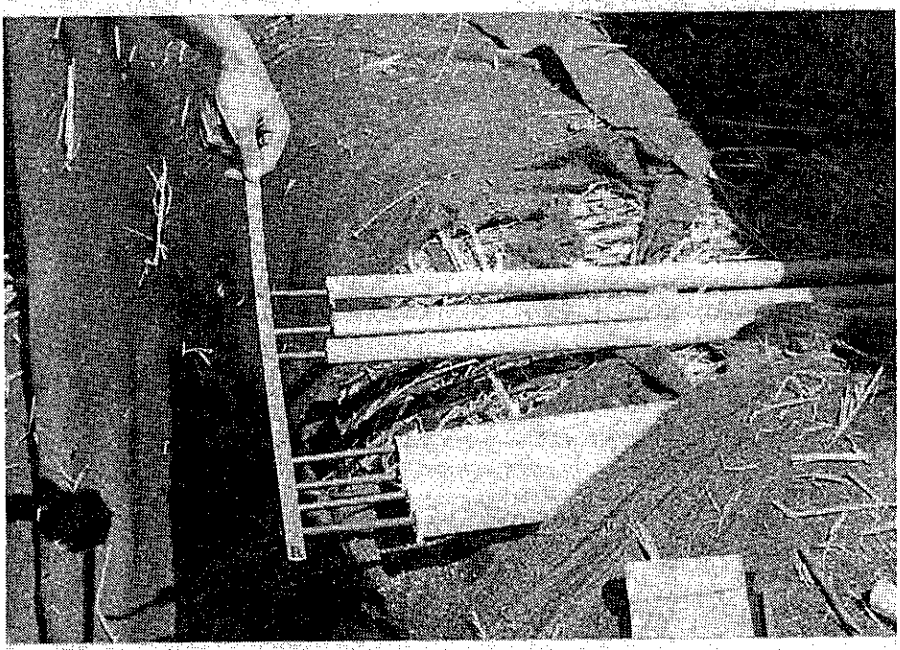
Photograph #16.

Extensometer installation.

Rods cut off evenly to complete installation.

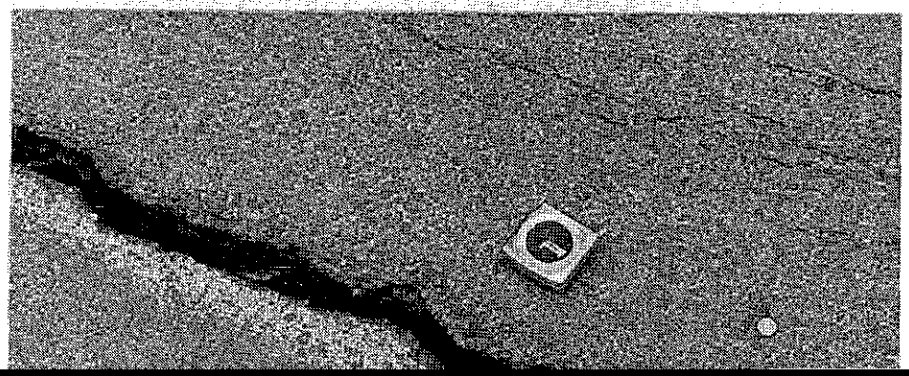
Photograph #20.

Immediately after construction the pavement cracked at both embankments as shown in Photographs #19 and #20. The cracking was controlled by minor patching and did not

Pavement cracking.

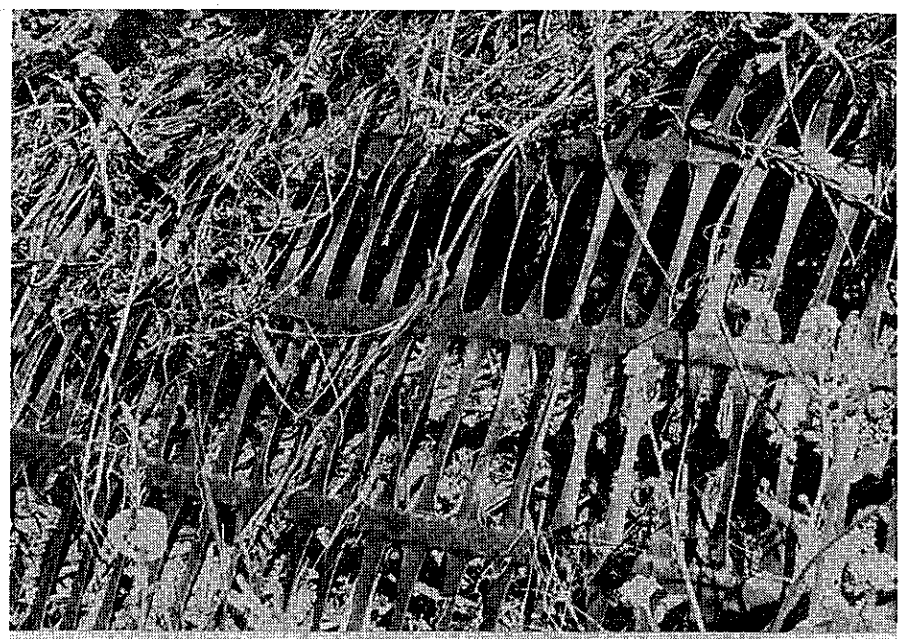
Photograph #21.

The straw has decayed, leaving voids behind and under the geogrid and the surface of the embankment is slowly changing from "step-like" to a more or less continuous slope, Photographs #21 thru #23. Moving about on the steps of the slope is becoming increasingly difficult and staff should be cautious when doing so.

It appears that more than 3 inches of straw was used in some places. The straw has now decayed, allowing voids to form under the geogrid. This leaves the geogrid unsupported and in some places the geogrid has deformed to approach a more natural slope. In other places, the geogrid is unsupported by any underlying materials. Both of these conditions make walking on the embankment difficult. Straw used in future projects should be kept to ~3 inches.

Present condition.

Void under geogrid left by decayed straw.
