DUST CONTROL DURING CONSTRUCTION OPERATIONS

Ernest Zube

Presented at the 39th Annual Meeting
of the Highway Research Board
Washington, D.C., January 11-15, 1960

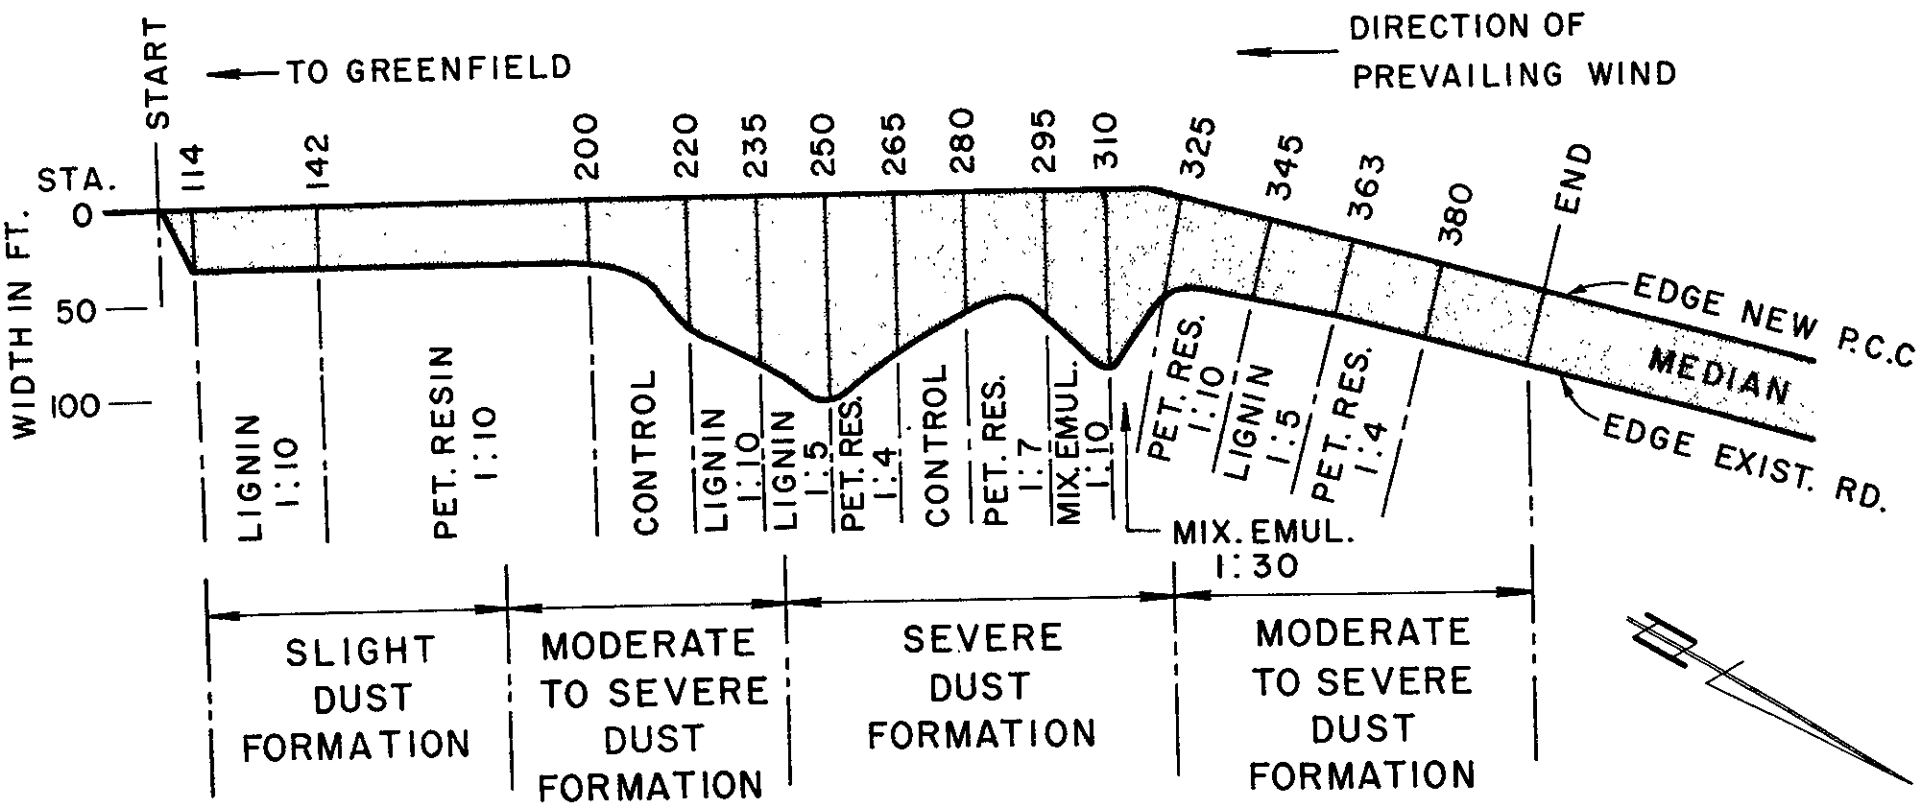
Fig. 1

DUST BINDER TEST SECTIONS
ROAD V-MON-2-D
Test Sections Laid on Aug. 12, 13 & 14 - 1957

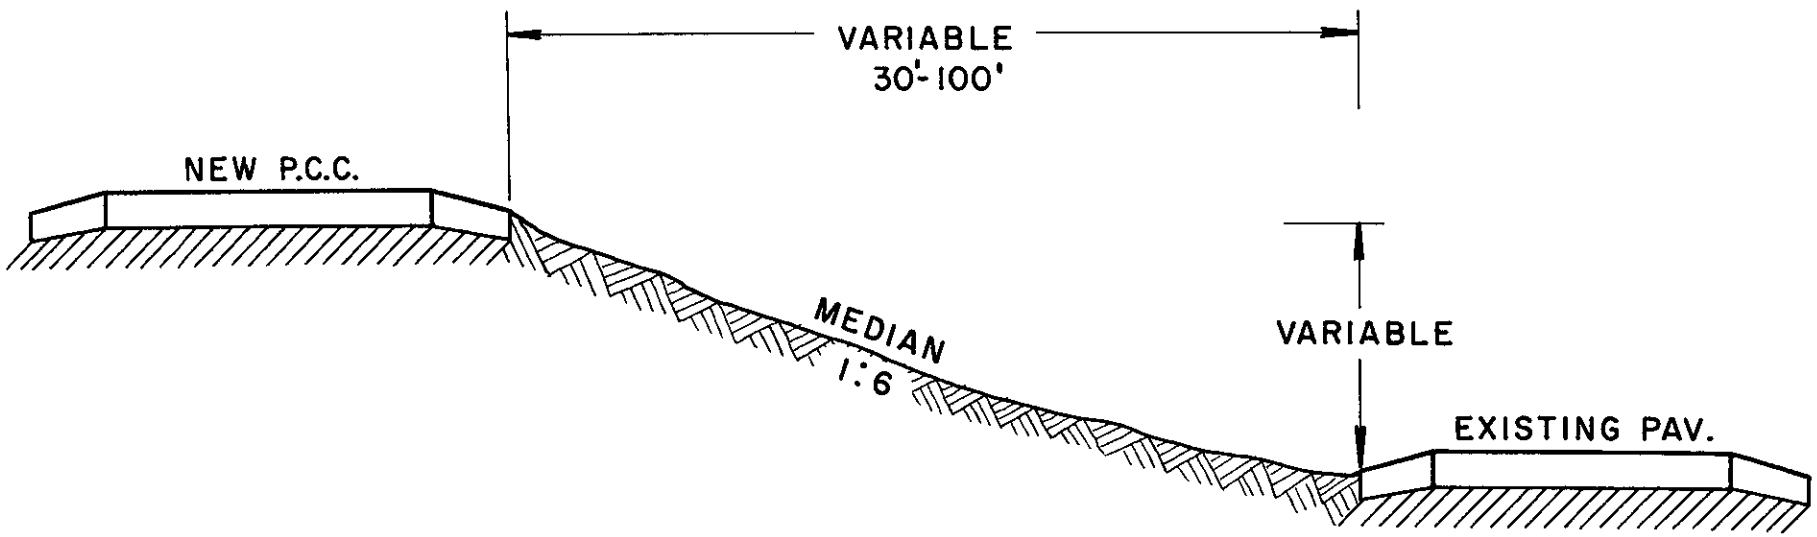
Fig. 2

CROSS SECTION
DUST BINDER TEST SECTIONS
ROAD V-MON-2-D

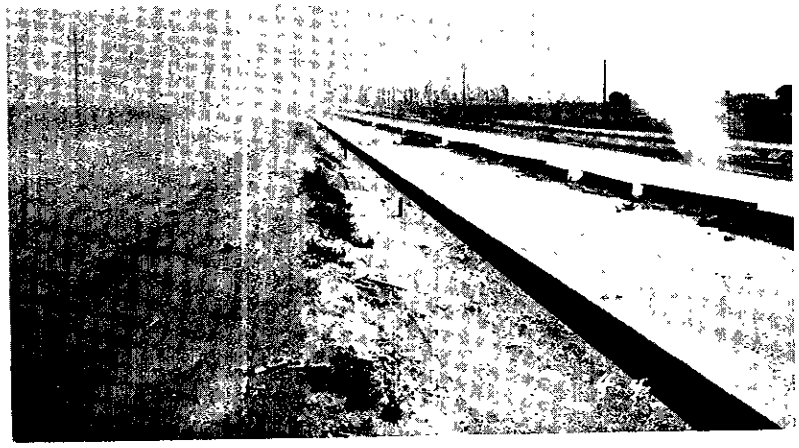
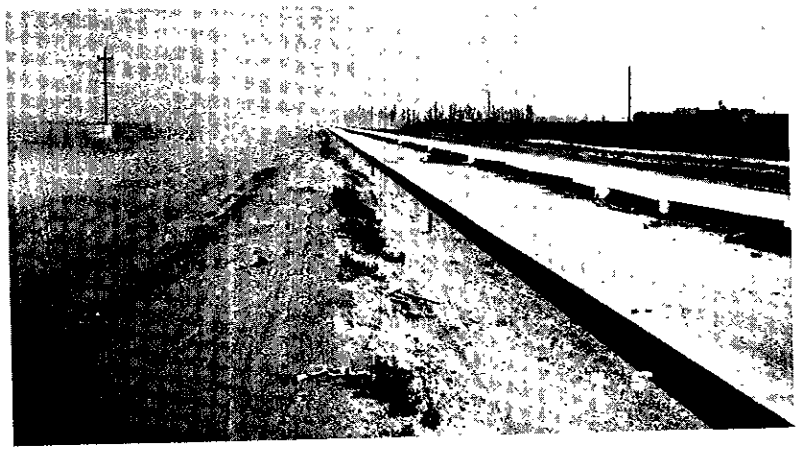
As mentioned previously, the median strip on Monday morning, August 12, was in a tightly compacted condition. Water had been placed on the median during the night and it was decided to stop all sprinkling in order to secure maximum penetration of the dust binders. Because of problems involving transfer of the concentrates to storage trailers and checking of spread rates, only one section, the lignin 1:5, was completed by noon. About 11 a.m. the wind began to blow and by 1 p.m. the wind velocity was averaging around 20 miles per hour, with gusts up to 25 miles per hour. By 1:30 p.m. visibility on the adjacent travelway had been reduced by dust from the median so that lights were required. The photographs shown in Fig. 5 indicate the extent of dust formation.

Typical dust formation on untreated sections five hours after cessation of watering operations. Wind speed 20-25 miles/hr. Note reduced visibility on existing travelway on left side of photograph. Median had previously been heavily watered for over a month and tightly compacted by movement of water trucks.

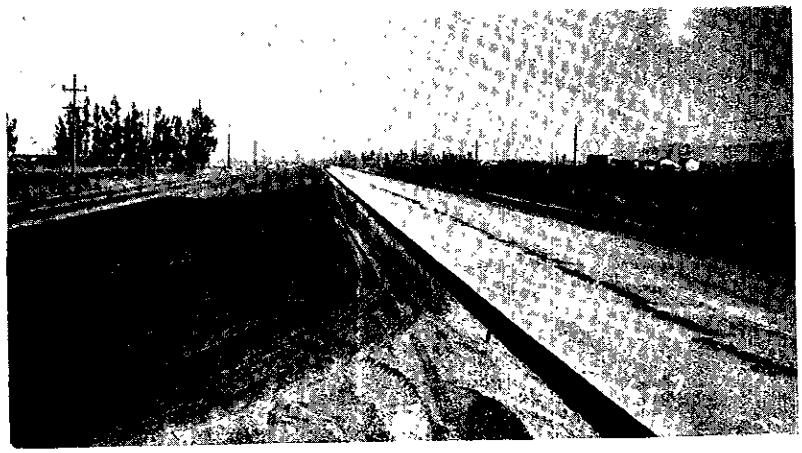
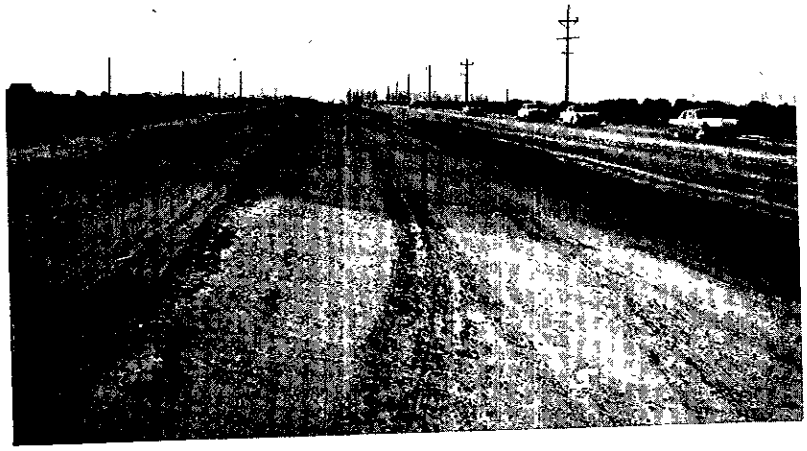
Approximately twenty-four hours after completion of spreading, the test sections were evaluated on the basis of surface appearance and dust formation, see Fig. 6.

Asphalt mixing emulsion 1:10 section in foreground Petroleum resin 1:7 section in background

Untreated section in foreground Lignin sulfonate 1:10 section in background

Appearance of test sections, 24 hours after application

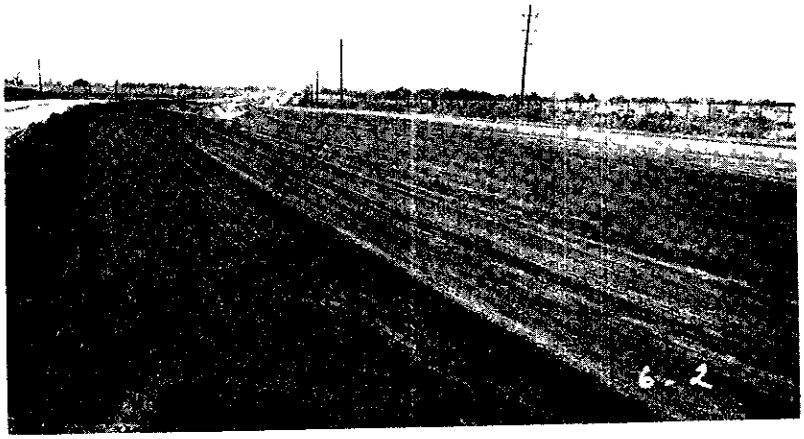
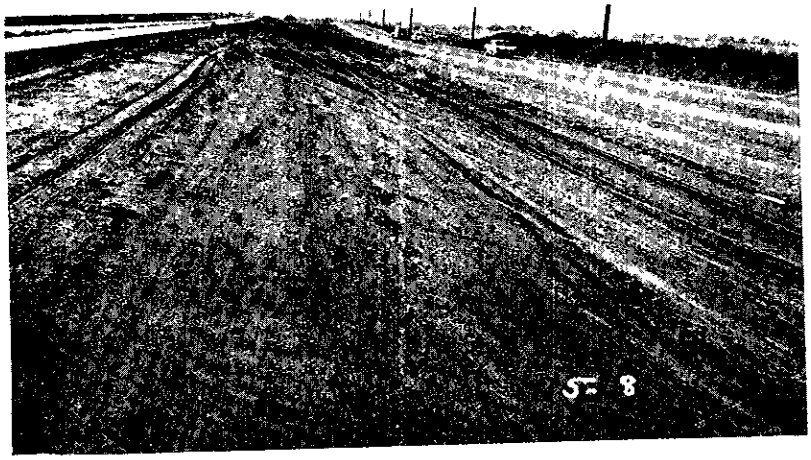
All of the test sections were completed by noon on Wednesday, August 14. At 11:00 a.m. the wind again started and reached Monday's velocity by 1:00 p.m. No water had been applied to any of the test sections, except the controls, after spreading was completed and although high winds persisted throughout Wednesday afternoon and evening, there were no signs of dust. Photographs shown in Fig. 7 show the lack of dust over the treated sections. We may conclude that dust formation had been completely reduced by all of the various dilutions of dust binder concentrates placed in the test sections.

Asphalt mixing
emulsion
1:30

Asphalt mixing
emulsion
1:10 background
Petroleum resin
1:7 foreground

Photographs showing lack of dust formation over treated sections. The top picture shows an area where the most severe dust formation was encountered on the job. These photographs were taken approximately 48 hours after treatment with a wind velocity of 20-25 miles/hr. Compare with photographs shown in Fig. 5.

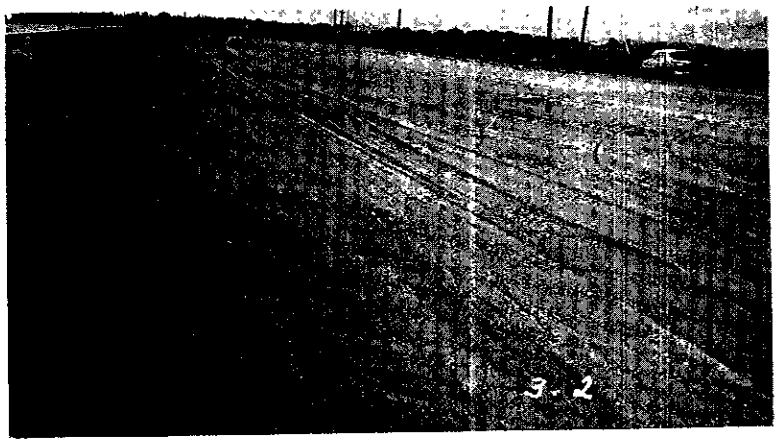
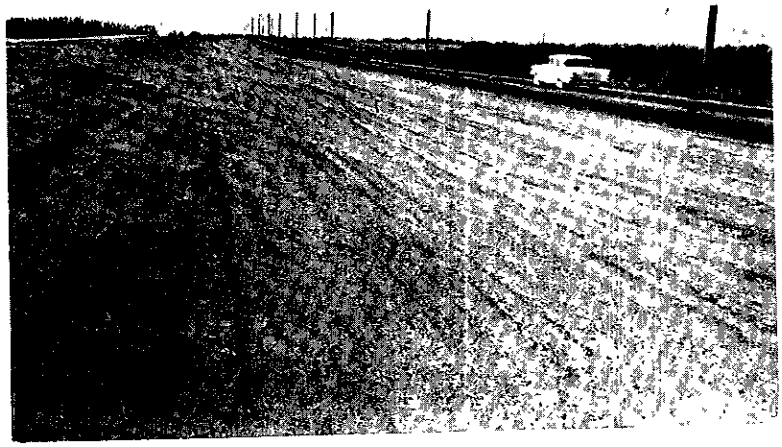
The survey made after thirty-five days indicated that all of the various sections were performing in a satisfactory manner, with the same general wind conditions encountered prior to treatment, Fig. 8. The general appearance of the test sections may be summarized as follows:

1. Lignin sulfonate 1:5 and 1:10 dilutions still appeared quite dark, with quite extensive cracking and curling in the 1:5 section. This cracking and curling had not caused separation of the crust from the underlying layer and no evidence of dust formation was present.

2. All of the various petroleum resin dilutions showed a remarkable change in color from the original. The sections gave no appearance of having been sprayed and showed no signs of cracking or curling as noted in the lignin section. On close inspection one could detect yellowish-like streaks where runoff had occurred during the second pass. Although these sections had assumed the color of the native soil the treatment provided full protection against dust formation at wind velocities exceeding 25 miles per hour.
3. There was no major change in the appearance of the emulsion sections. There was no evidence of drying out or cracking and curling.

Petroleum resin
1:10 foreground
Lignin sulfonate
1:5 background

Asphalt mixing emulsion
1:10 foreground
1:30 background

Petroleum resin
1:7 foreground
Asphalt mixing emulsion
1:10 background

Typical appearance of various areas of the treated median 35 days after completion of treatment.

Wind velocity at time that photographs were taken was 20-25 miles/hr. No water had been applied to these sections following treatment. Note complete freedom from dust.
